SR 24 Washington County Georgia Landslide

Project Background

The landslide occurred between Stations 308+00 to 320+00. This was a new, four-lane alignment section to replace the two-lane existing alignment. Embankment construction began in 2011 and paved in 2013.

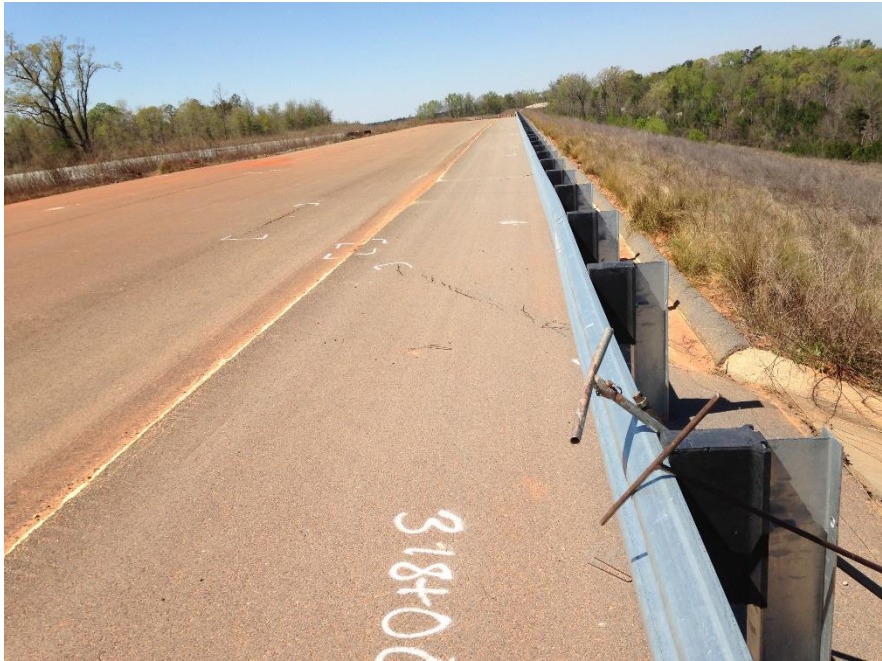
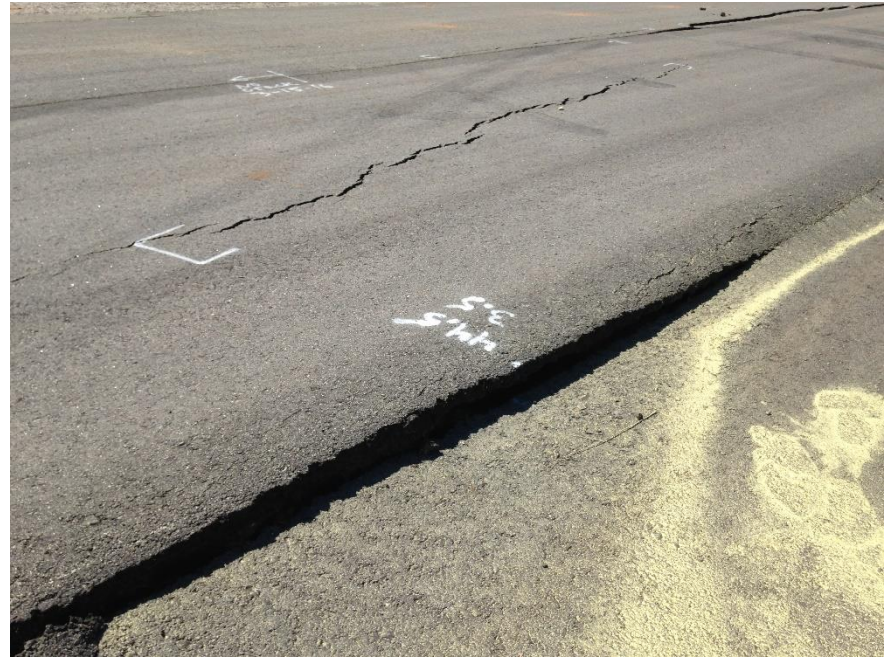
Photos were taken 3/21/2016

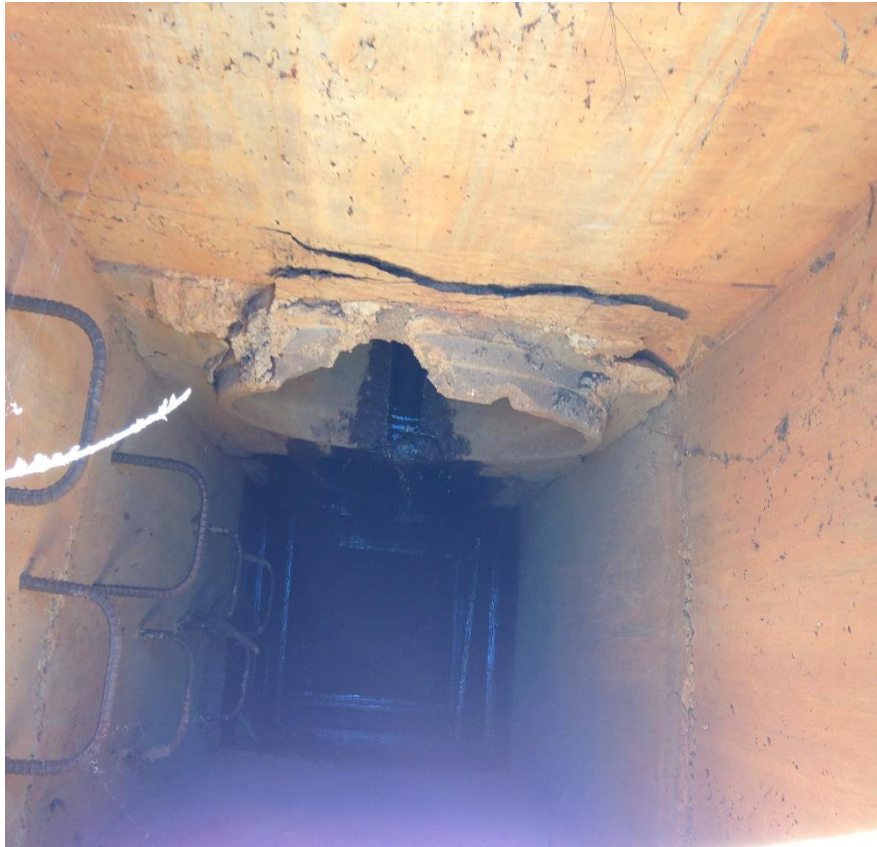
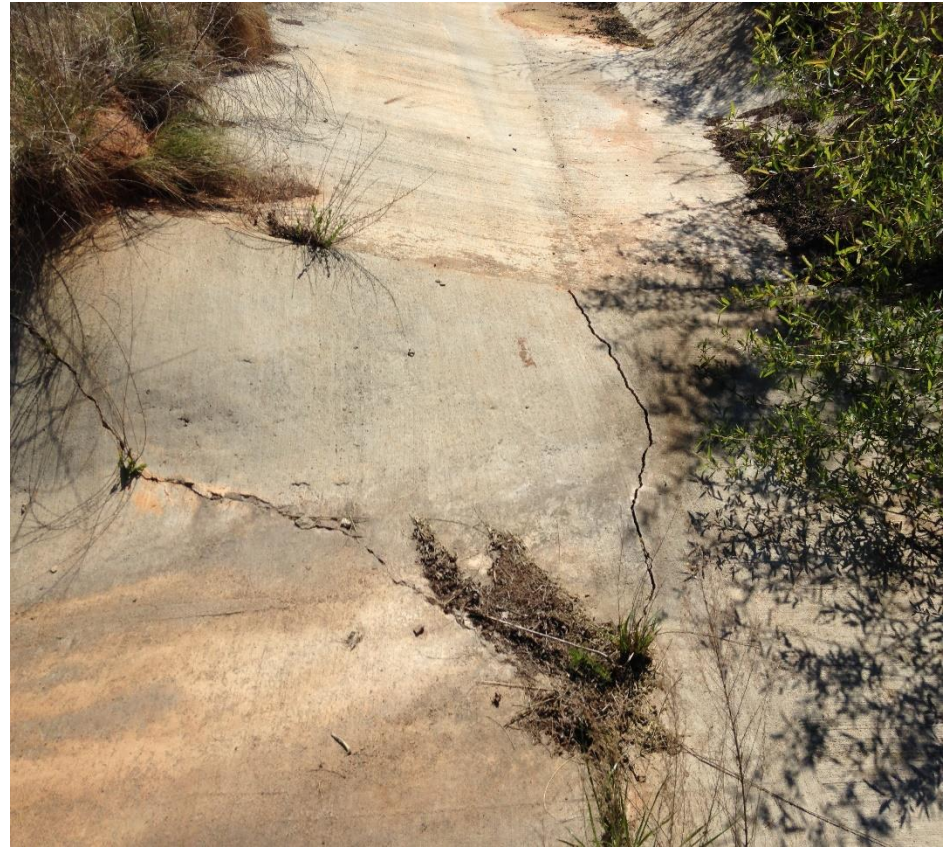
Photos were taken 3/21/2016

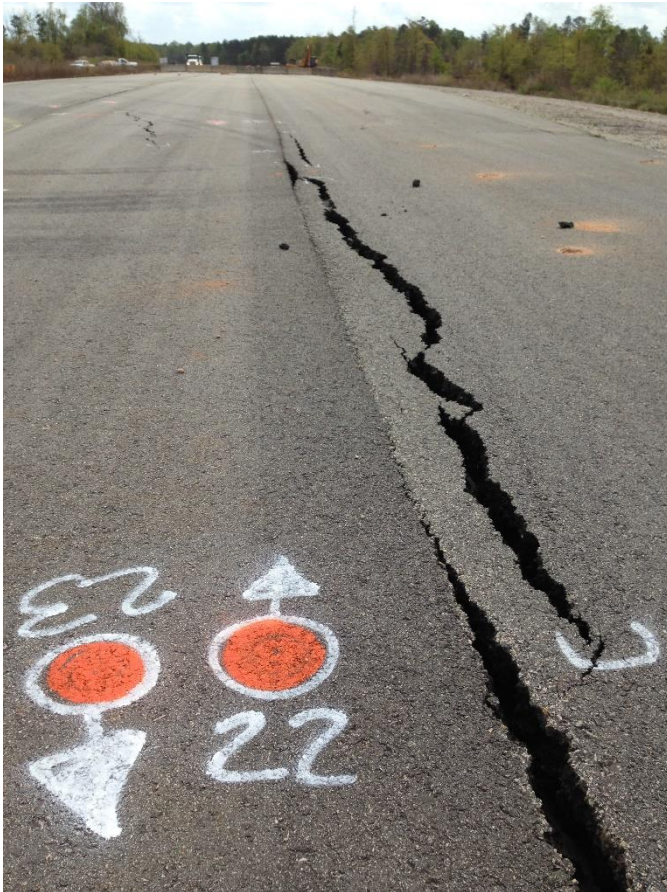
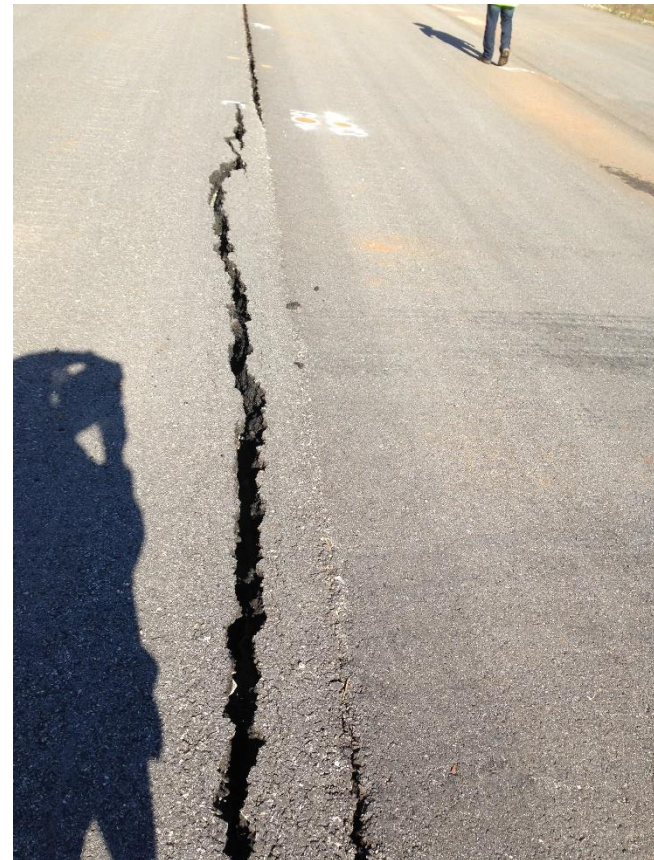
The failure progressed quickly, and our Office made multiple site visits to track the progress visually.

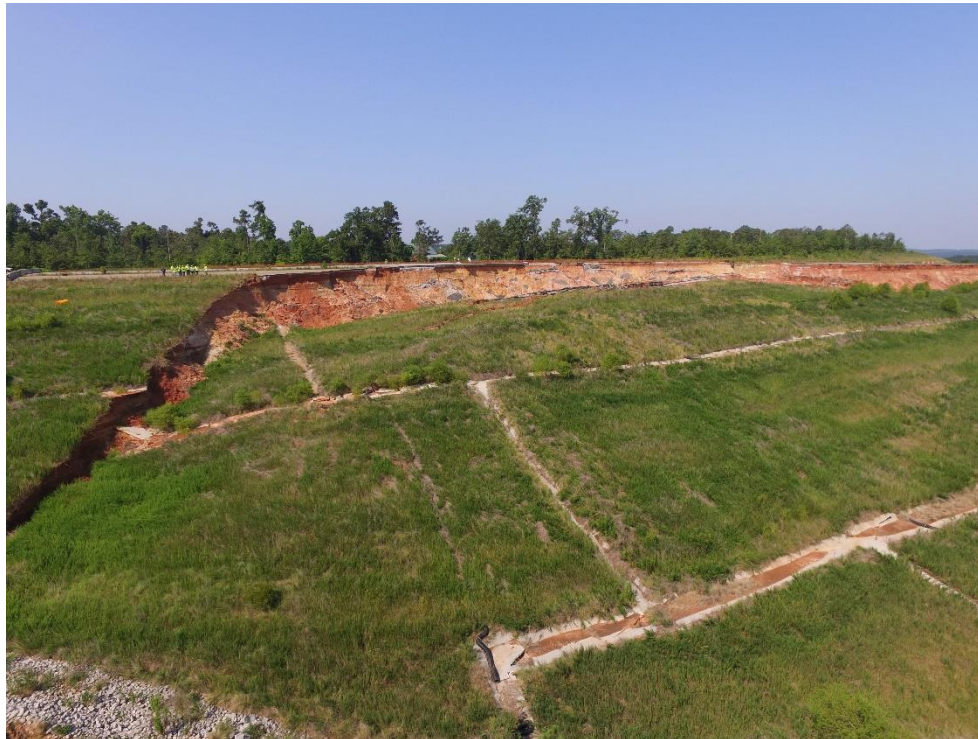
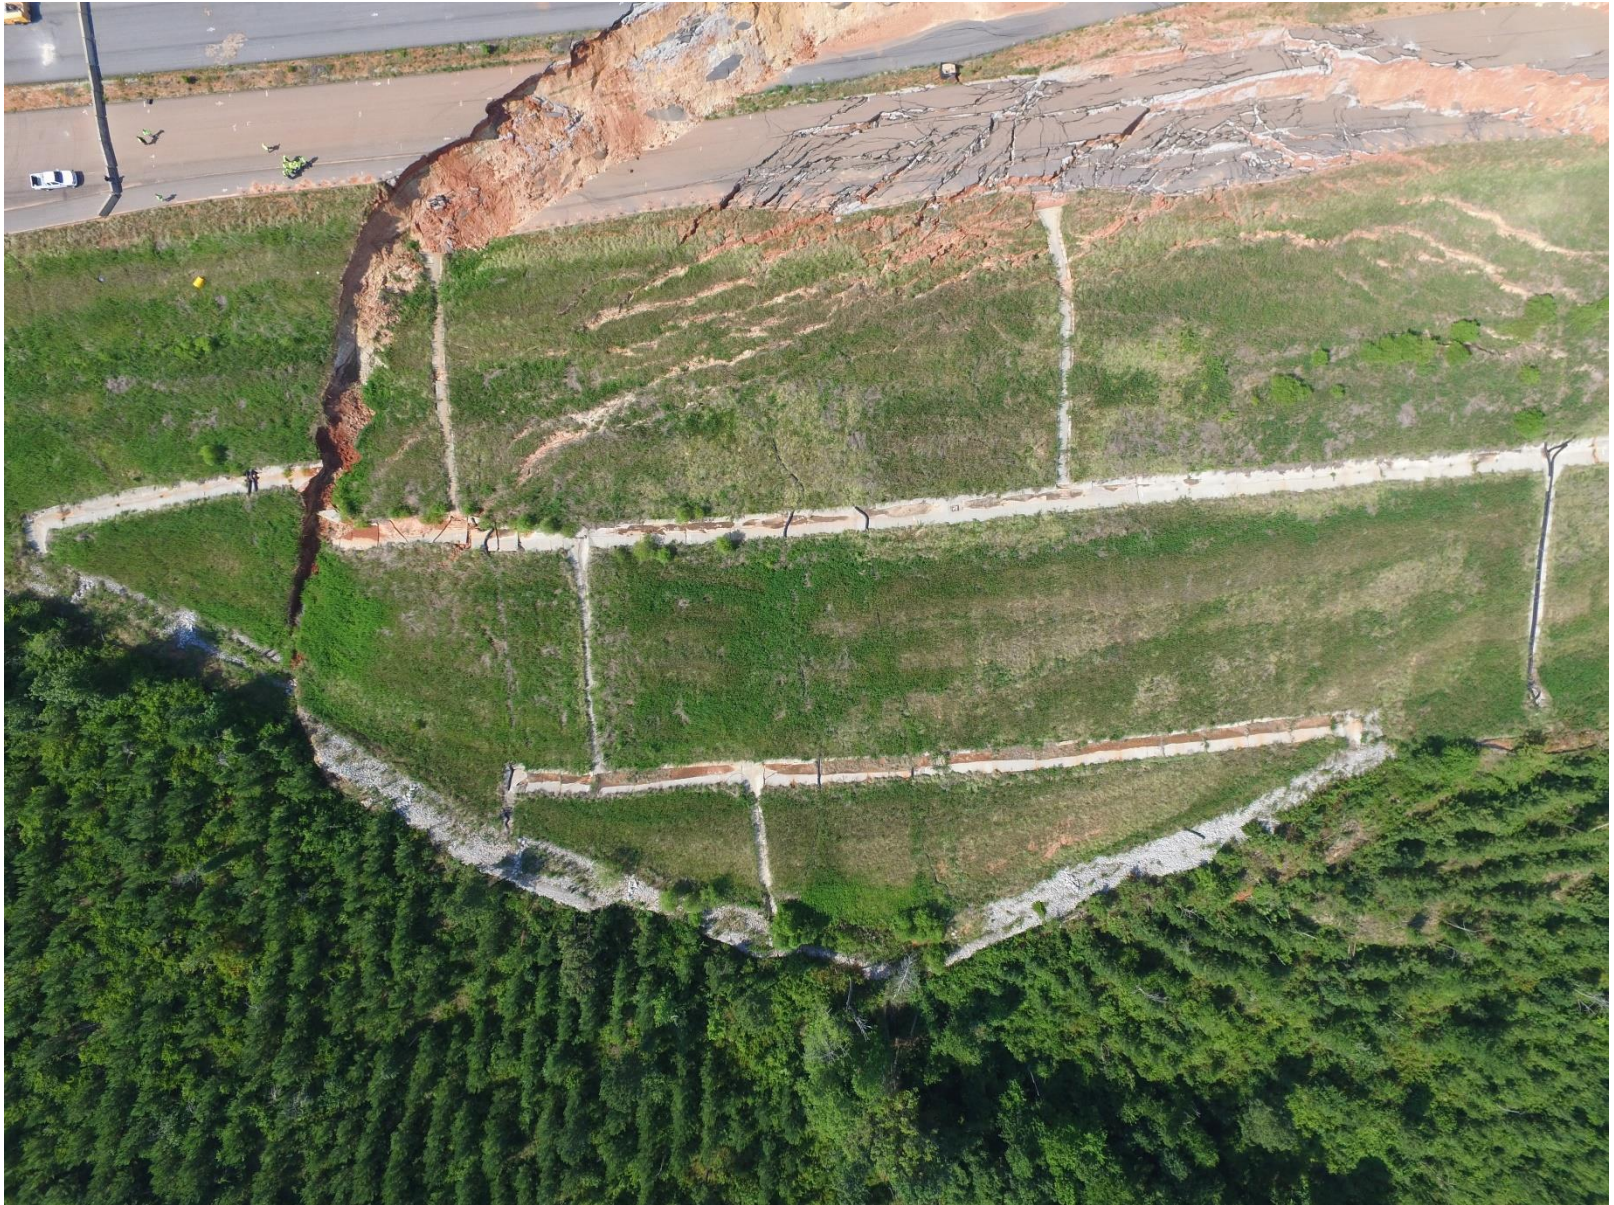
The slope completed its circular failure and began to drop around April 12, 2016. Approximately 6 inches of rain fell prior to this failure occurring which was a record based on the last 50 years of rainfall data.

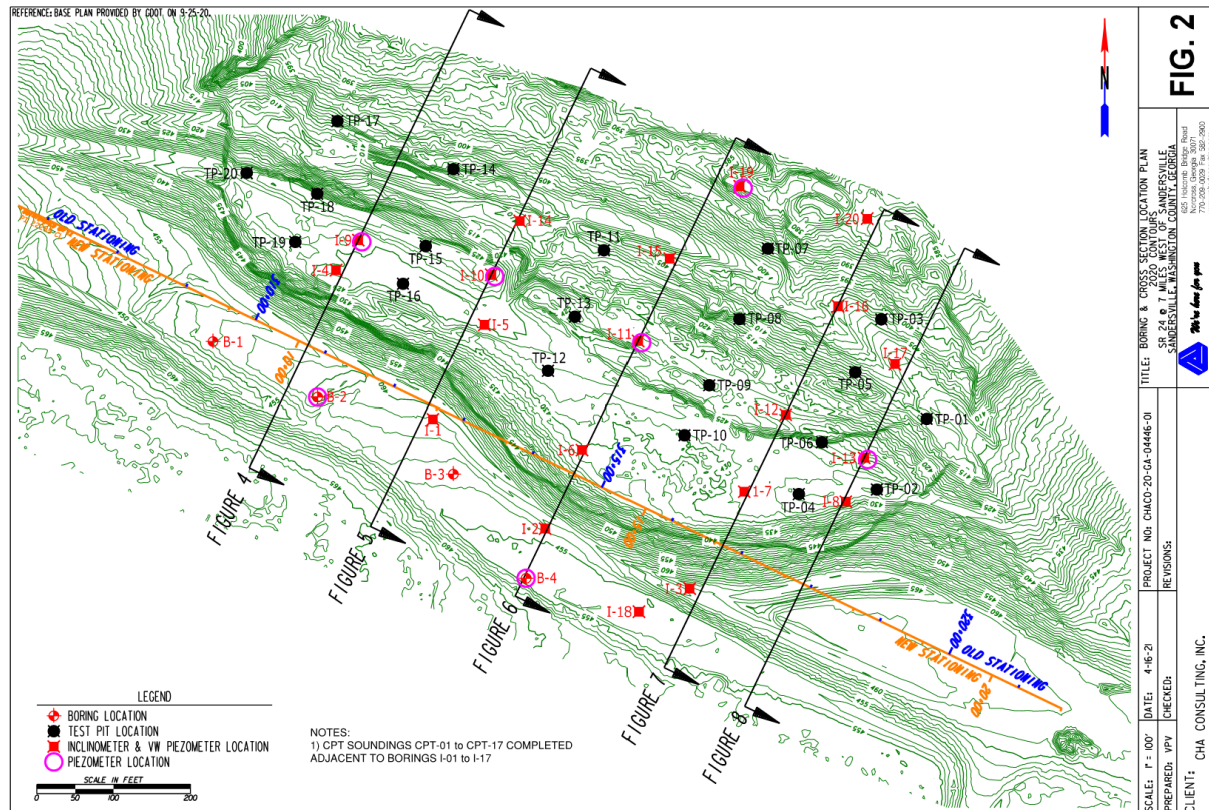
CPT borings, SPT borings, slope inclinometers, piezometers, and test pits were used to provide a complete subsurface investigation.

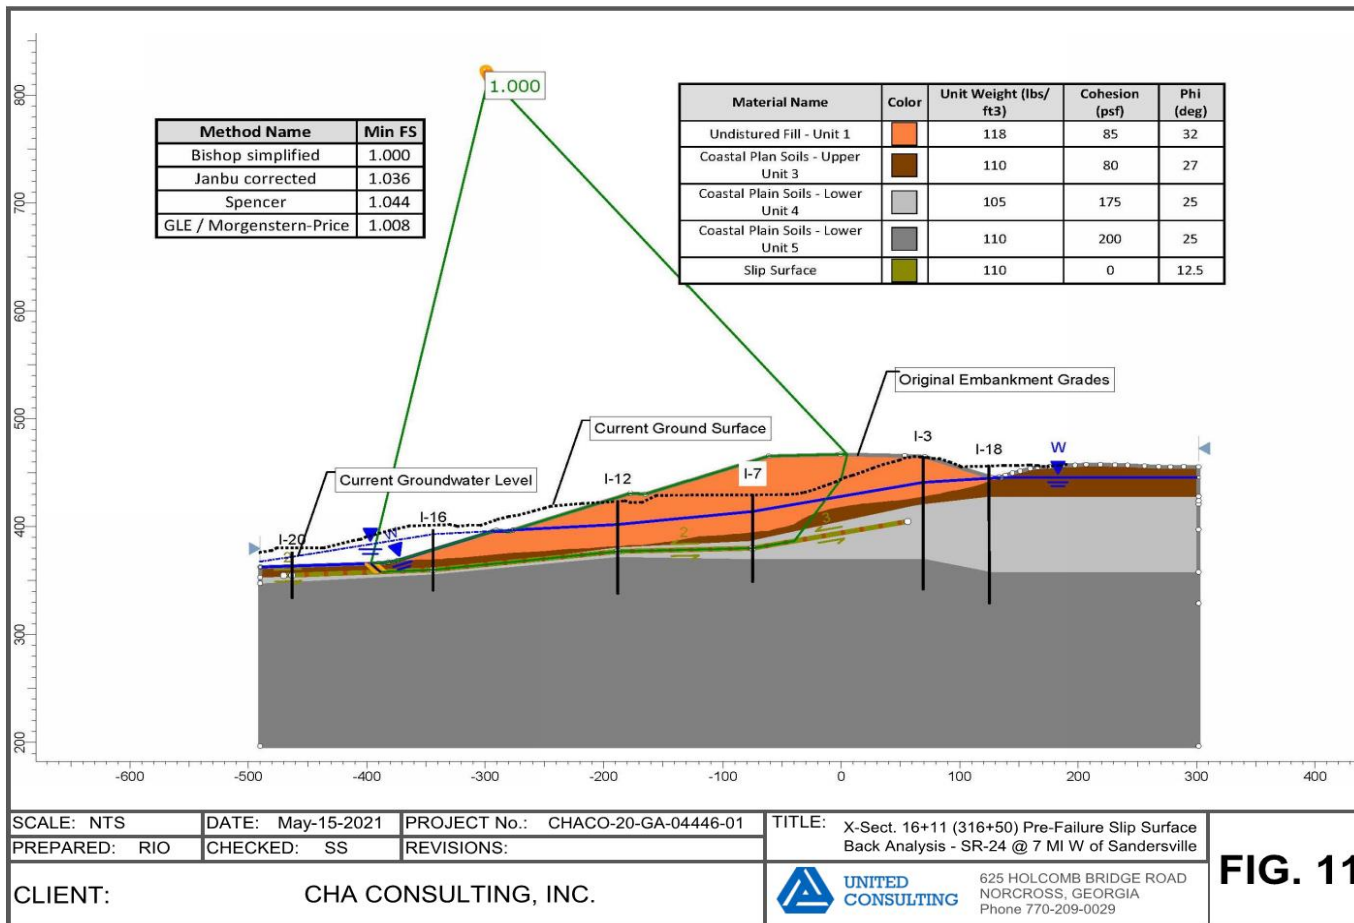
Through this drilling program, information was gathered for a thorough back analysis of what the slope stability was at the time of failure and how to effectively remediate the slope at it's current stability.

It was also shown that the slide was still moving based on the last inclinometer readings in April 2021.

Groundwater and rainfall are the driving forces for this failure along the low shear strength subsurface soils.
