# Railroad Embankment Slope Stabilization with Tiebacks and Micropiles

Gary Brill, PE (Schnabel Engineering),

## Problem Statement and Challenges

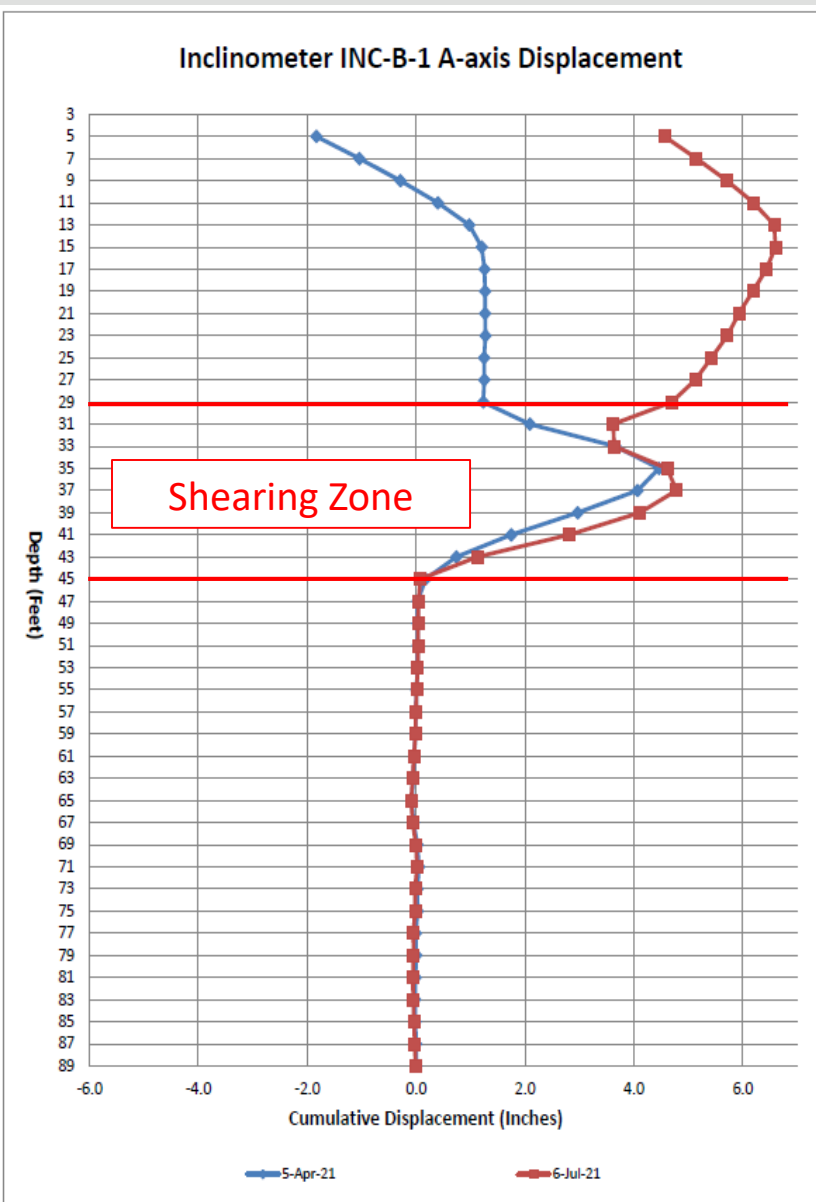
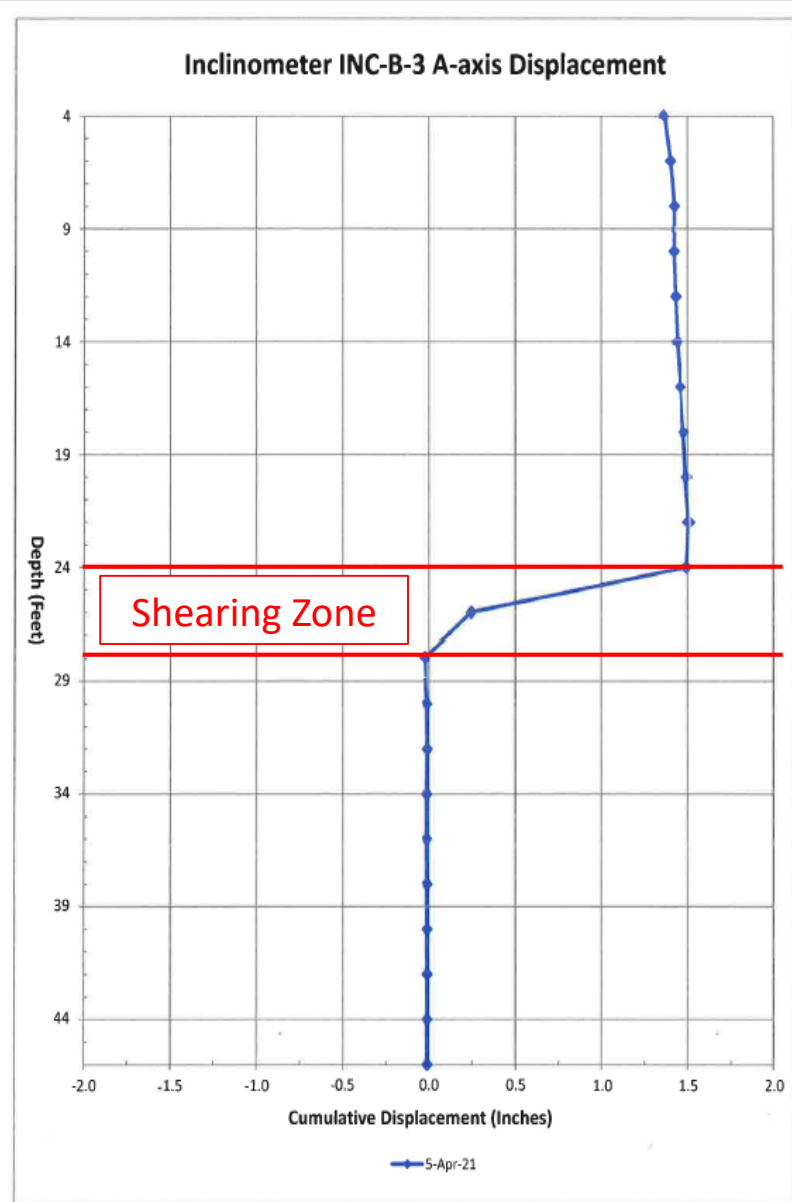
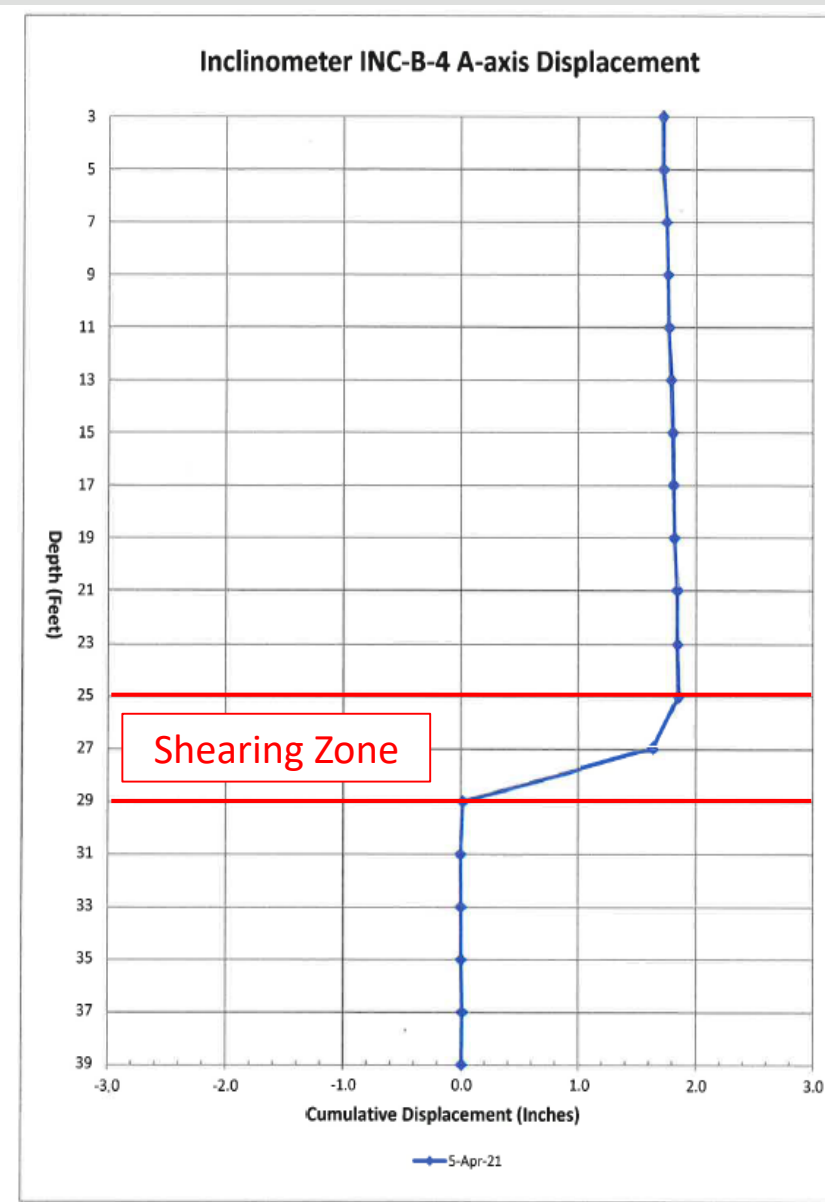
# Inclinometer Data, Cumulative Displacement vs Depth

- LIDAR data can be a useful in understanding site conditions and planning a subsurface investigation.
- Slope inclinometers were critical to identifying slip plane and formulating repair methods.
- The selected type of stabilization elements allowed for relatively small installation equipment which was more conducive to the site conditions and limited access.
- Communication and coordination were key to fulfilling the client's desire to keep the railroad active throughout construction and limit impacts to railroad operations.
- The A-frame stabilization system was completed in June 2022 and no signs of slope or rail movement have been reported since.

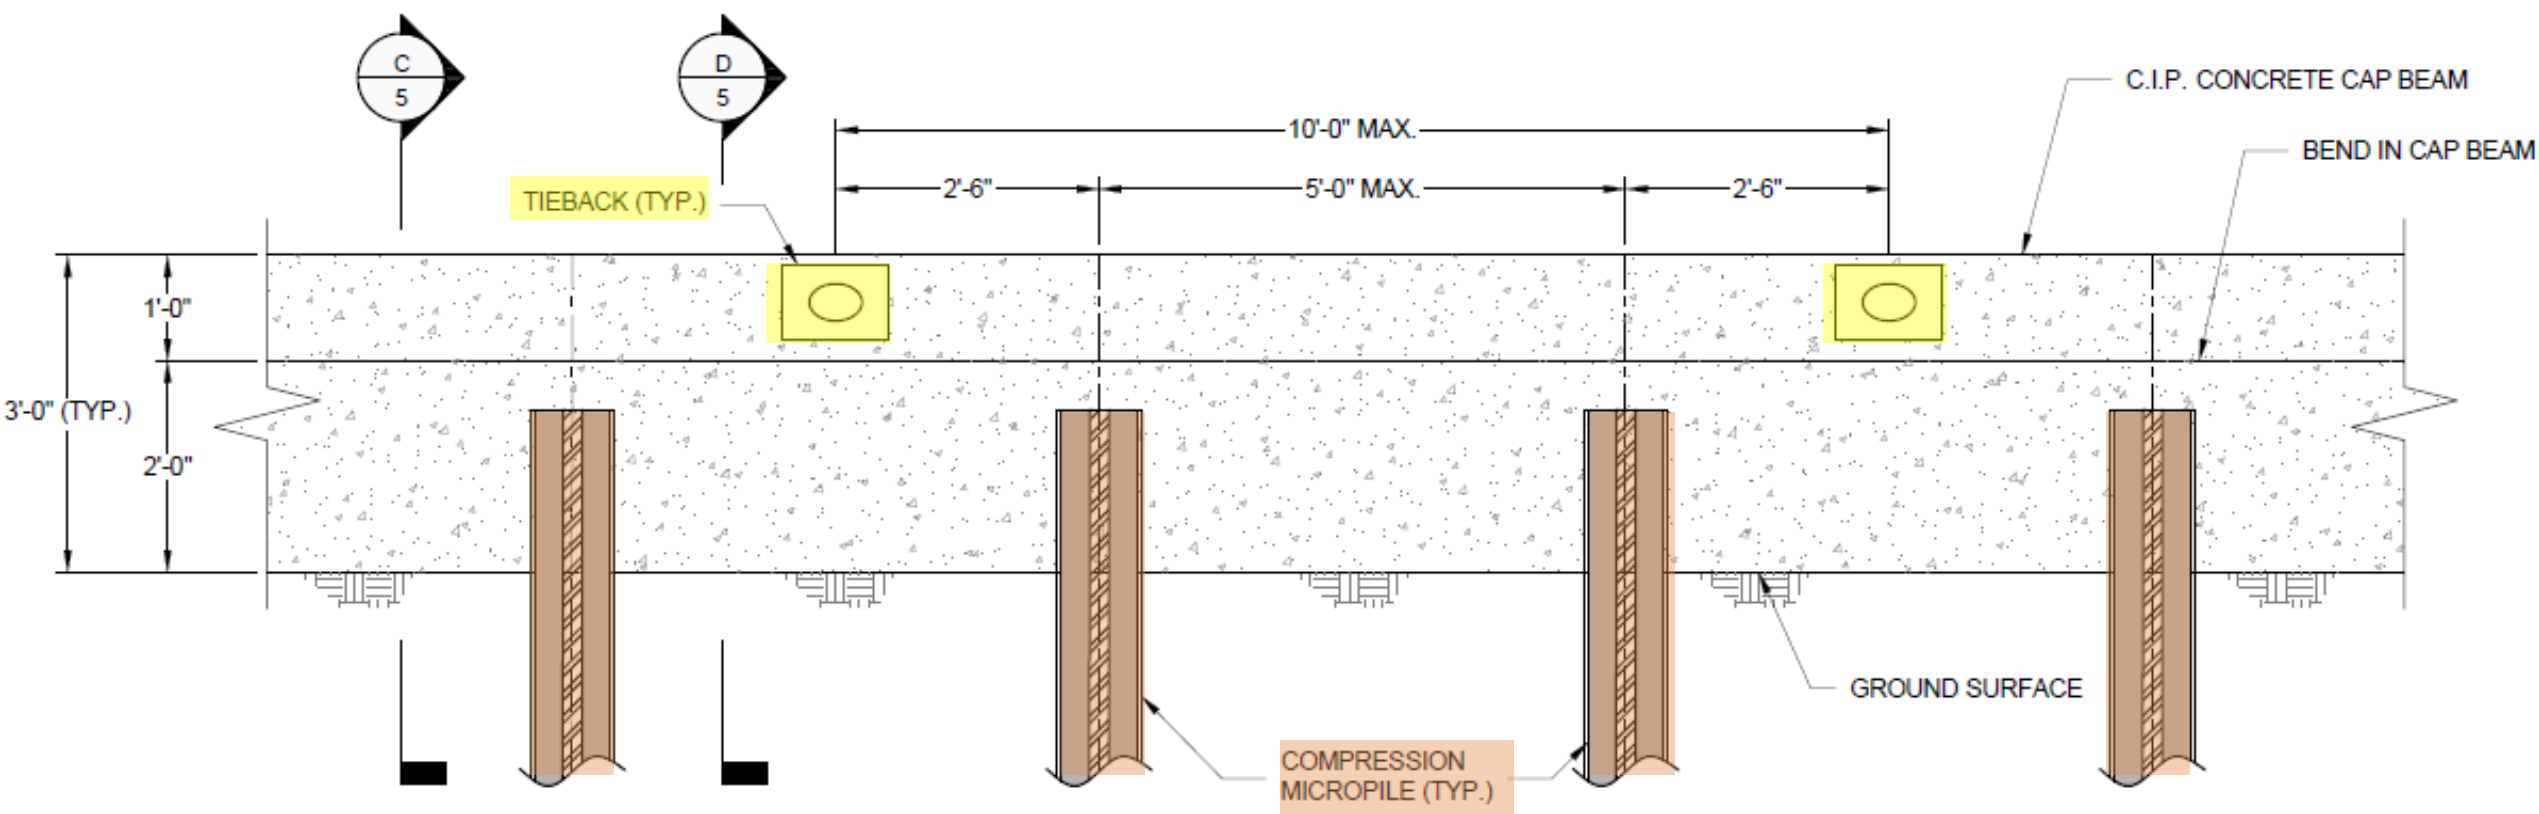
BOTTOM CAP BEAM DETAIL - PROFILE VIEW

- Micropiles (Compression):
  - Compression Force: 56 kip
  - Bending Moment: 175 kip-ft
  - Lateral Shear Force: 72 kip
- Tieback Anchors
  - Tension: 176 kip
  - No shear capacity from tiebacks

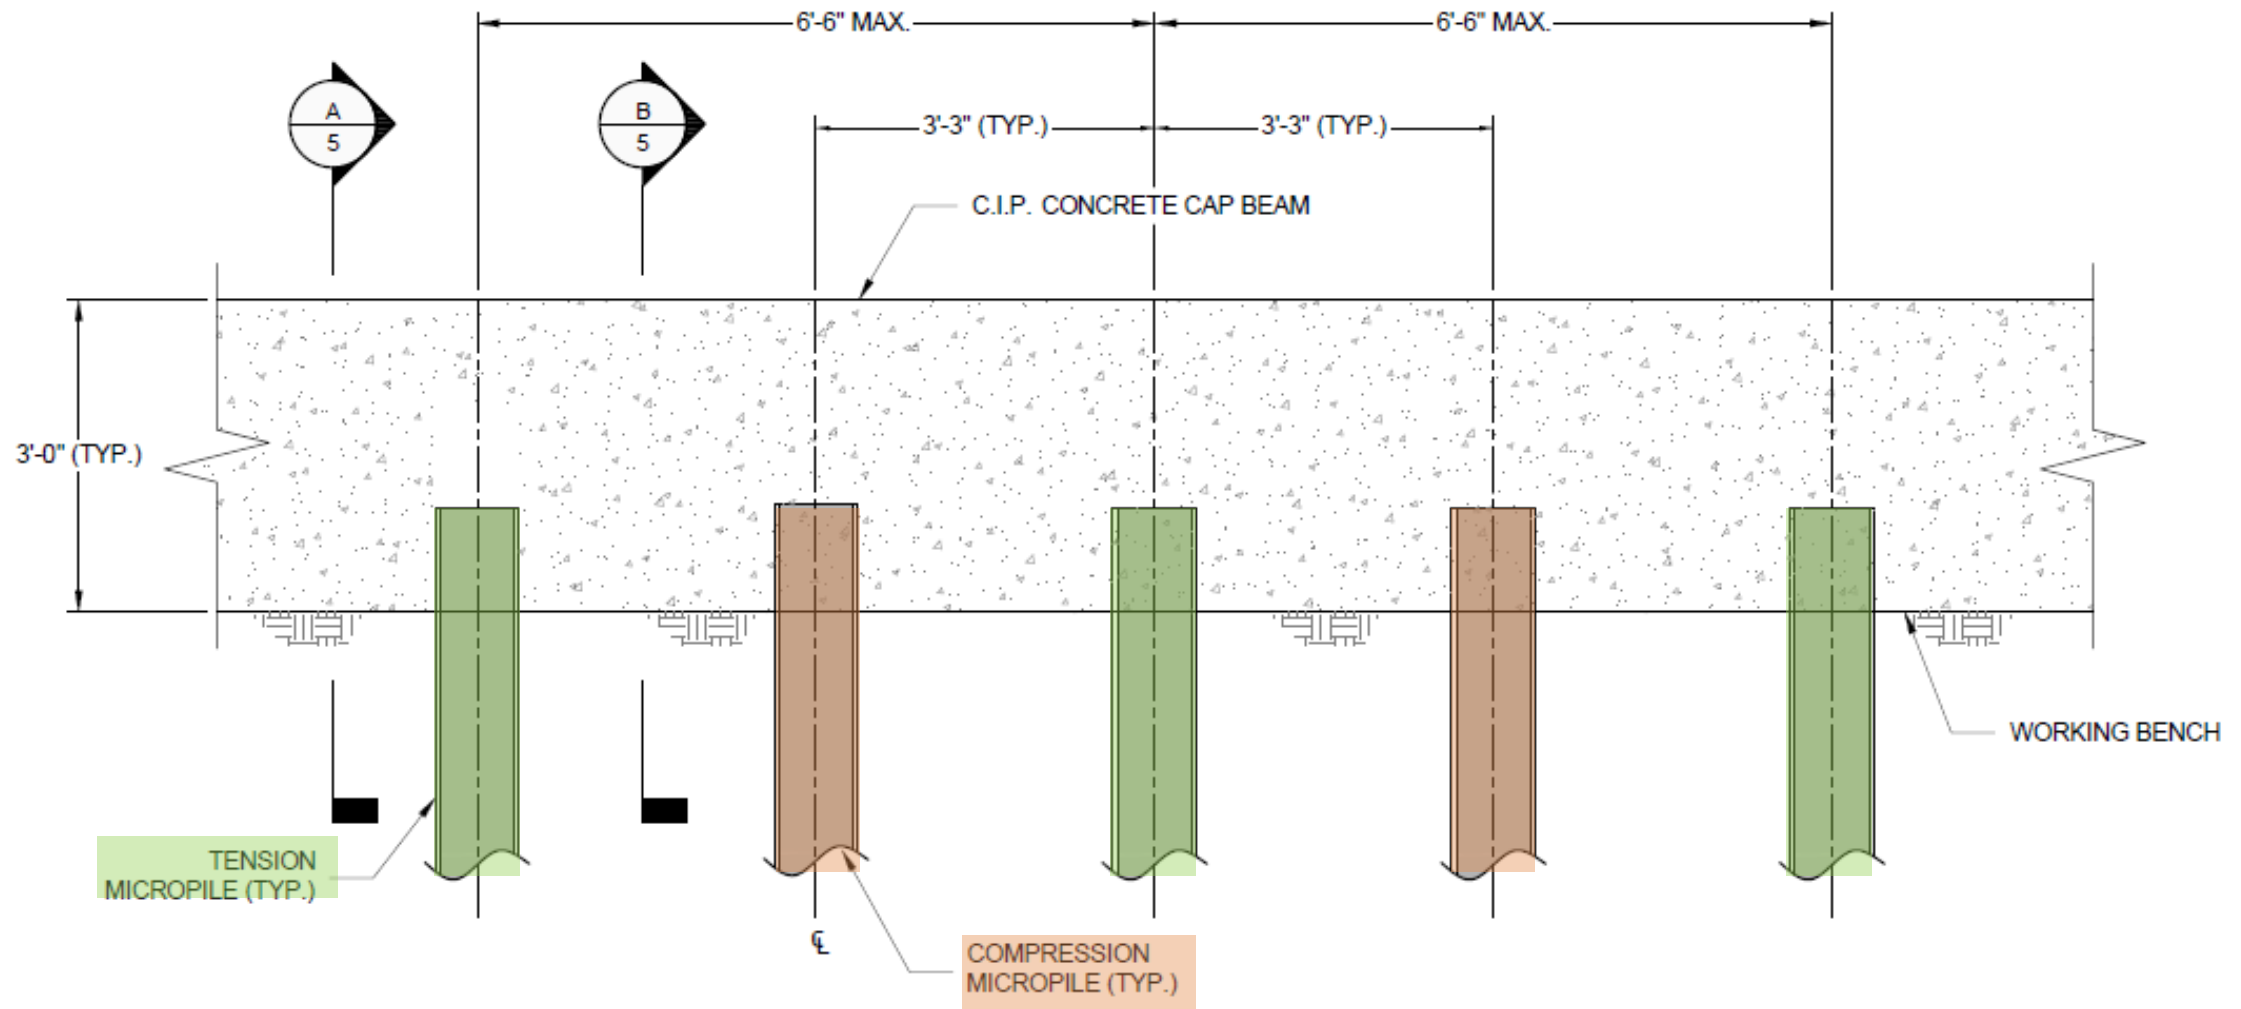
1 TOP CAP BEAM DETAIL - PROFILE VIEW  
N.T.S.

- Micropiles (Compression):
  - Compression Force: 53 kip
  - Bending Moment: 118 kip-ft
  - Lateral Shear Force : 42 kip
- Micropiles (Tension)
  - Tension Force: 40 kip
  - Bending Moment : 106 kip-ft
  - Lateral Shear Force : 37 kip
