Low Mobility Grouting on the LA 1 Port Allen Canal Bridge

Miranda V. Perkins, P.E.

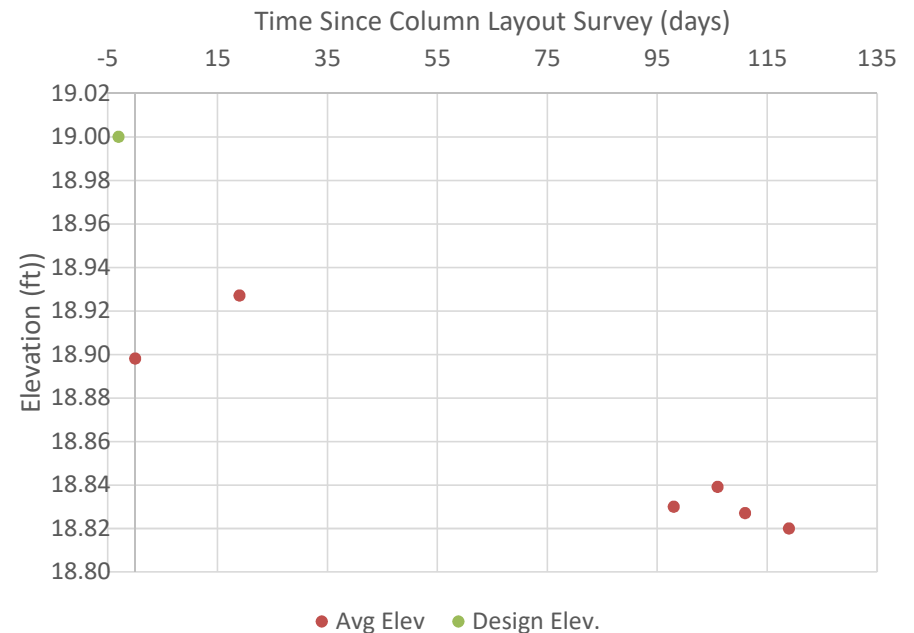
Bent 10: Surveyed Elevations of Top of Cap

- No surveys were taken at the time of completion of the pour of footing.
- Column layout shots were taken typically within a few days of the footing pour.
 - One of these suggested settlement of over 1" in three days
- Footings were not typically surveyed again for several months.

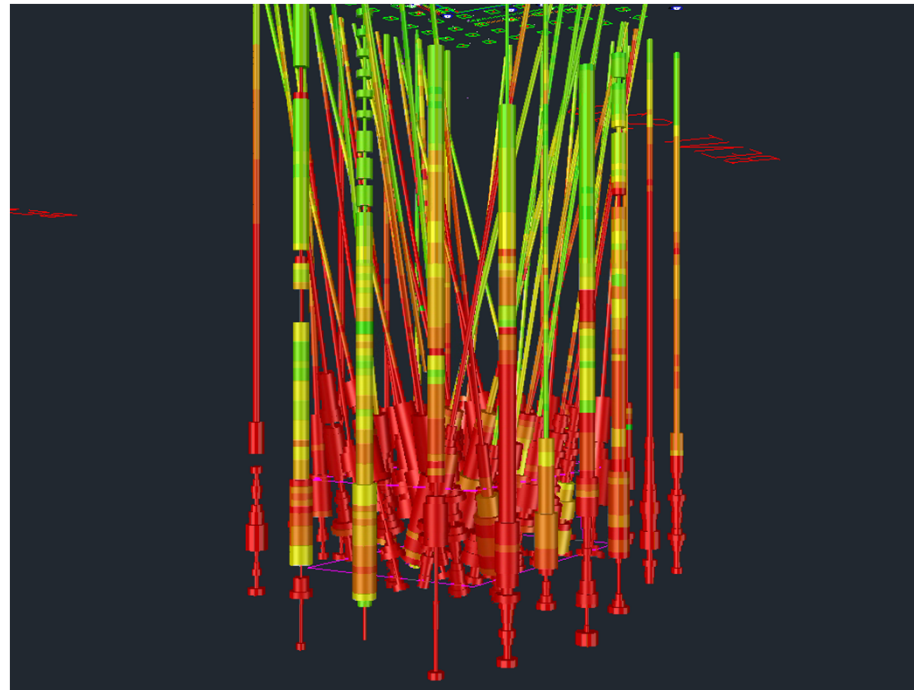
Bent 10

3D CAD model of LMG locations provided by Keller

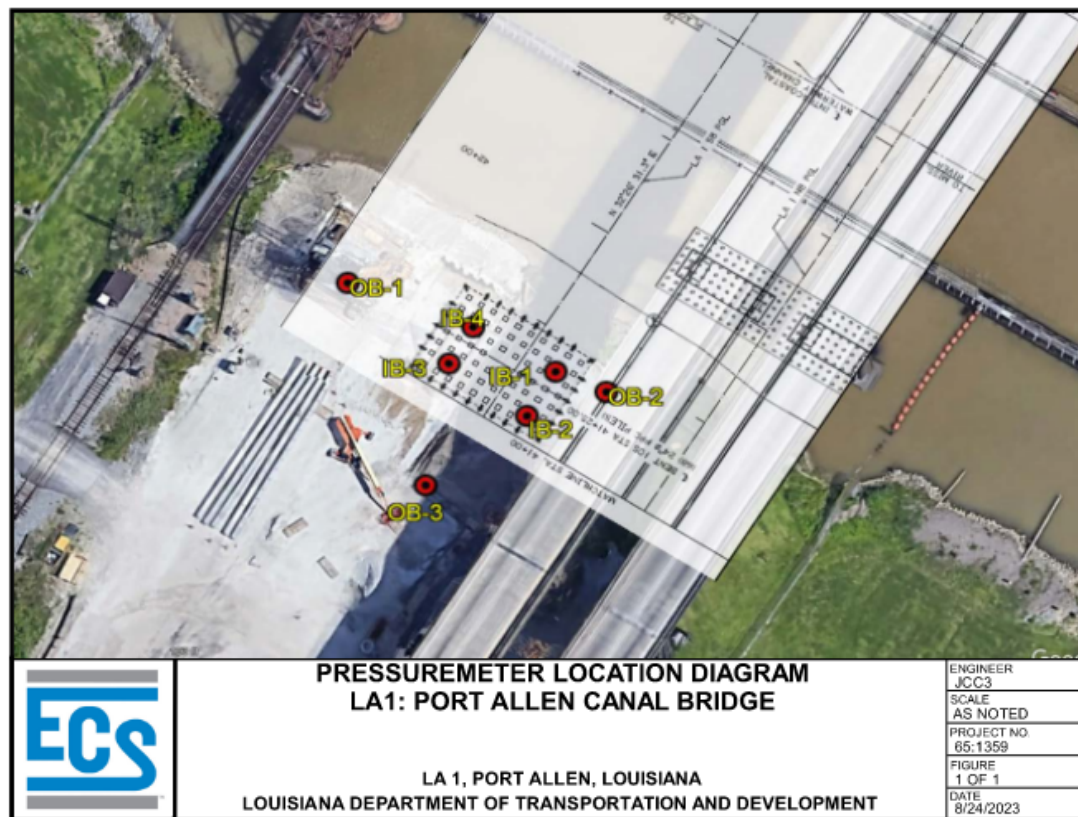
Pressuremeter Testing

- Geotechnical Consultant hired by LA DOTD analyzed the results of the testing program.
 - It was seen that the PMT modulus inside the LMG zone was almost 3 times higher than those outside the LMG zone.
- Consultant concluded potential future settlements could be approximately 2 inches once girders and deck were placed based on results of the PMT.

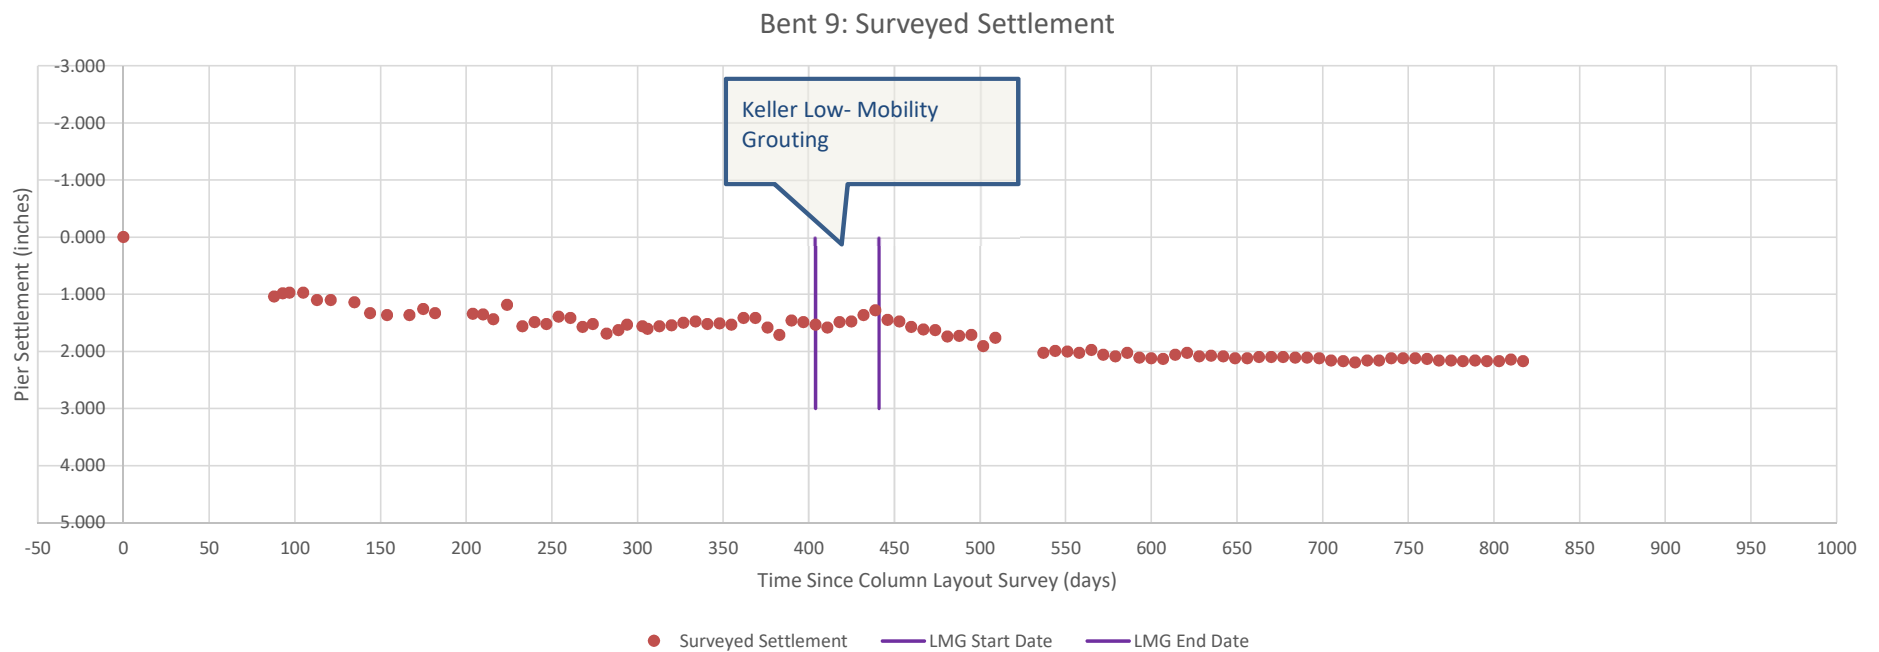
Survey of Bent 9

| Treated Bent | Settlement after LMG prior to additional loading (in) | Settlement after additional loading (in) | Total Settlement after LMG (in) |
|---|---|--|---|
| Bent 9 | 0.8 | 0.1 | 0.9 |

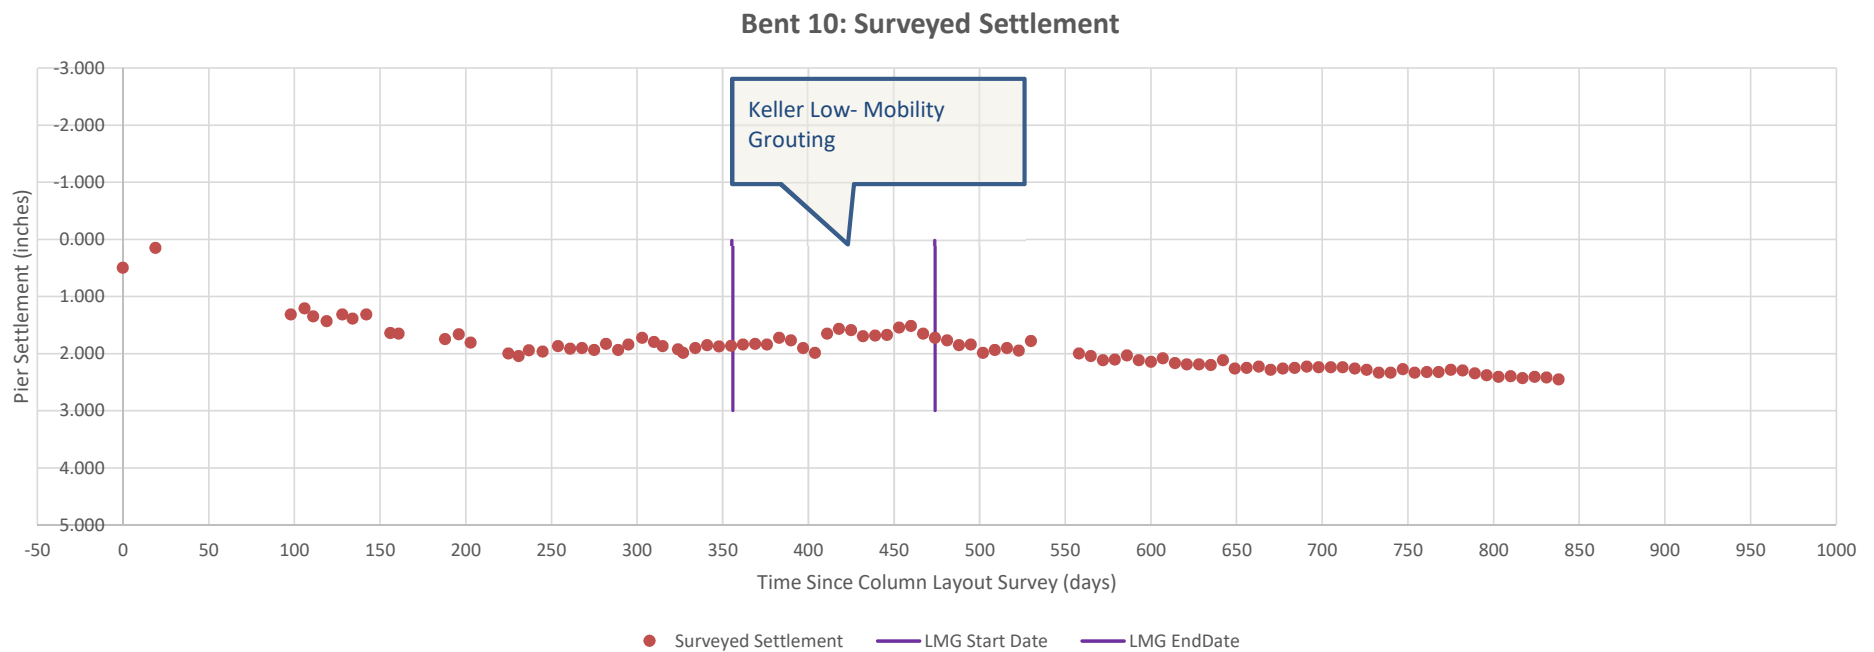
Survey of Bent 10

| Treated Bent | Settlement after LMG prior to additional loading (in) | Settlement after additional loading (in) | Total Settlement after LMG (in) |
|---|---|--|---|
| Bent 10 | 0.5 | 0.3 | 0.8 |

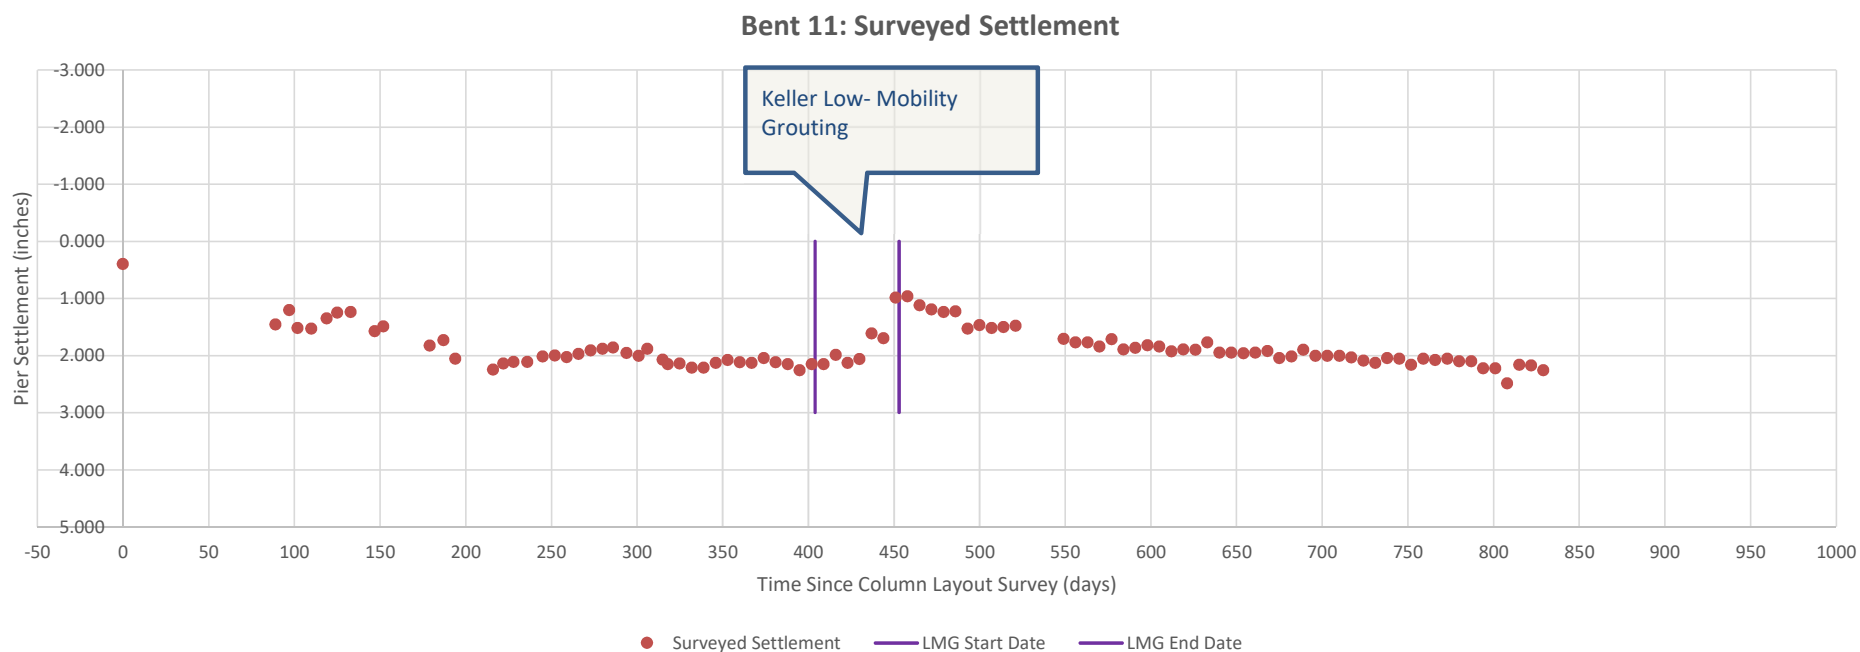
Survey of Bent 11

| Treated Bent | Settlement after LMG prior to additional loading (in) | Settlement after additional loading (in) | Total Settlement after LMG (in) |
|---|---|--|---|
| Bent 11 | 1.0 | 0.3 | 1.3 |

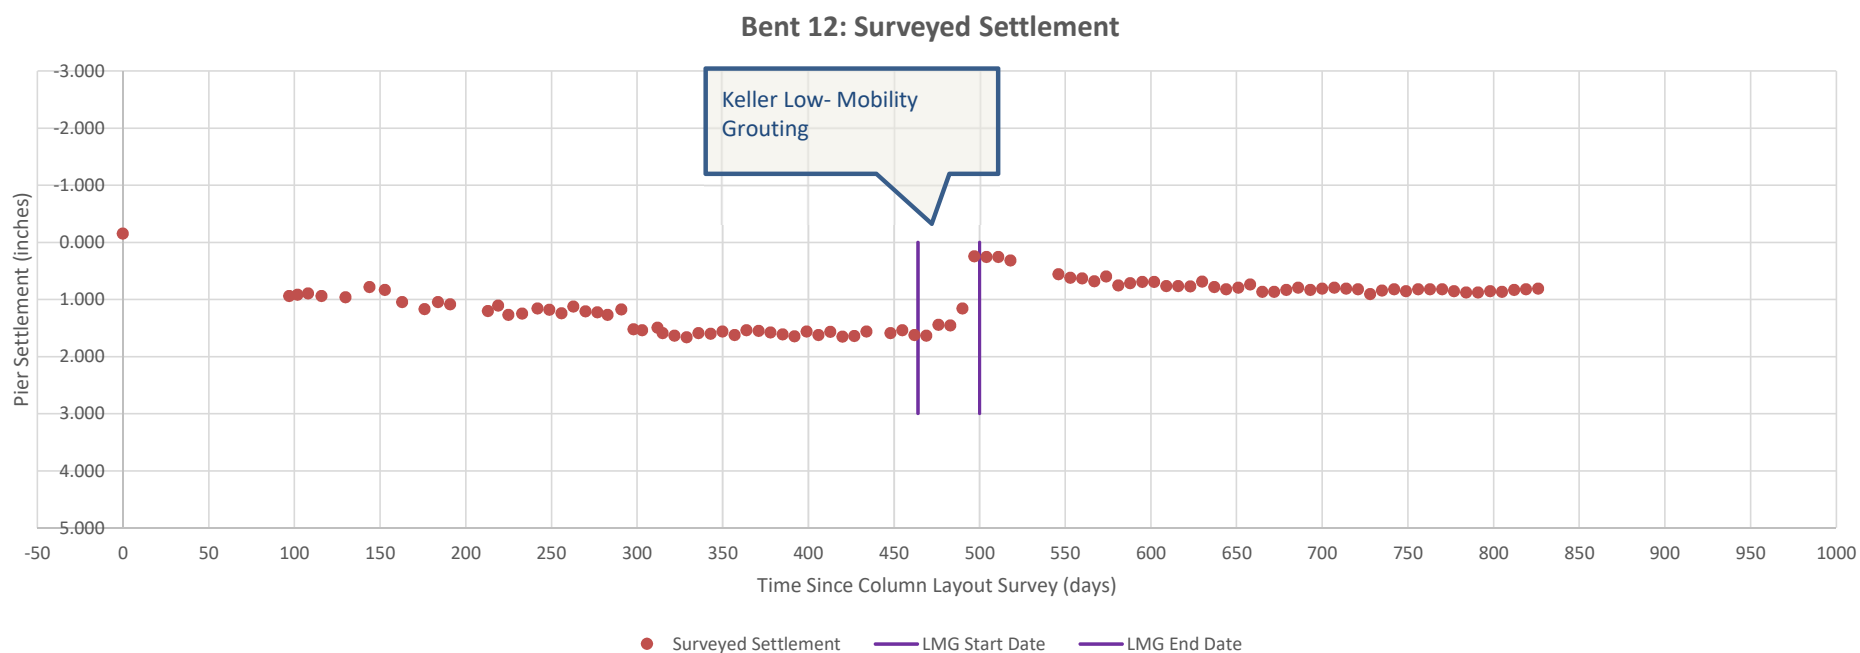
Survey of Bent 12

| Treated Bent | Settlement after LMG prior to additional loading (in) | Settlement after additional loading (in) | Total Settlement after LMG (in) |
|---|---|--|---|
| Bent 12 | 0.5 | 0.1 | 0.6 |
