HISTORIC ROCK / SOIL WALL STABILIZATION CASE STUDY – TENNESSEE CAPITAL HILL, NASHVILLE, TN

Presented By: John D. Godfrey, Jr., P.E.

PREPARED FOR THE 54th STGEC CONFERENCE 2025
Williamsburg, Virginia
September 16, 2025

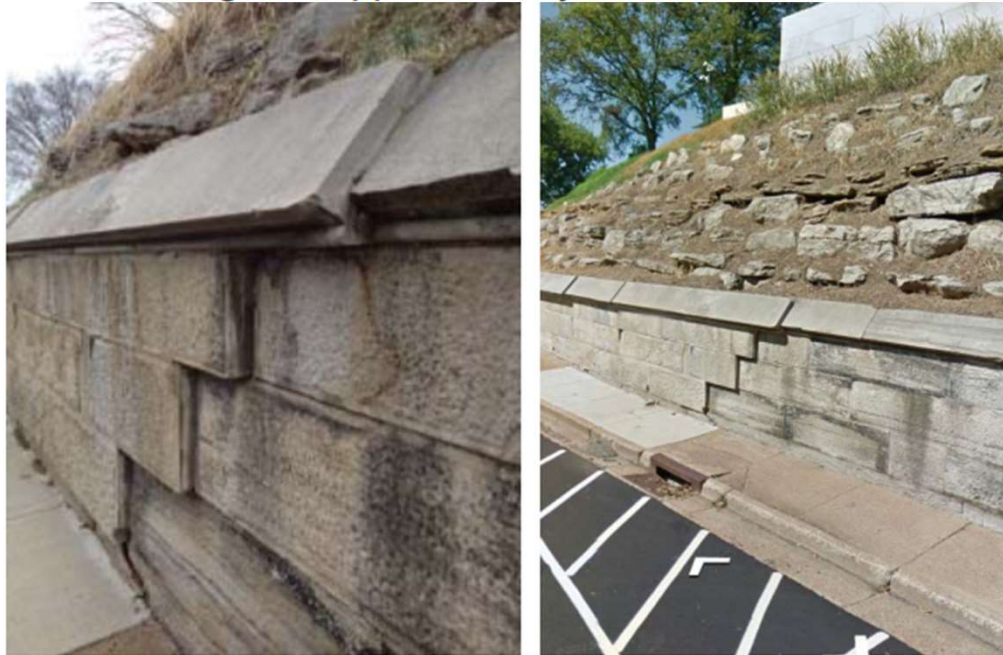
- Existing limestone block gravity retaining wall along the NE edge of 7th Ave N.
- 85 foot long distressed section of wall (NW end of 7th Ave N)
- Maximum wall height of approximately 6 feet

Photo 3: Distressed wall conditions (Source – Right Photo: Google Maps, 2014)

- The increase in lateral pressure could have resulted from the settlement/movement of fill behind the wall due to self-weight settlement or the raveling of soil into voids associated with boulder laden fill.
- Hydrostatic pressure buildup behind the wall could have attributed to the failure.
- The existing instability can be adequately remedied using a technique known as soil nailing.
- The limestone blocks can be strategically removed as the soil nailing progresses in a top-down manner.
- Based on the composition of the slope materials and the steep existing slope geometry, it is our opinion that these conditions indicate a high potential for long term instability of the slope.

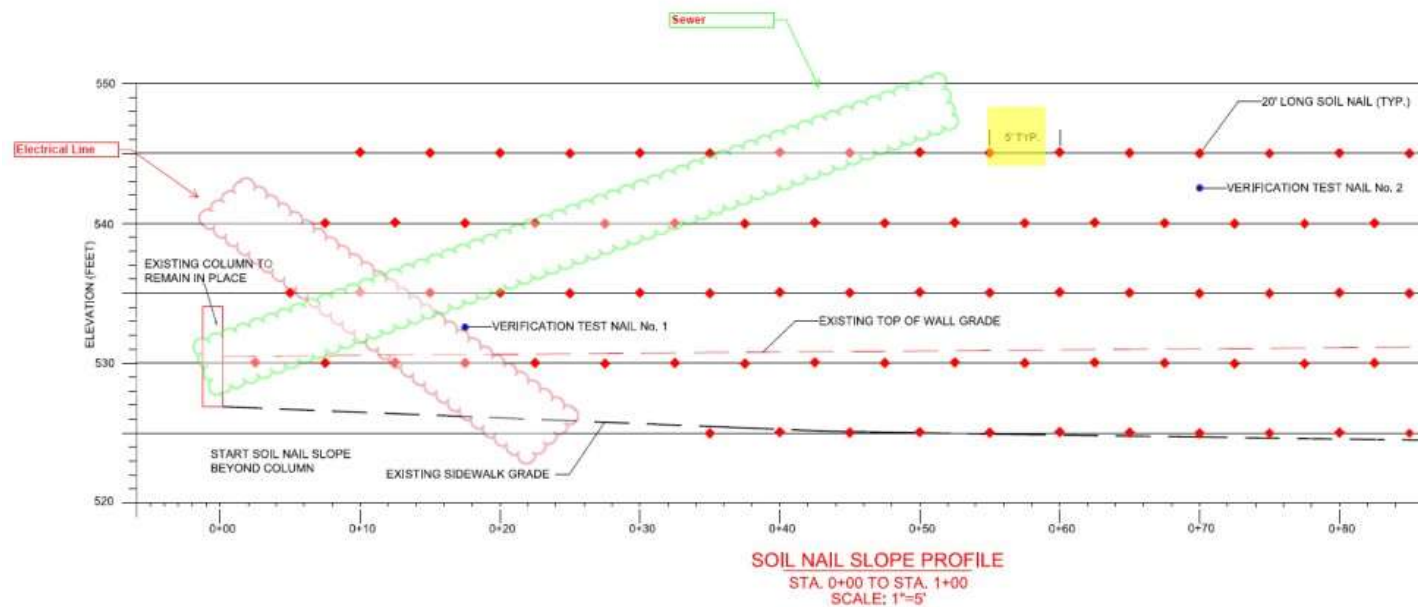
- Review existing utility conflicts with design nail locations per drawing.
- Storm line identified behind stacked stone wall section may be damaged and leaking.
- ECS Response: Adjust nail spacing as necessary to clear utilities.

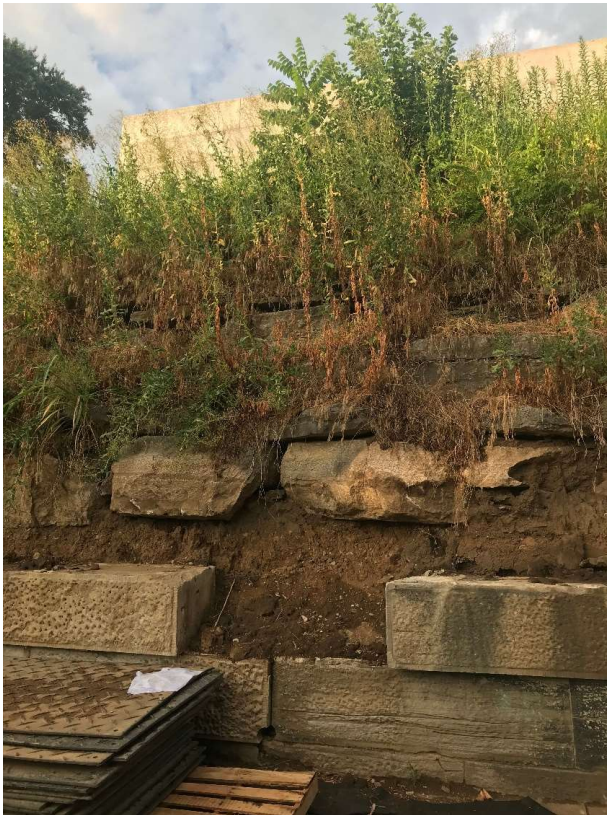
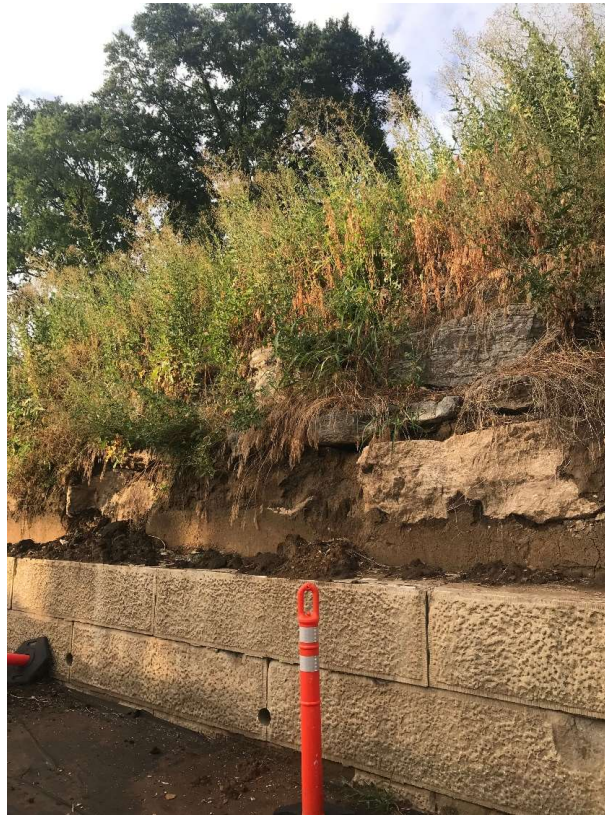
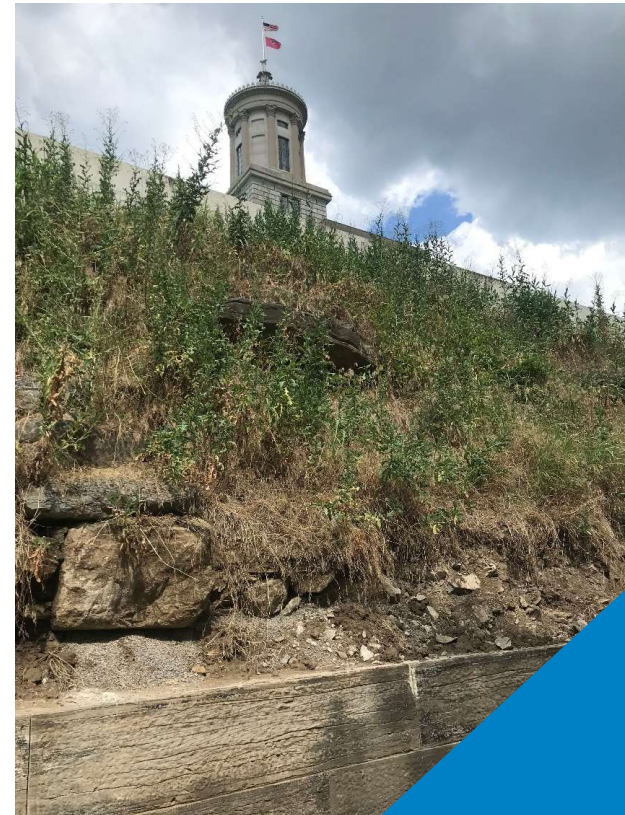
STACKED STONE WALL

- Stack Stone Wall discovered between approximate Stations 0+00 to 1+80.
- Stacked Stone Wall should be stabilized prior to removing additional rows of milled stone wall.
- ECS approved adjustment of nails to move vertical as needed to clear bottom limestone wall section.
- Remove overhanging rock outcroppings.
- Change 6-inch tolerance of nail spacing to 2 feet tolerance due to boulder spacing.
- Verification and proof test locations can be moved.

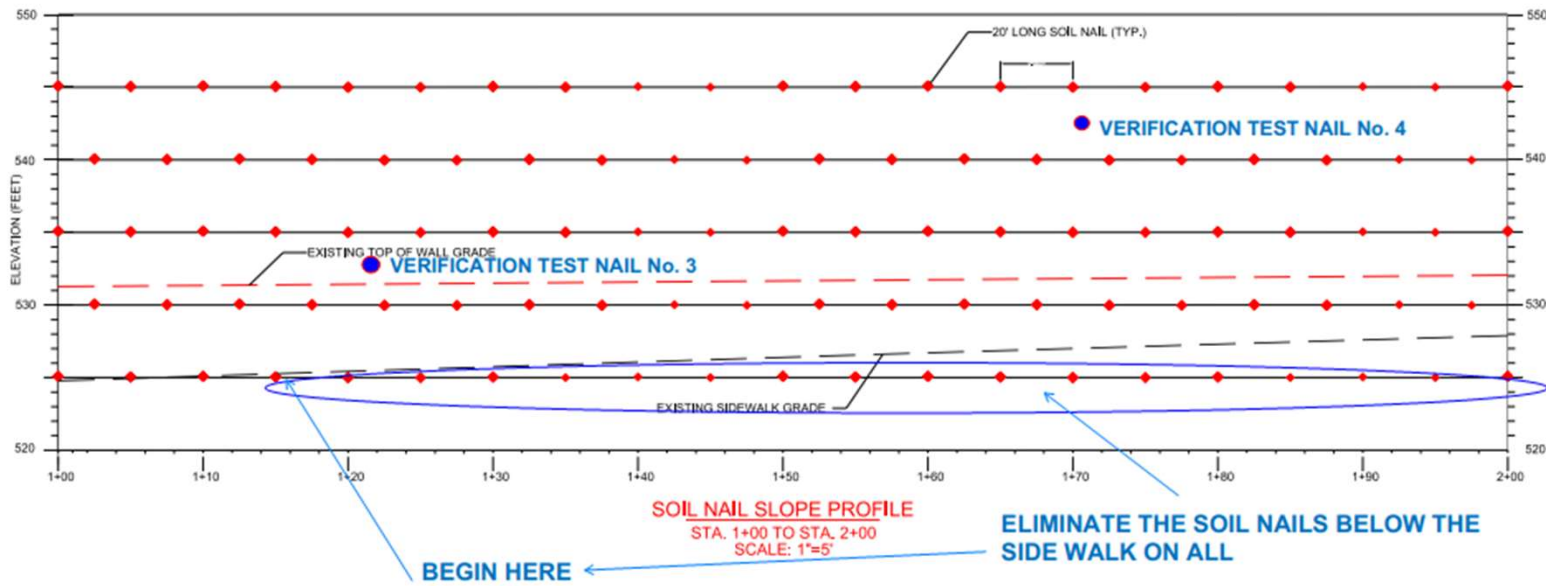
- Eliminate soil nails indicated below side wall along entire length.

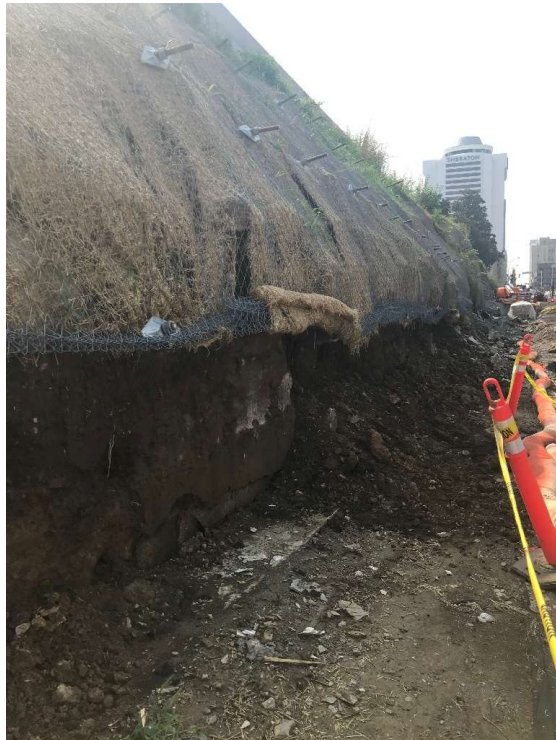
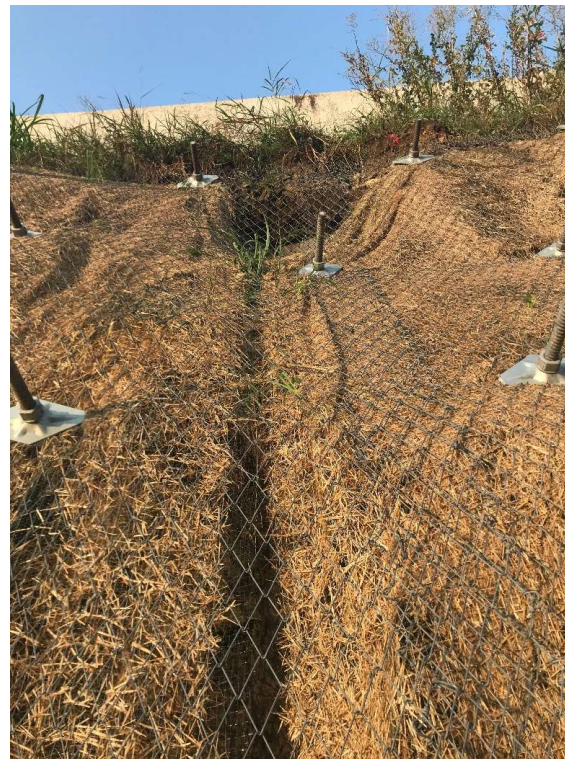
SLOPE FAILURE

During the Sunday night work (8-1), it was observed that an area of the stacked boulder wall had failed, possibly the result of the heavy rainfall on Saturday night (7-31). Some of the boulders had dropped behind the netting and a few of the nails showed evidence of bending as a result of boulder(s) dropping on the exposed nail length. Also noticed was that the contractor had removed most of the bottom rows of stacked, milled stone last week (7-25 thru 7-30) to provide access for installation of the bottom row of nails. There was evidence behind the netting that runoff was coming down the slope or possibly out from between the boulders and washing away support soils.

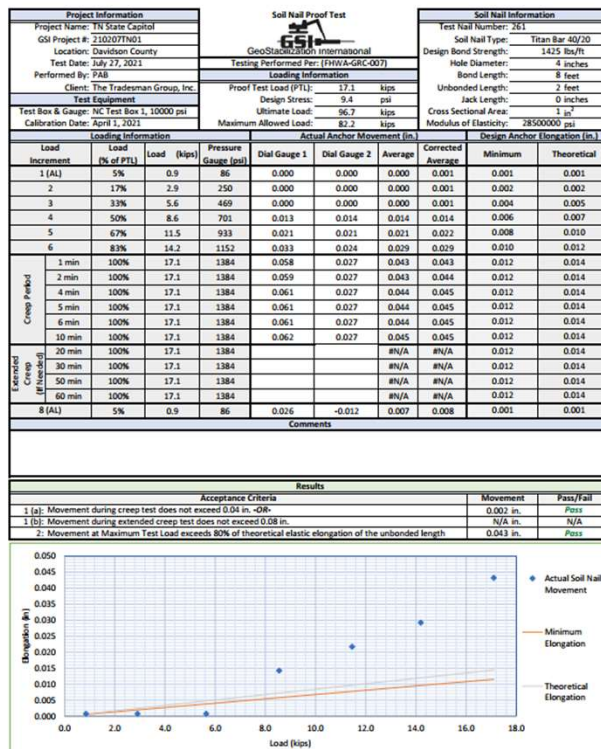
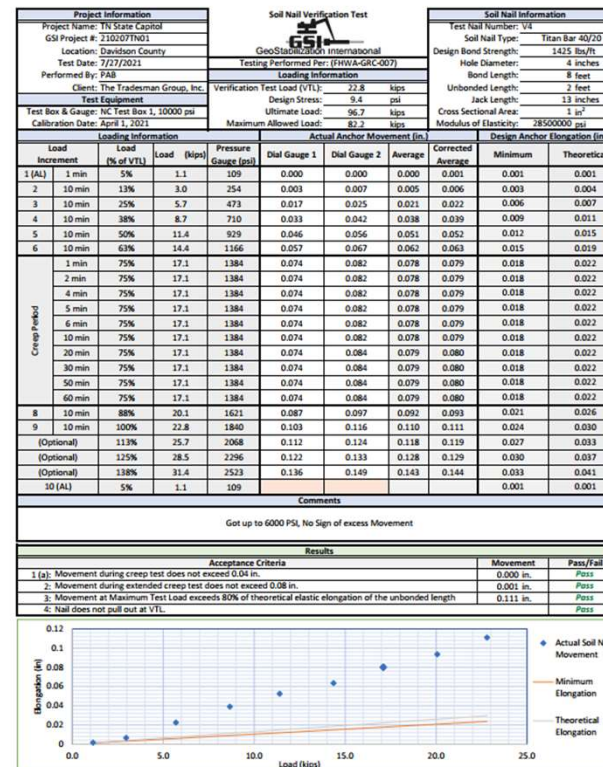
Proof Test Load – 17.1 kips

Verification Test Load – 22.8 kips

All Acceptance Criteria

PASS
