Concrete Integrity Anomalies above the Mudline in River Bridge Drilled Shafts

David Graham, P.E.
Senior Engineer
Dan Brown and Associates

STGEC 2022
Southeastern Transportation
Geotechnical Engineering Conference

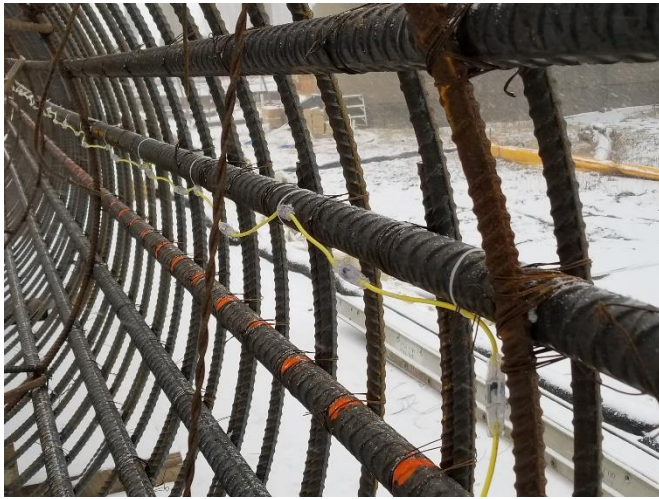
Sensor String

- Measure concrete temperatures during curing with TIP wires tied to the cage (or probe method)
- Data must be collected during hydration period

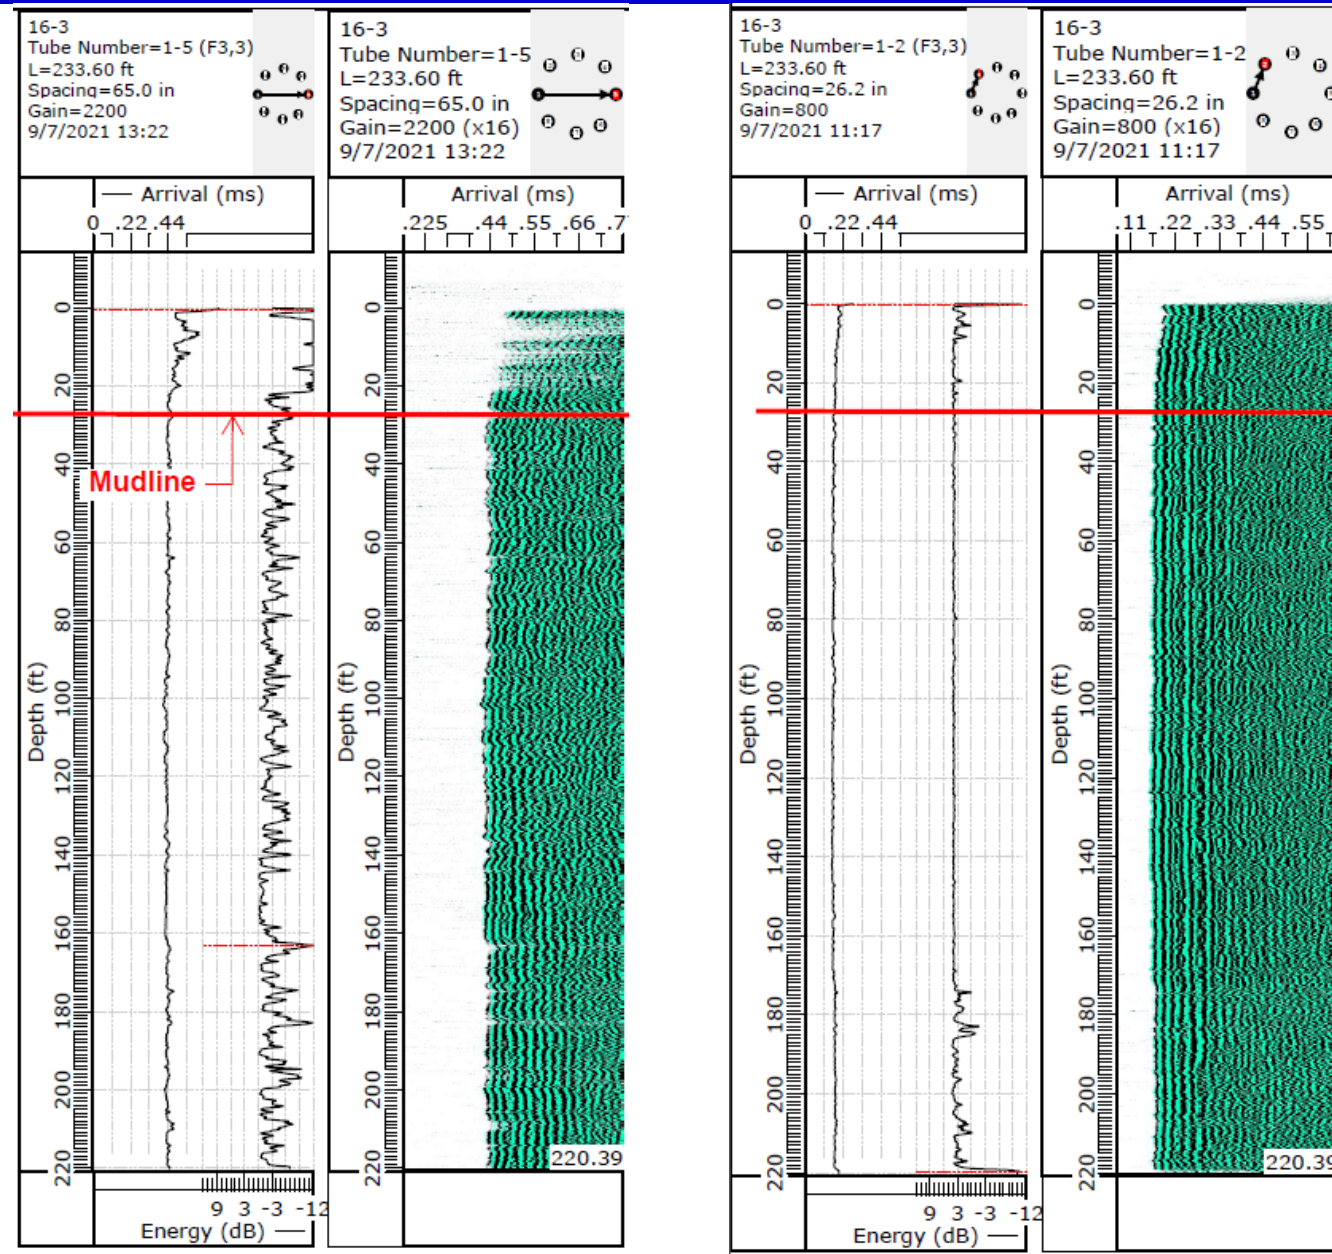
CSL Anomaly Signature

- Anomalies are significantly more pronounced in cross-shaft shots than perimeter shots
- Anomalies primarily consist of signal energy loss

- 8-ft diameter shafts, permanently cased
- CSL
- TIP performed on one shaft in addition to CSL
- High-flow, self-consolidating concrete mix
- Variety of ambient temperature conditions including some very cold
- Concrete bleed observed at some shafts
- Consistent CSL issues above the mudline with all river shafts (86 shafts)
- Cored six shafts with some bleed water channels encountered
- Compressive strengths of core samples were above design strength

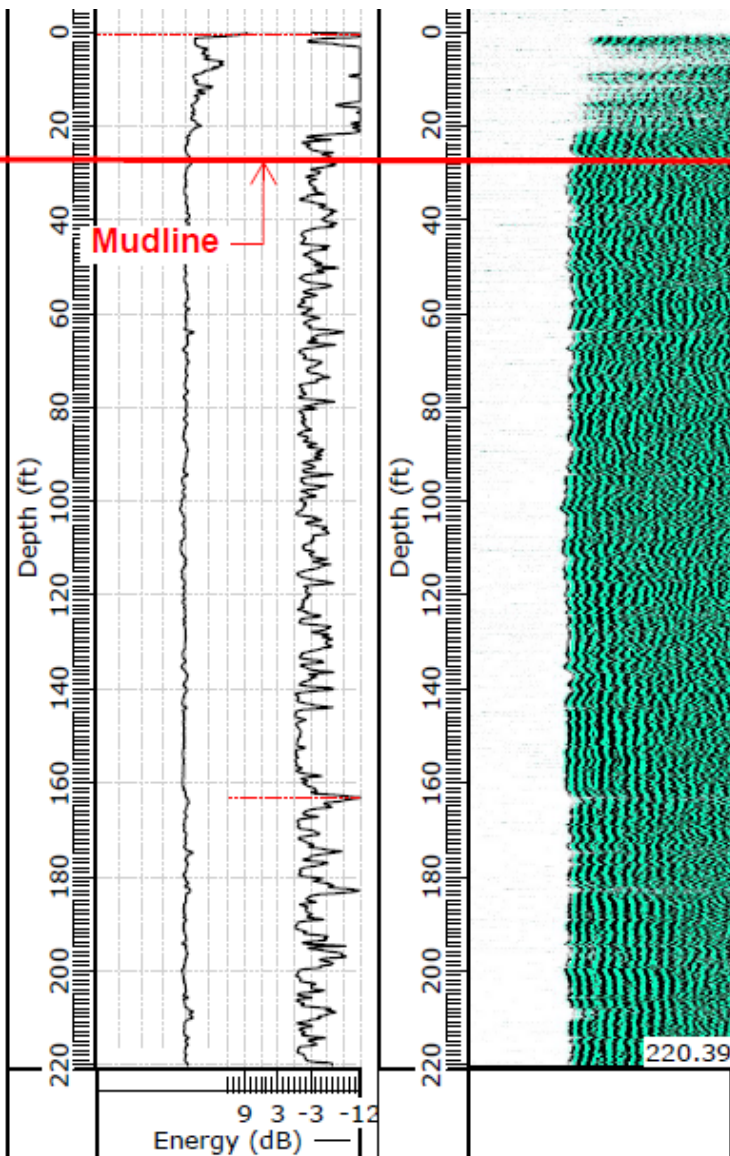
Comparison of TIP and CSL

TIP-R Version 2021.19.40

- Different thermal conditions above the mudline can influence TIP and CSL results.
- Influence on CSL results is possibly attributed to tube debonding and/or concrete bleed.
- TIP interpretation is difficult in the zone above the mudline, especially when CSL results show anomalies in the same zone.
- The examples presented are not defective shafts, but rather shafts with anomalous data due to the thermal conditions.
- Evaluation of CSL and TIP results must be considered in the context of what is known about the concrete placement.
