Stabilizing Slides in Pennington Formation with Drilled Ground Anchors

Slope Stabilization @ I-40 WB MM 342, Roane Co.

Geotechnical Engineer: WSP\Golder

Presenter: Robert Jowers, PE

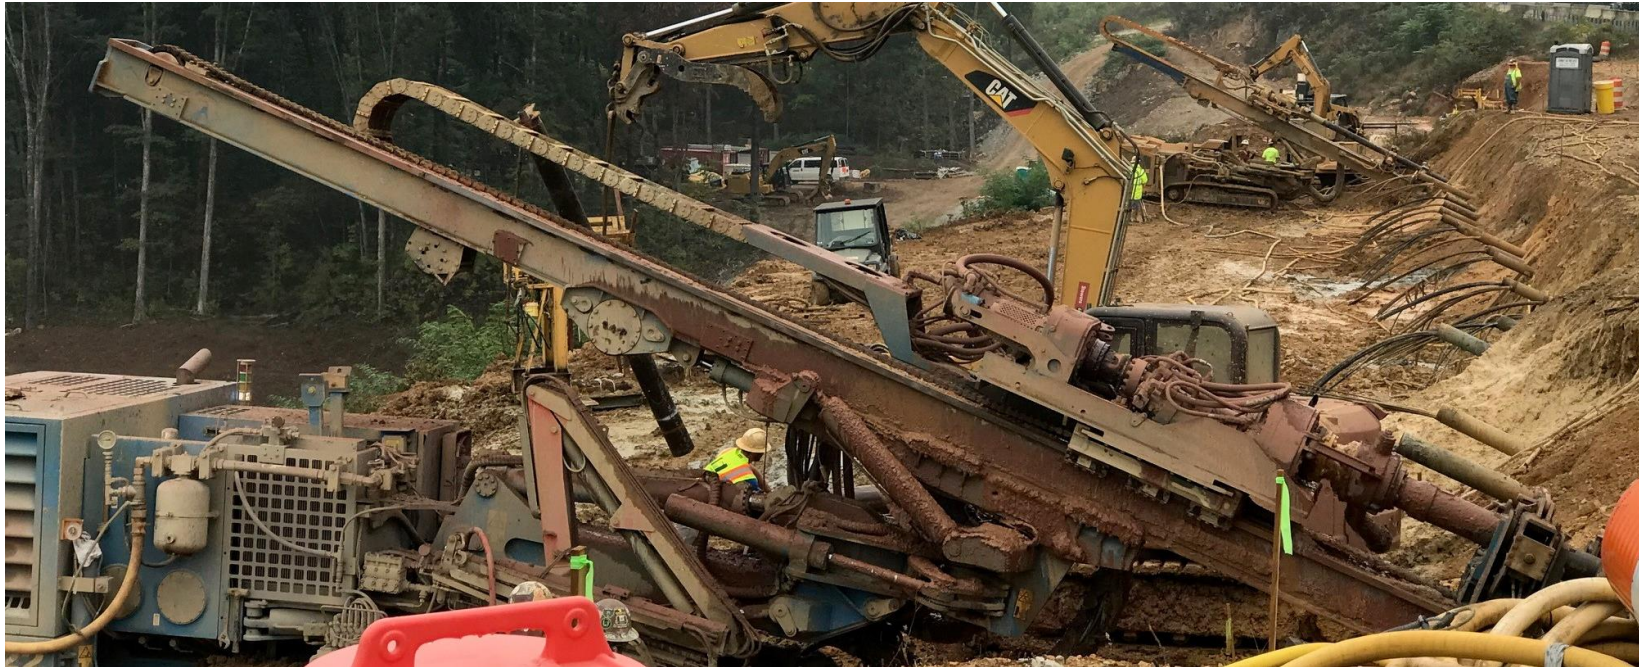
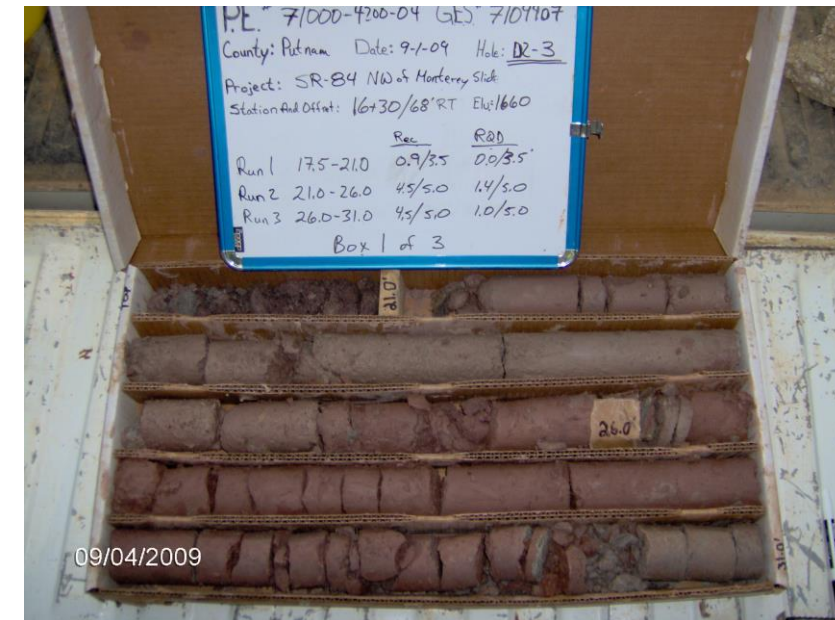
- ❖ Pennington Shale Formation Test Boring (1/3
- ❖ Notice the color on the drill matching the test boring samples

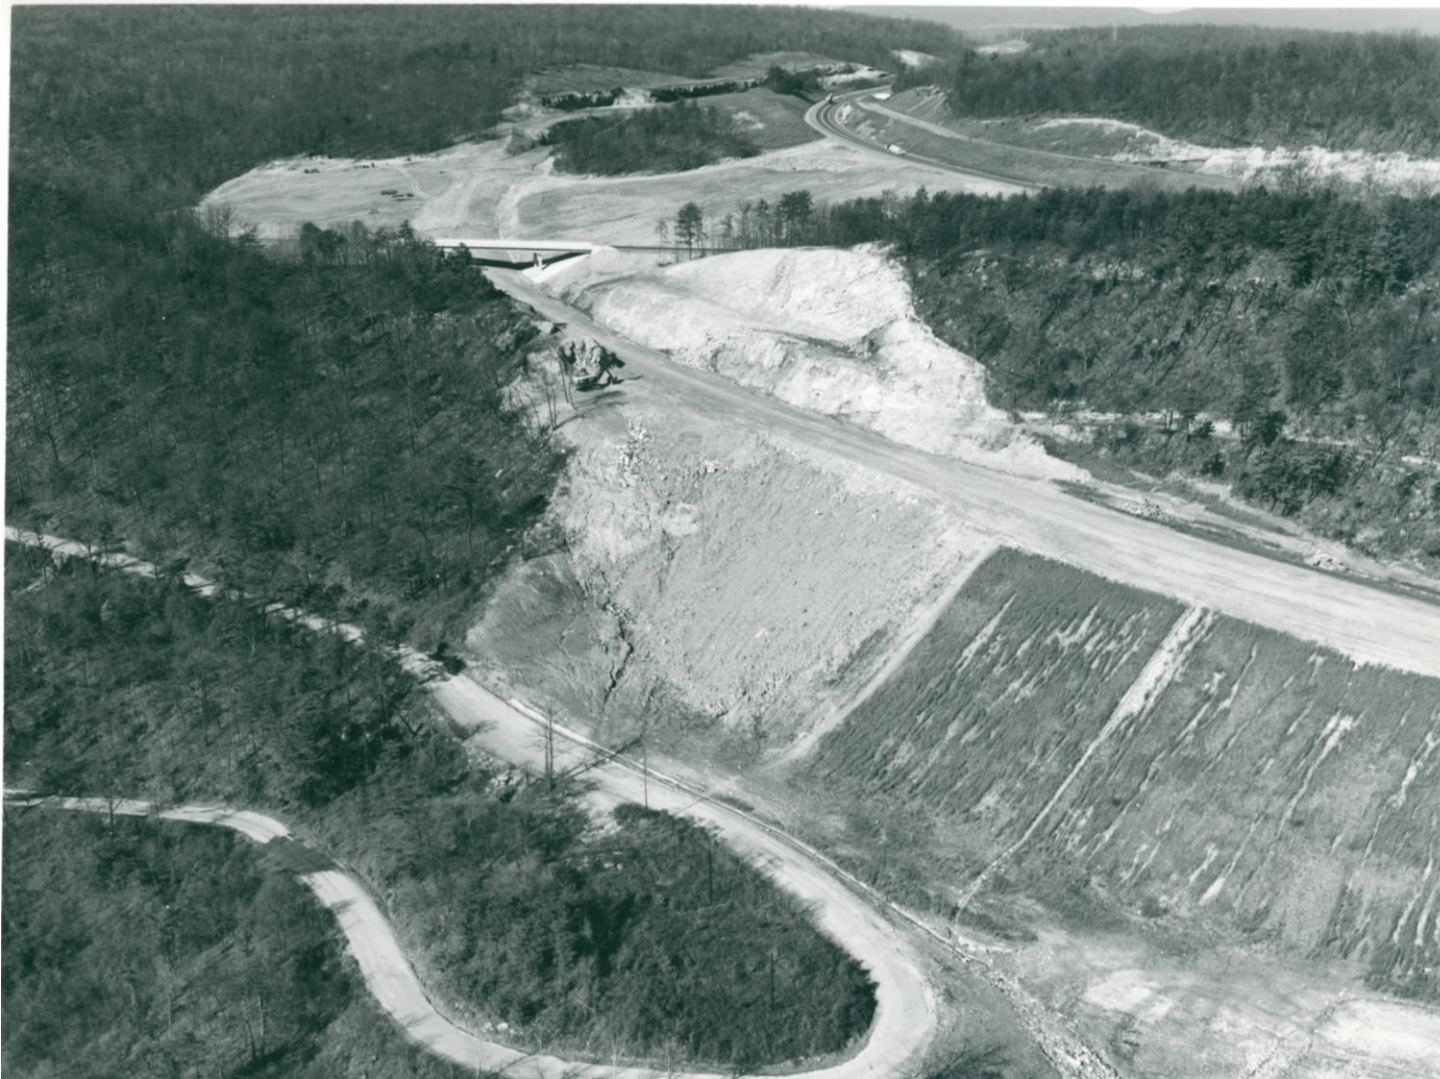
I-40 Construction in 1968

- ❖ South of Walden Ridge, near the city of Rockwood
- ❖ Fill Slide proposed near MM 341.5-342
- ❖ Halted Construction

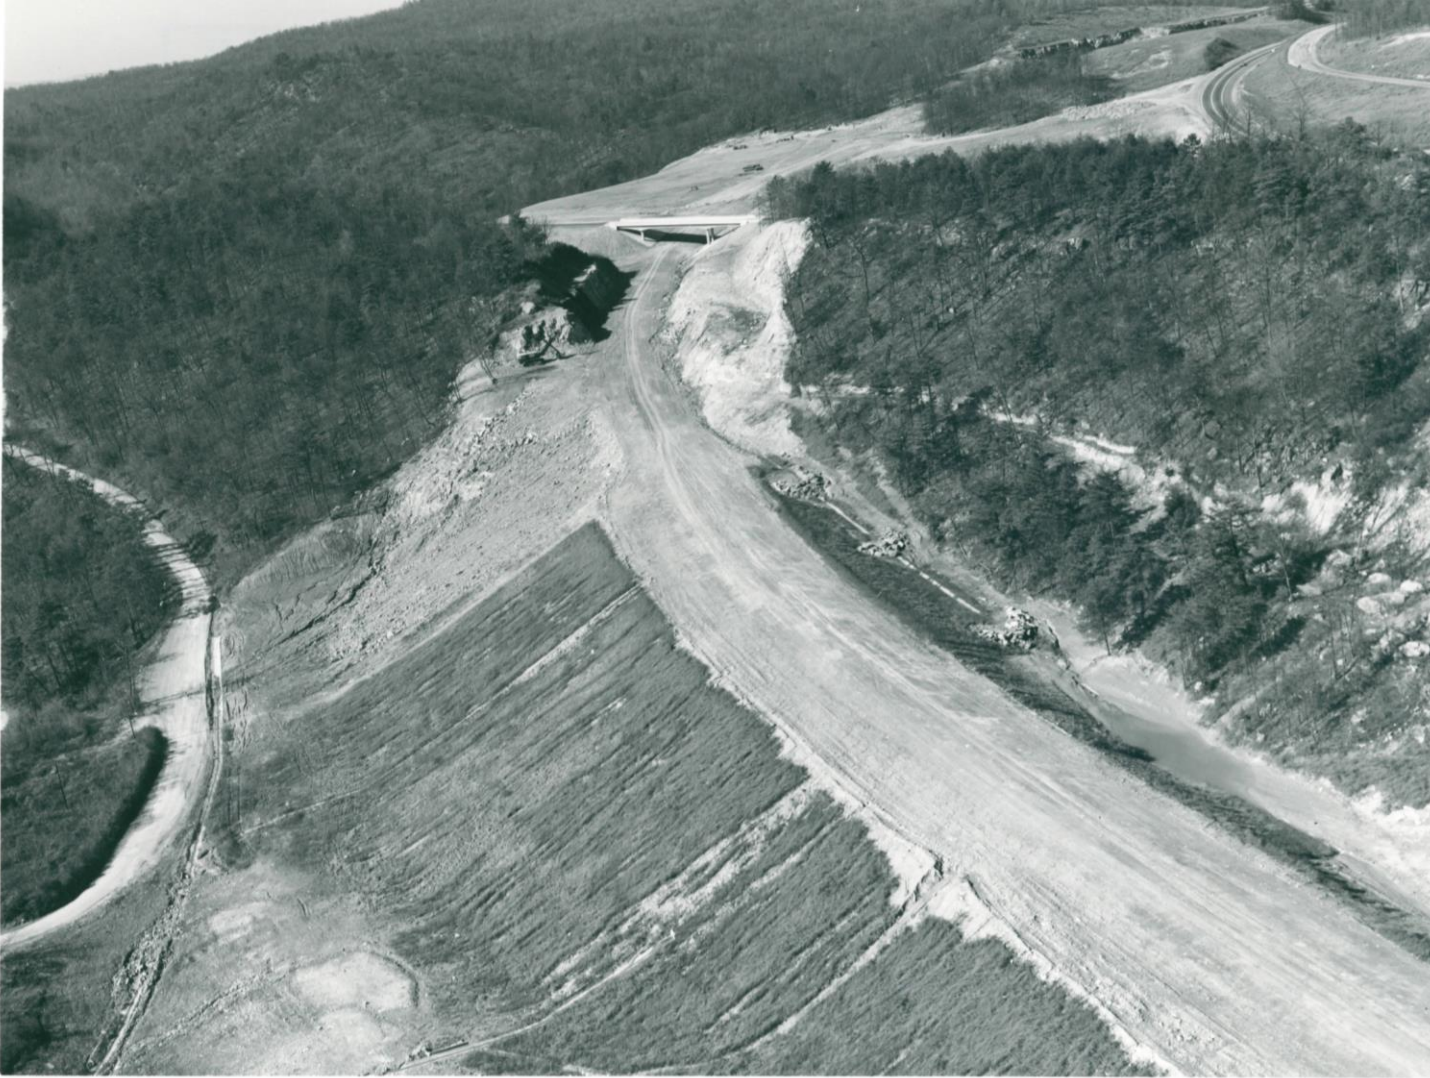
I-40 Construction in 1968

- ❖ **Entire corridor is built on unstable colluvial material**
- ❖ **Must contend with the Pennington Shale colluvium**

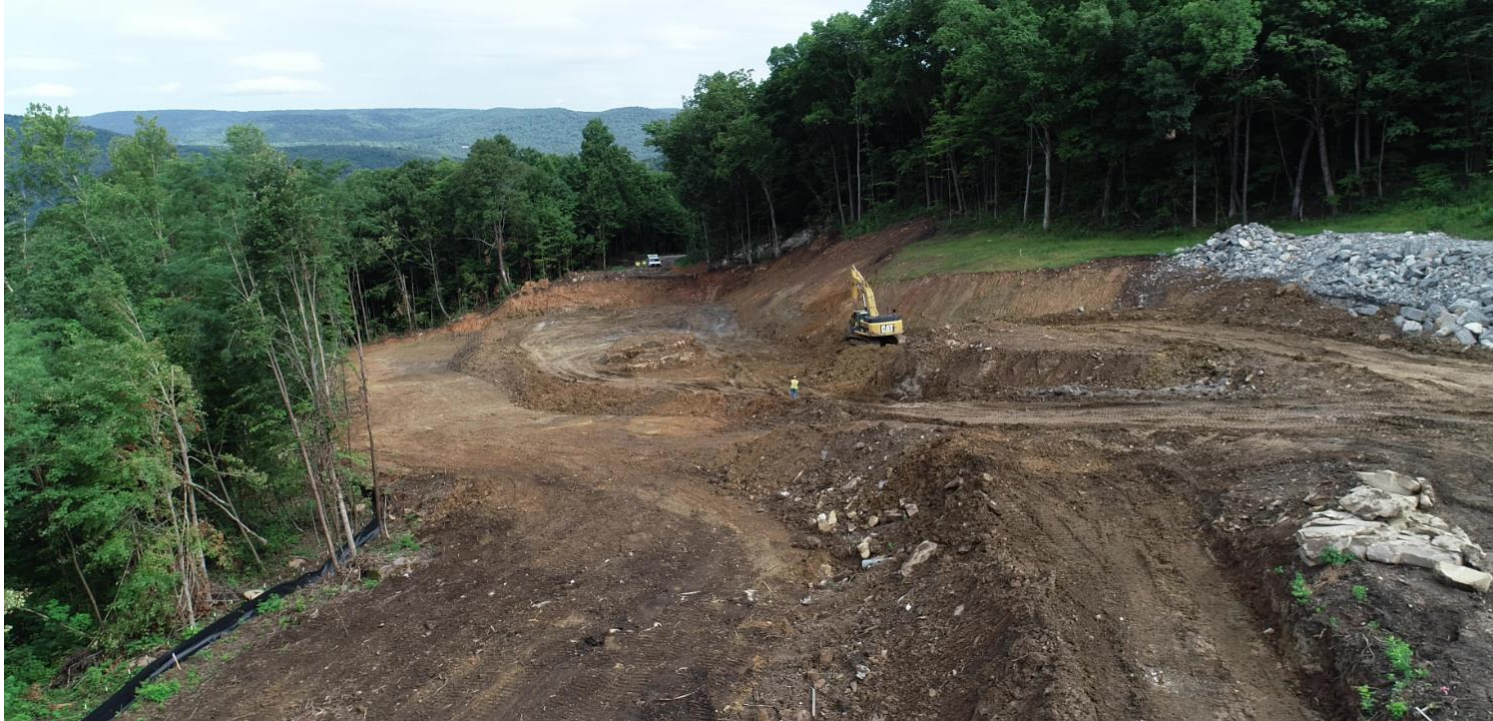
Restraint – Stone Buttnress

- ❖ **Earthwork Volume excessive**
- ❖ **Practical if colluvium shallow**
- ❖ **Typically requires road closure**
- ❖ **Impractical in urban \ high ADT**

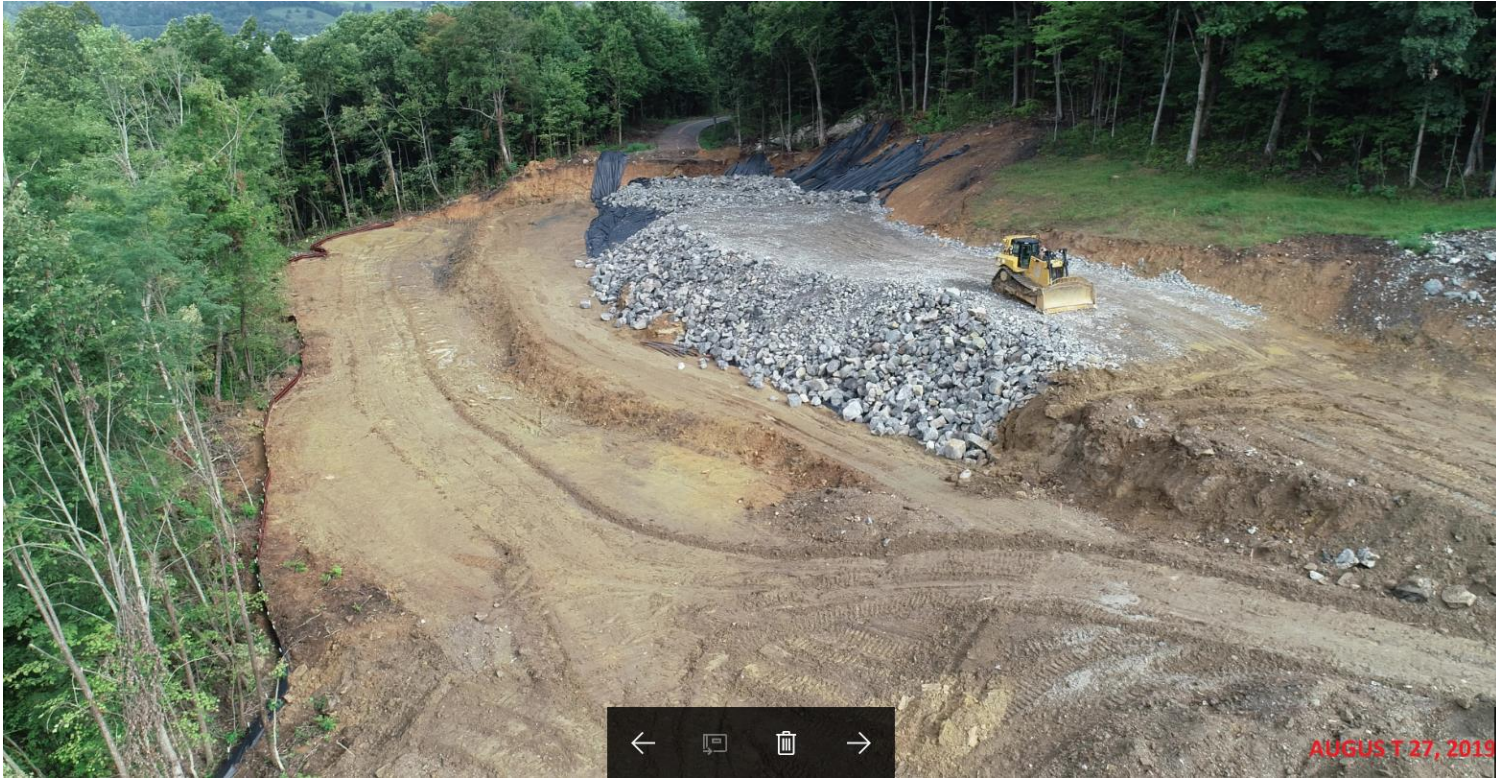
Restraint – Stone Buttress

❖ SR-85, Fentress Co.

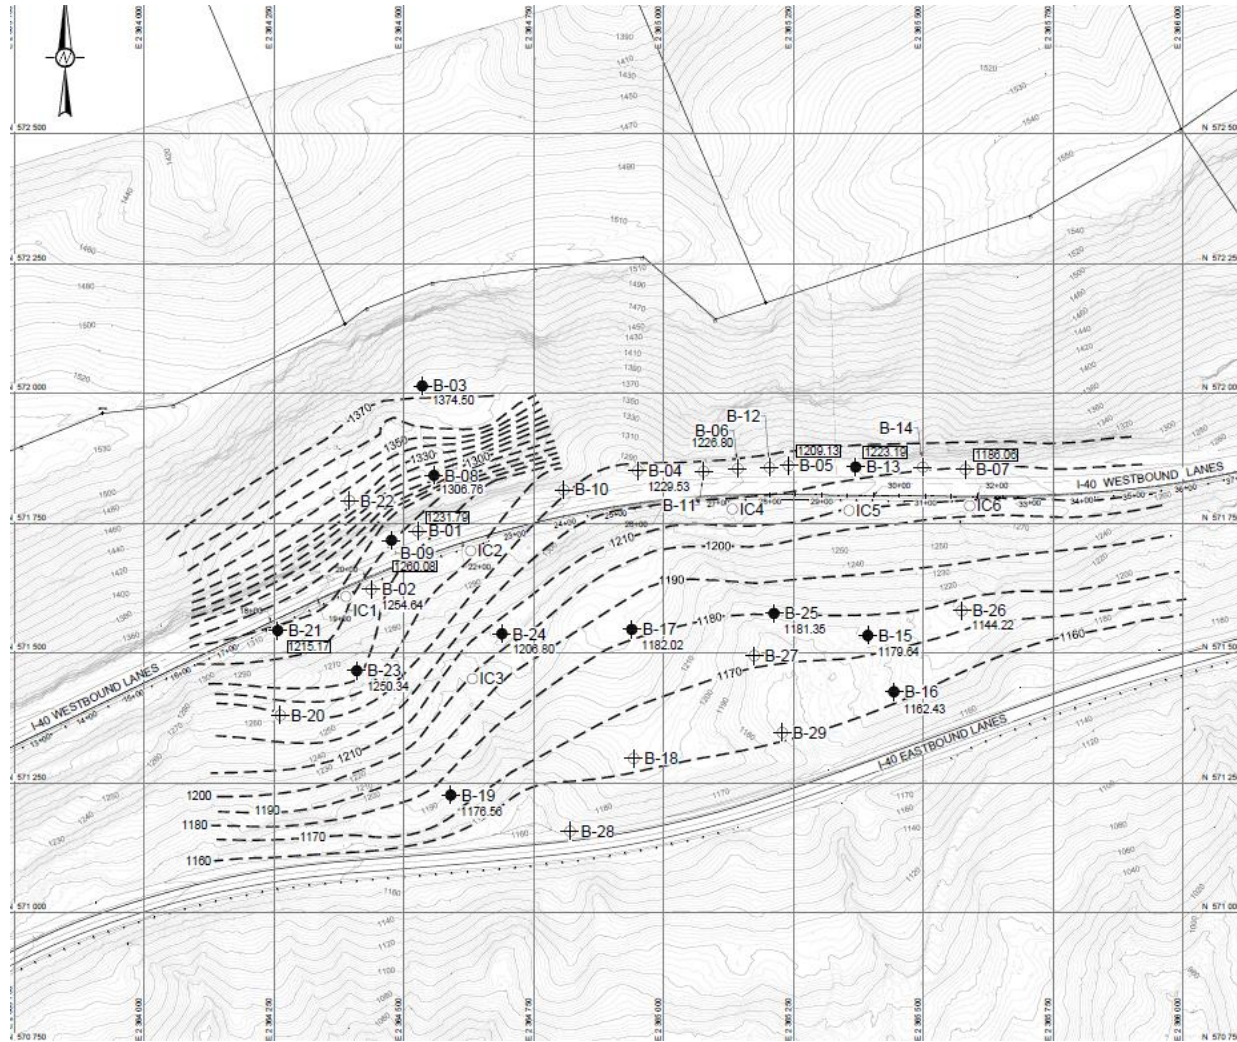
WB Site Characterization

❖ Extensive Site Characterization Required

❖ Thirty-five test borings

❖ Developed six slope inclinometers

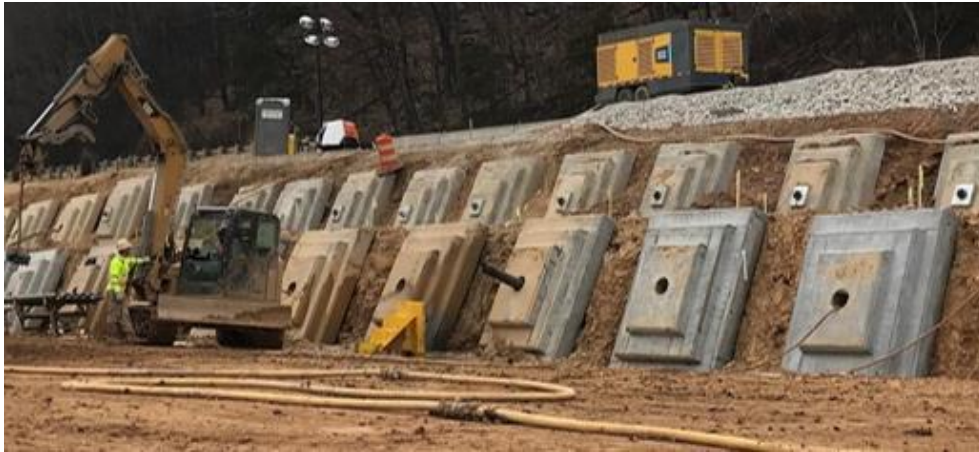
WB Plans Design - Anchors

- ❖ Bid plans required 3, 7, and 9 Strand cable
- ❖ Design loads of 80 kip, 246 kip and 317 kip
- ❖ Drill depths between approx. 150 ft. and 250 ft.

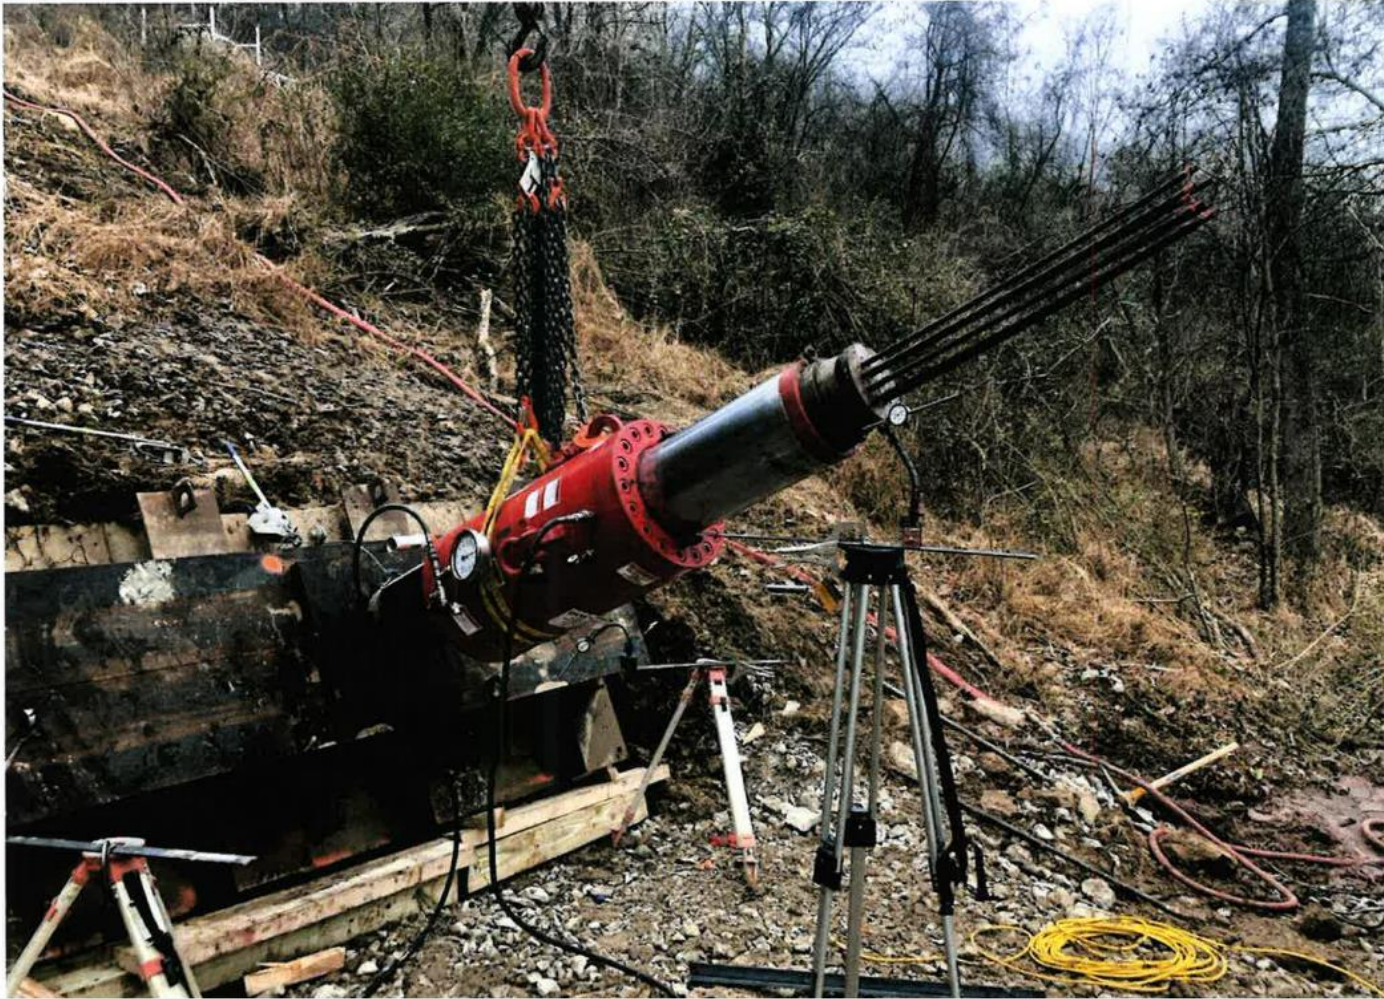
TA1 TEST SETUP

- ❖ Prior to consideration, TDOT required load tested anchors
- ❖ Design loads of 500 k were applied
- ❖ 12 strand anchors
- ❖ 8 in. diameter
- ❖ *VECP approved*

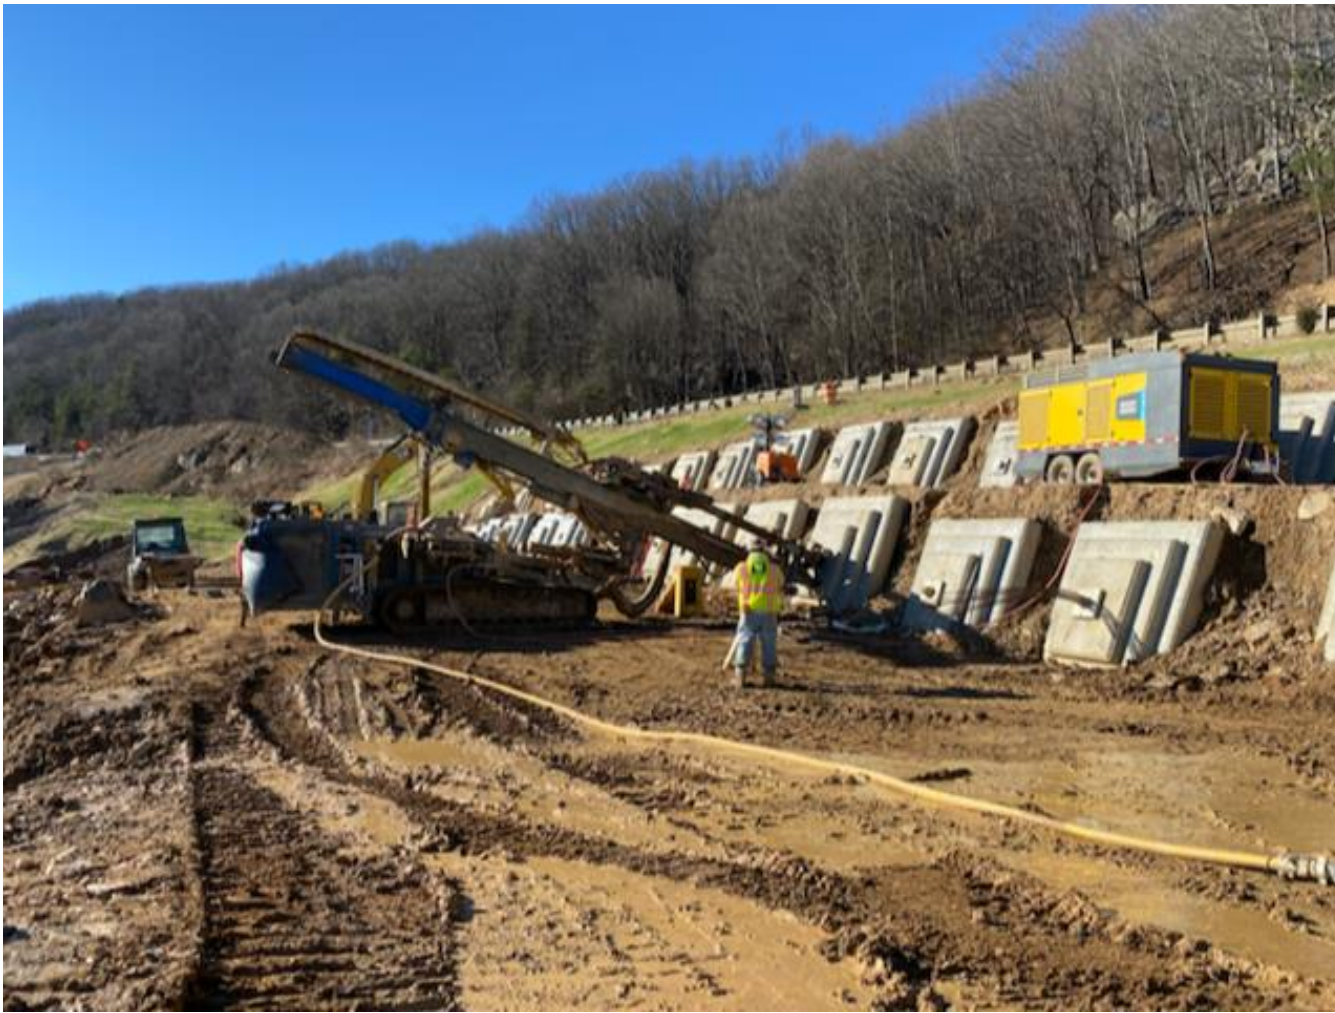
Anchor Drilling

TYPICAL SECTION

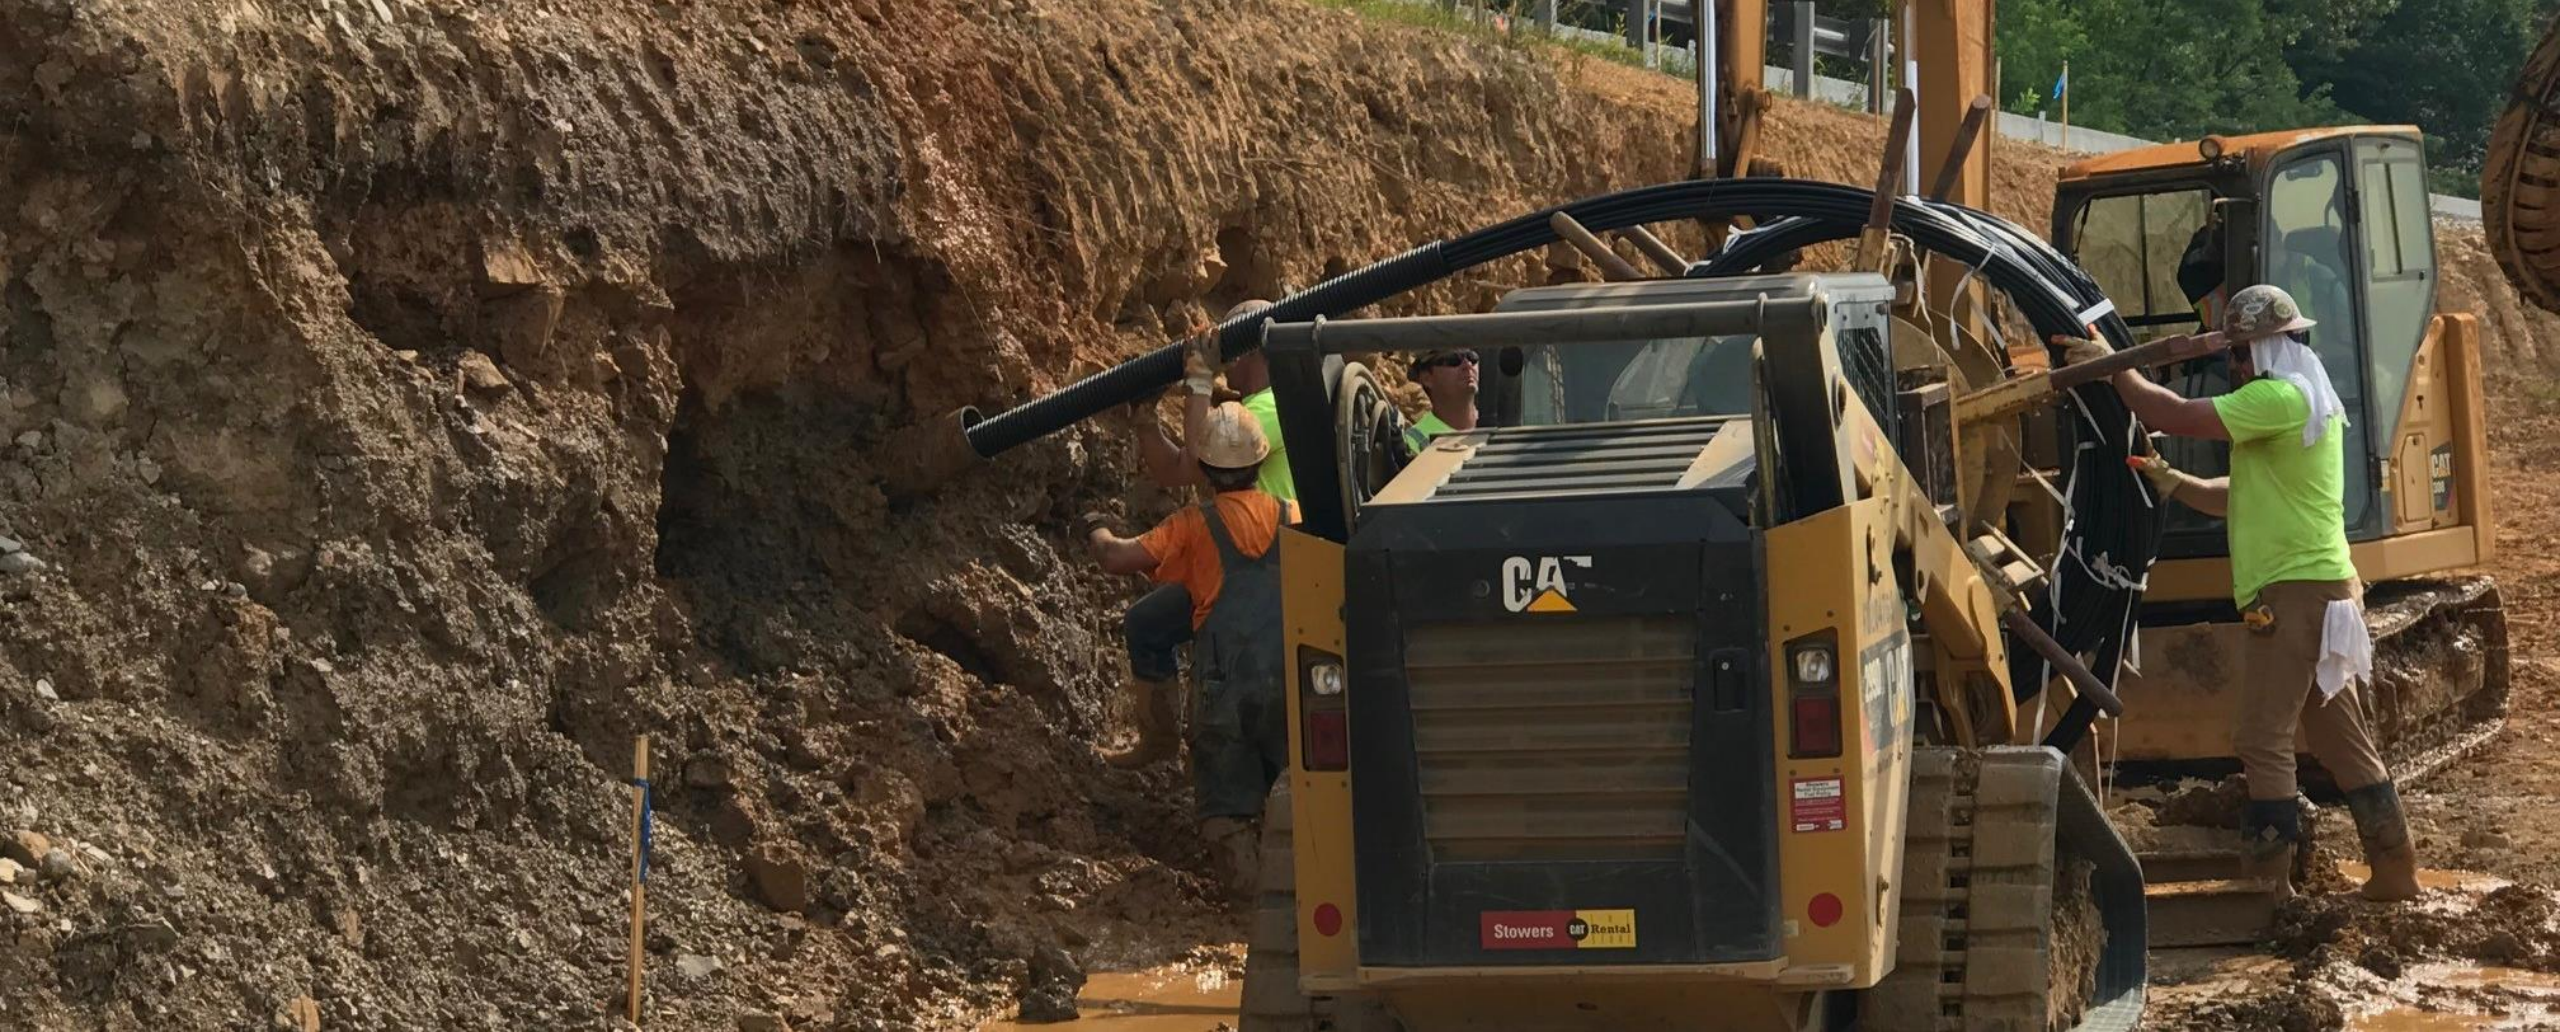
Anchor Drilling - Strand Placement

TYPICAL DETAIL SECTION

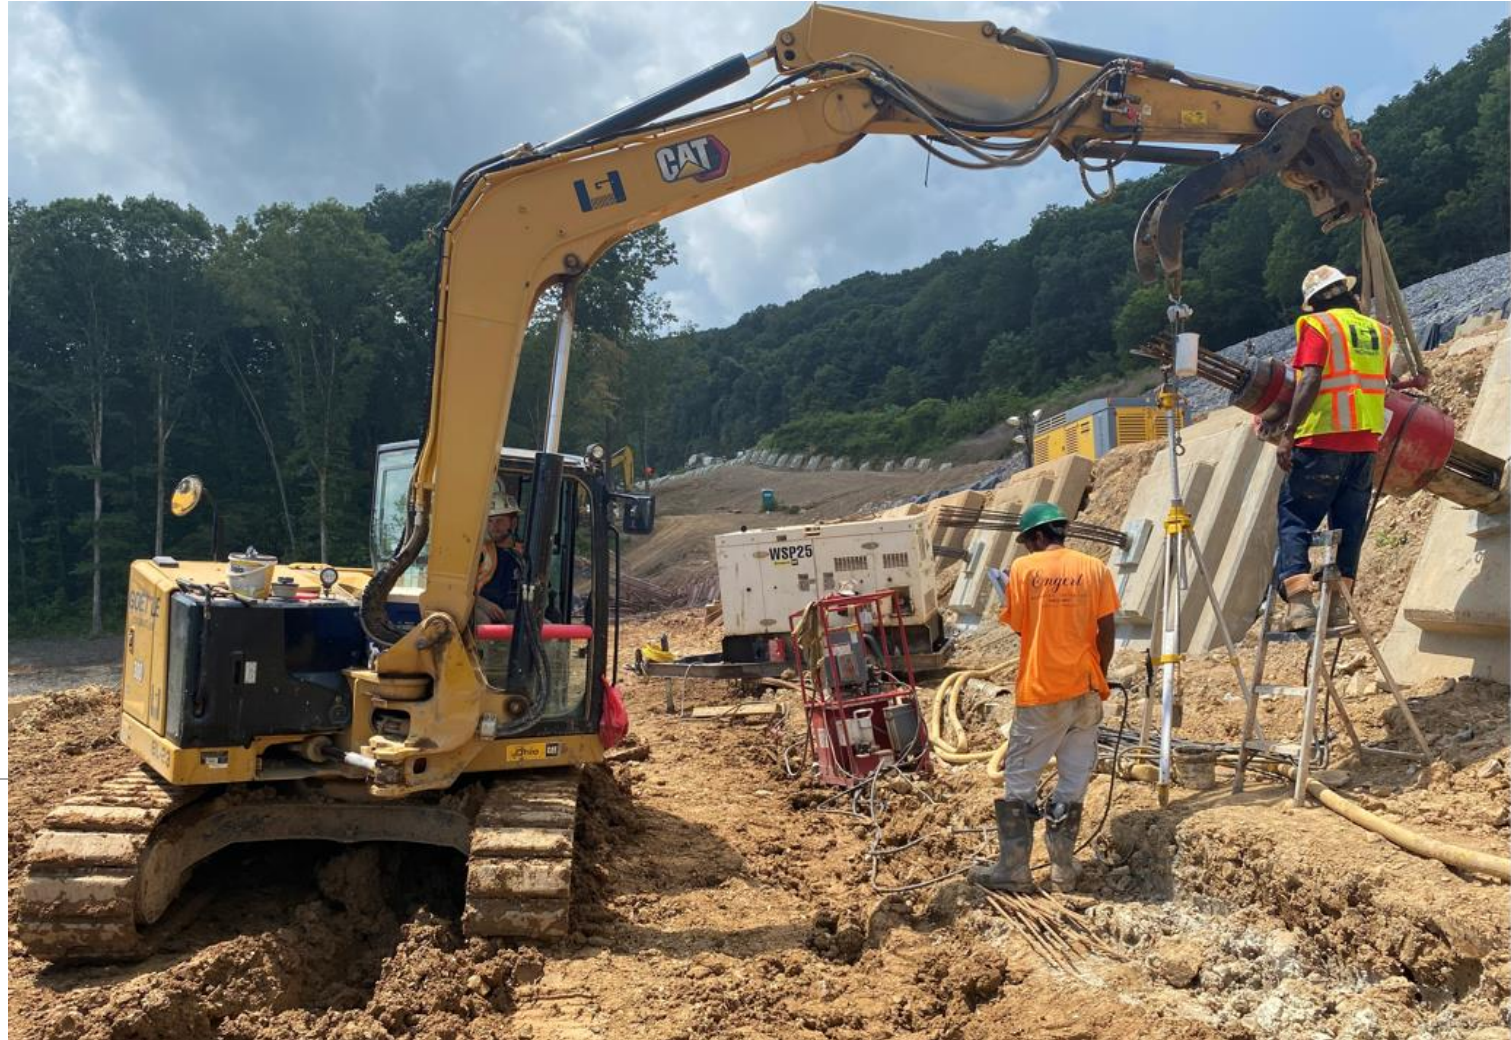
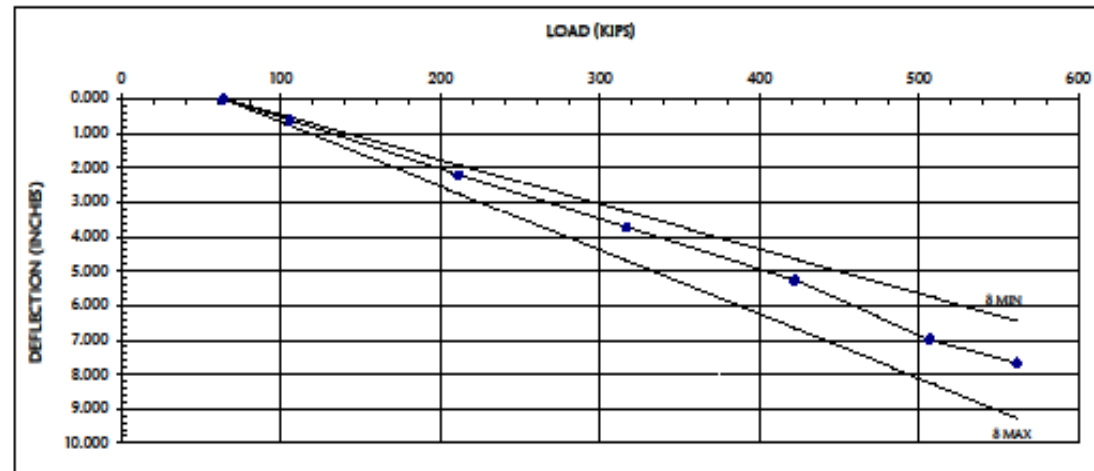
Anchor Proof Test

TENDON DATA			%DL	AL	25	50	75	100	120	133
ANCHOR DESIGN LOAD 421.8 Kips			LOAD	63.3	105.5	211.0	316.4	421.9	506.3	561.1
BOND LENGTH 30 ft			ELONG'N	-	0.820	2.210	3.736	6.272	8.982	7.886
FREE LENGTH + JACK SETUP (6 FT) 100.0 ft			d MIN (in)	0.000	0.546	1.910	3.275	4.639	5.730	6.440
TAIL LENGTH 10.0 ft			d MAX (in)	0.000	0.785	2.746	4.707	6.668	8.237	9.257
ANCHOR STRAND QUANTITY 12			gauge, psi	880	1,100	2,130	3,180	4,180	6,010	6,640
TOTAL STRAND AREA 2.80 in ²										
MODULUS OF ELASTICITY 28,600 ksi										
CREEP TIME:			1	2	3	4	5	6	10	15
TEST	READING:	7.886	7.888	7.871	7.872	7.873	7.874	7.876	-	-
INFO	CREEP:	-	0.004	0.006	0.007	0.008	0.009	0.010	-	-

target	actual	
421.8	423	kips
4,190	4,200	psi

Total Elongation	7.665
AL After Backing Off MTL	0.469
Elastic Movement @ MTL	7.196

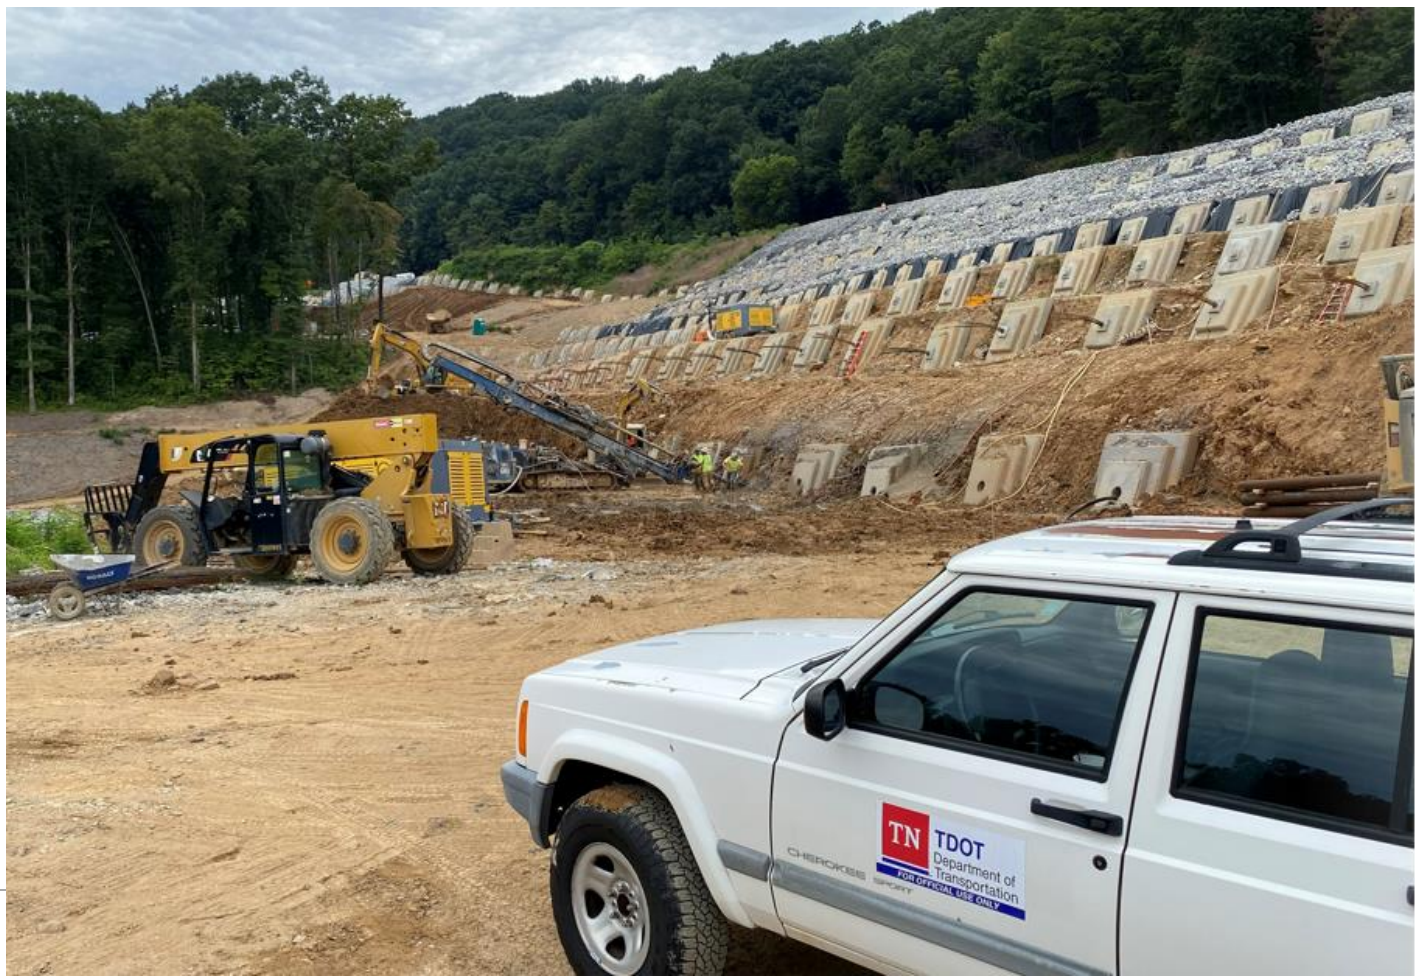
Progress Time Line

Status Key	Status Number	Indication	Instances	% of Total
	0	Not Installed	57	9.42%
	1	Installed, Not Tested	37	6.12%
	2	Installed, Tested, Pending Test Submission	0	0.00%
	3	Pending TDOT Acceptance	0	0.00%
	4	TDOT Acceptance	511	84.46%
			605	100.00%
Status Date		9/6/2022

1st Day Drilling	8/5/2021
Days Elapsed Since	397
Avg. Anchors Approved Per Calendar Day	1.29
Projected Anchor Completion By Straight Line Interpolation	11/18/2022
