EVALUATION OF NON-CONFORMING PILES

TOPICS

- Minimum Tip Elevation
- Required Driving Resistance
- Geometrical Tolerance
- Pile Damage

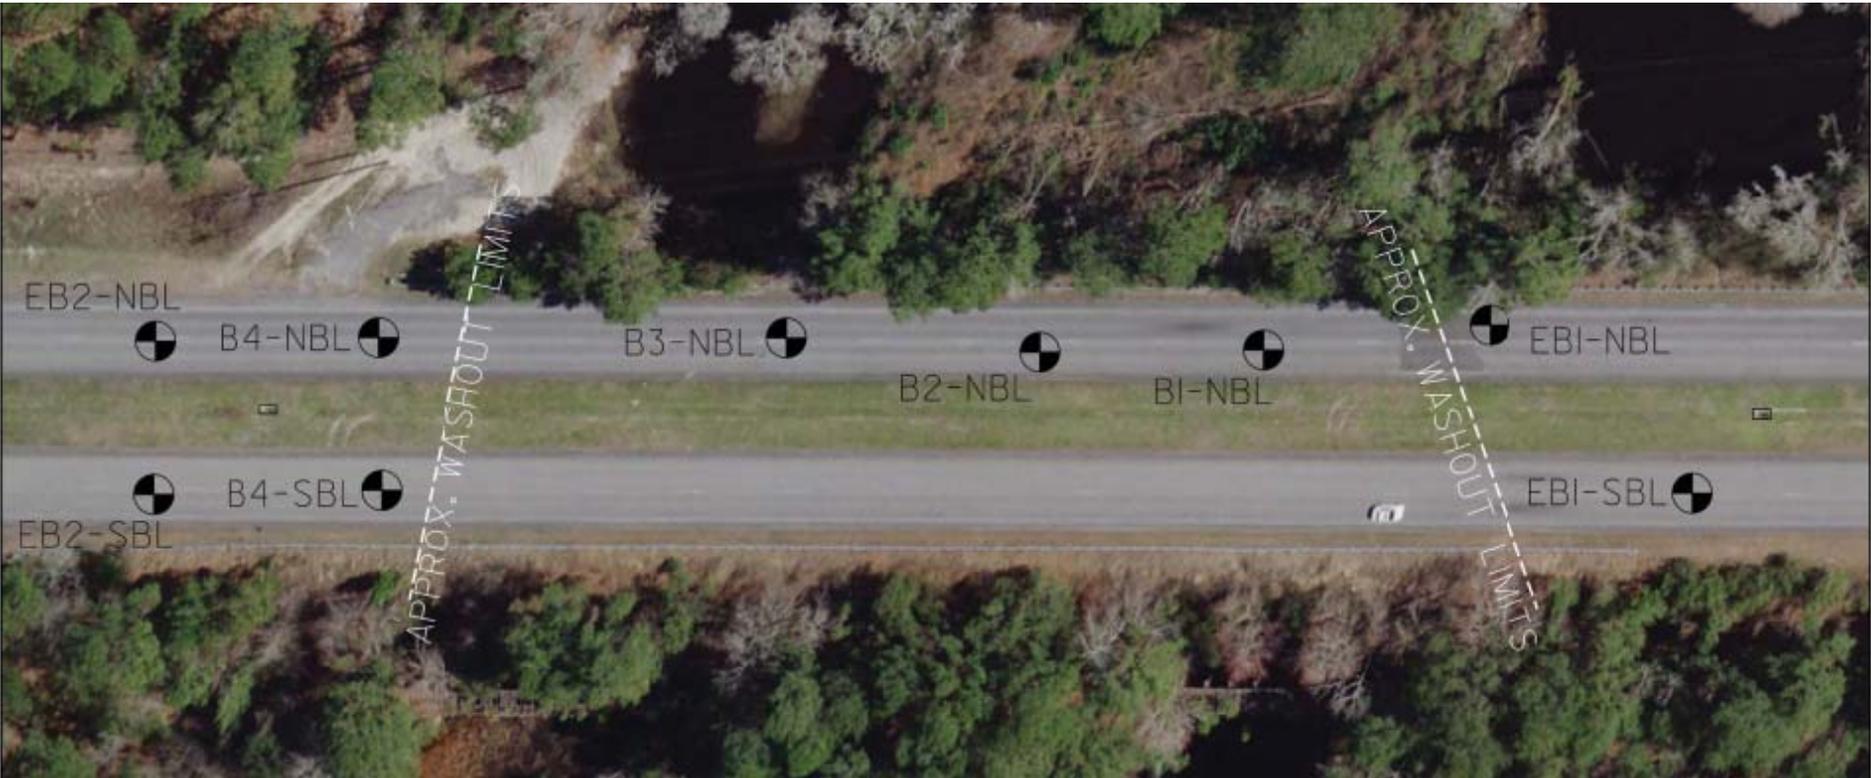
BORING LOCATION PLAN

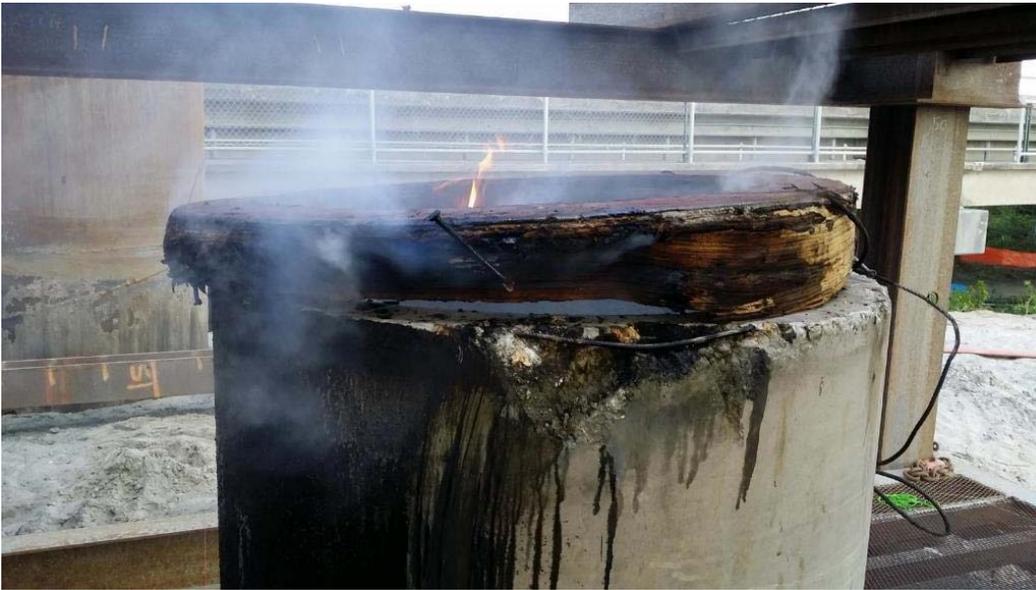
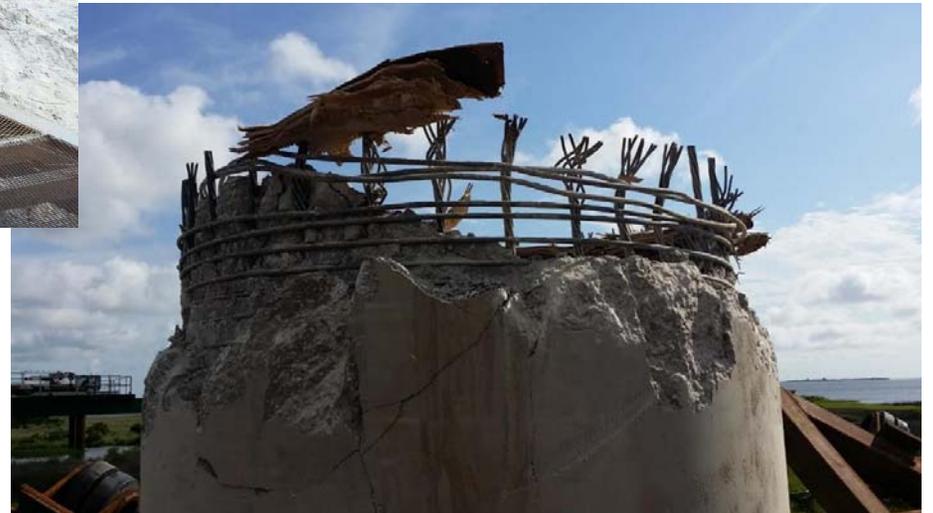
CYLINDER PILE SURFICIAL DAMAGE

- Damage to pile top was surficial only
- Damaged portion cut off after driving
