SR-2 Corridor Study and PROTECT-Act Review

Darren Beckstrand, C.E.G., Landslide Technology Robert Jowers, P.E., TDOT

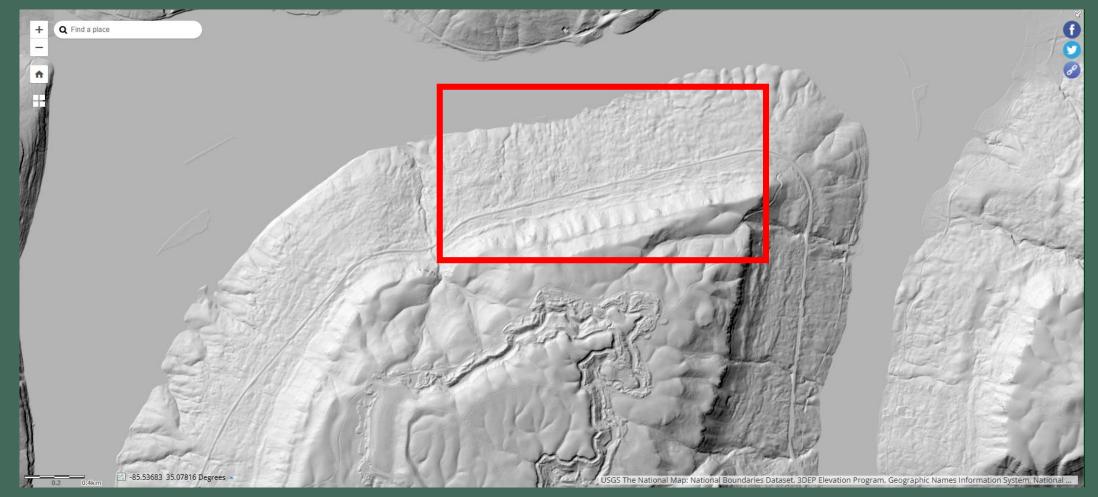
- Interpret landslides and debris flow paths on bare earth LiDAR maps
- Conceptualize sensor types and locations

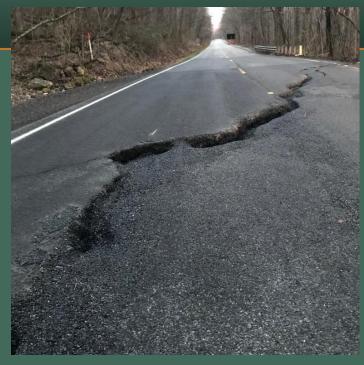
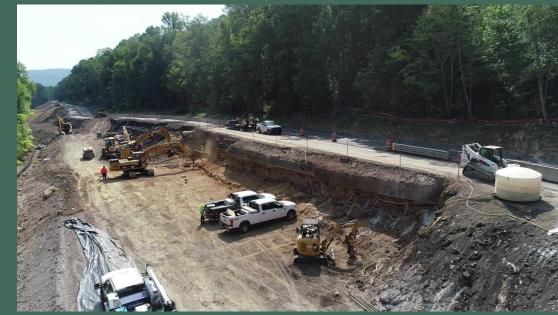
Stability Issues LM 25-26

- Minor distress in several locations
- 12/2018 and 1/2019 several storms led to landslides
- Several inches of vertical displacement
- Landslide was too fast to keep road open, ER contract let
- Realignment, soil nail walls, and horizontal drains installed in summer 2019
- Distress is on going

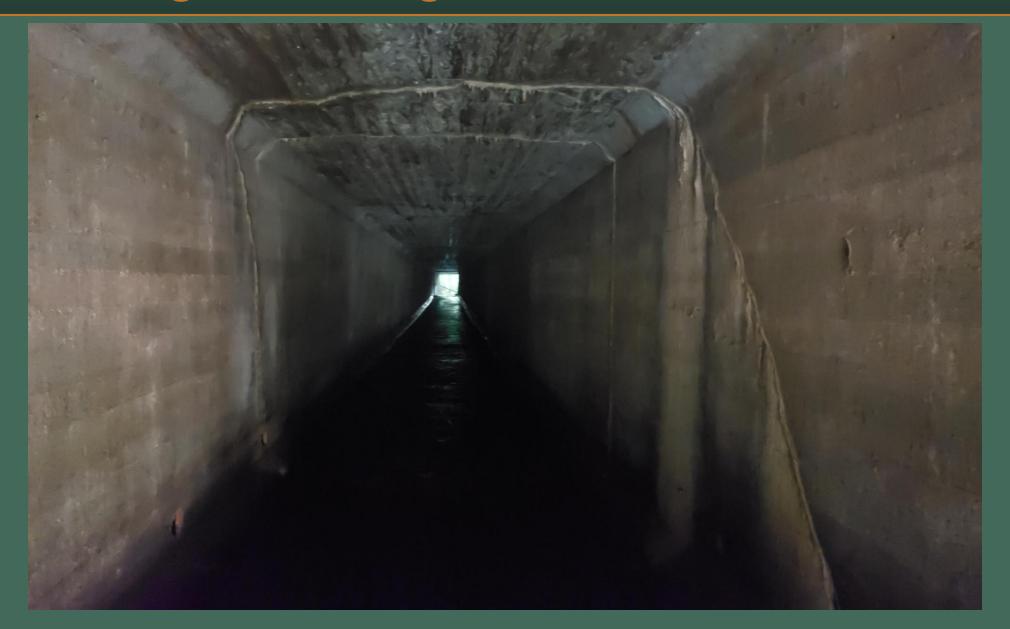
Other Damages – Damaged/Distressed Box Culverts

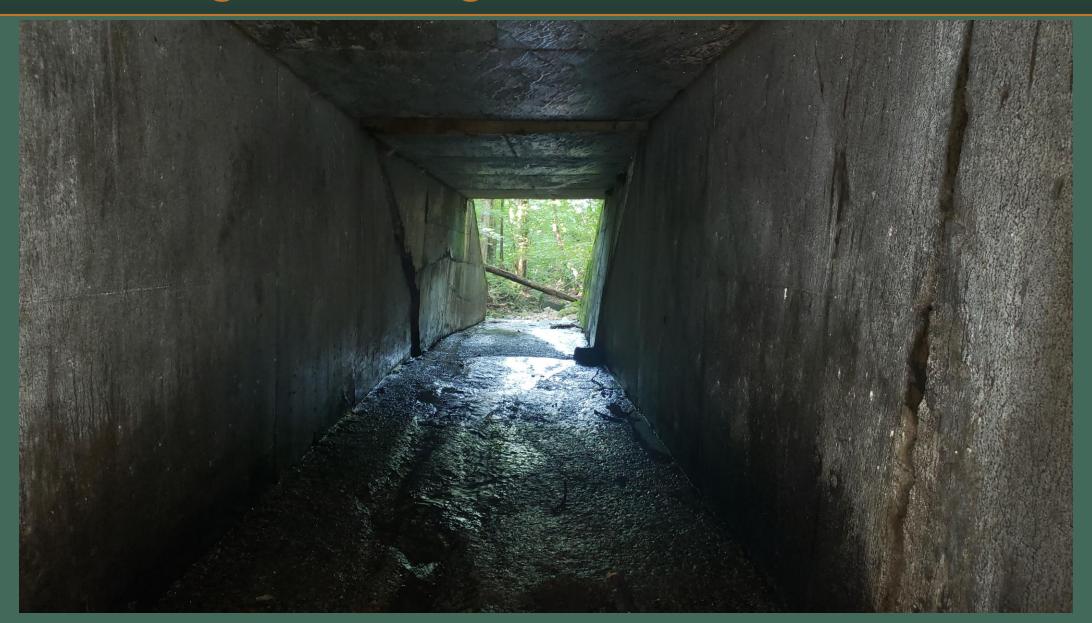
Other Damages – Damaged/Distressed Box Culverts

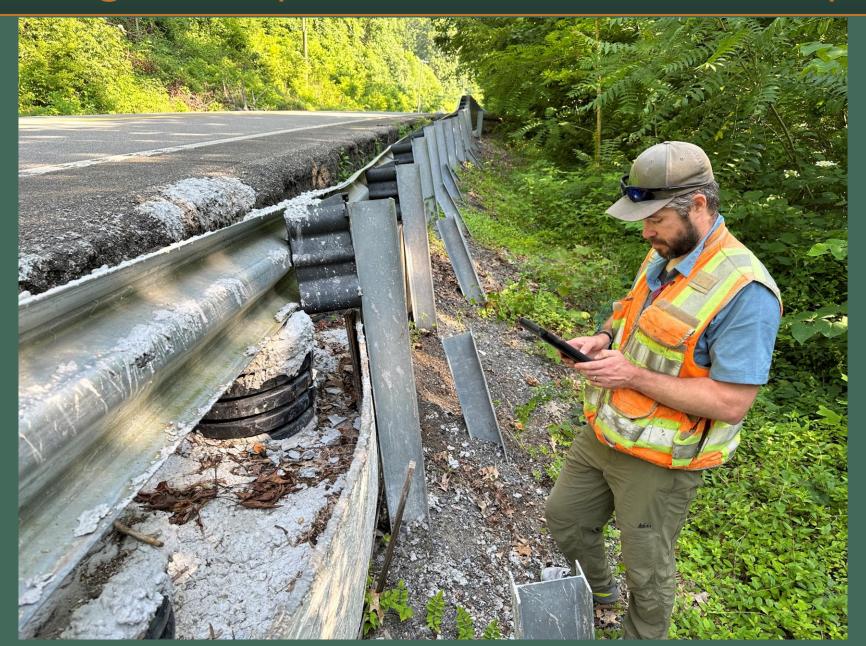
Other Damages – Repairs Stacked on Other Repairs

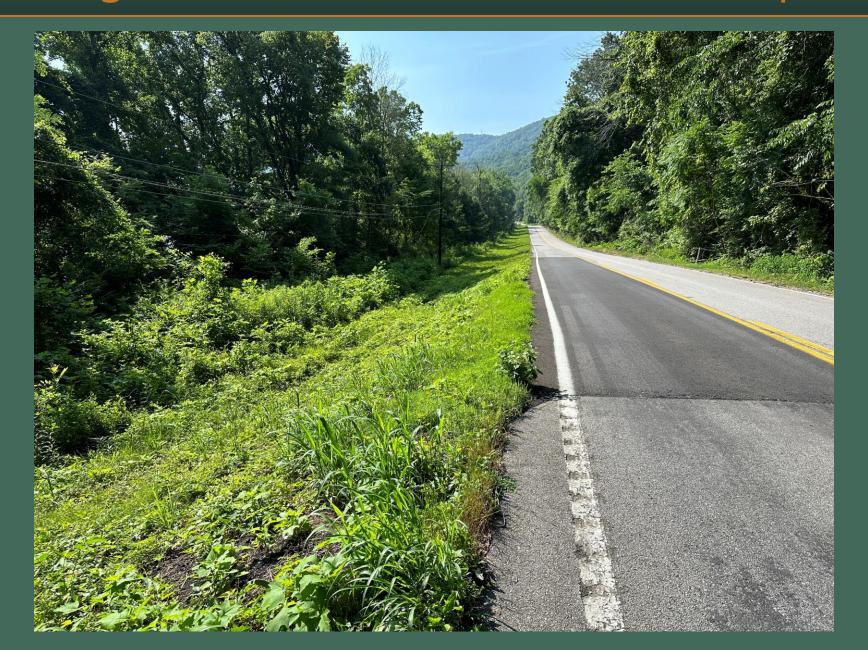
Other Damages – Shoulder/Embankment Repairs

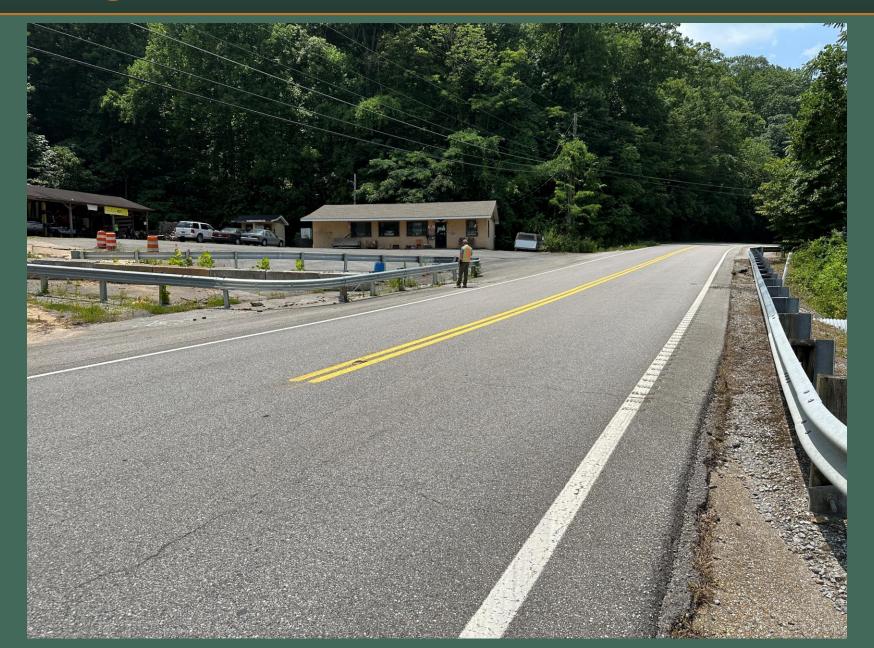
Other Damages – Past Events

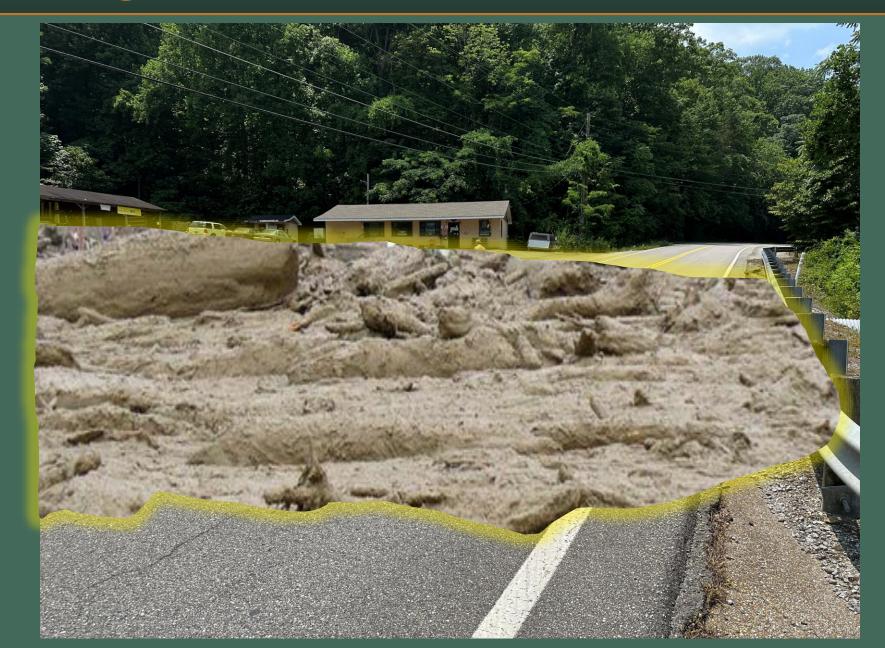
Other Damages – Past Events

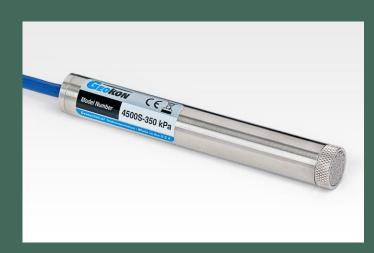
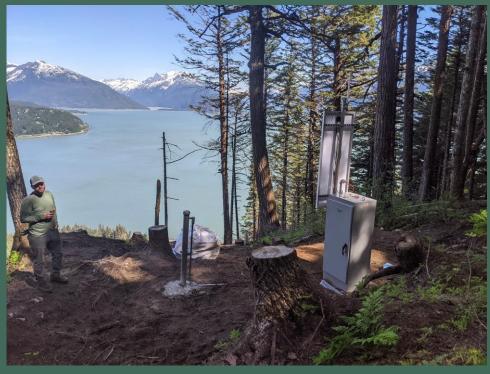
- Pilot Study for InSAR, Lidar, and SfM Photogrammetry Change Detection
- Geotechnical Borings focusing on Landslide Sensors
 - Vibrating Wire Piezometers
 - Inclinometers (discrete IPIs after movement is known)
 - Option to install ShapeAccelArrays
 - Depths and access estimated for each boring

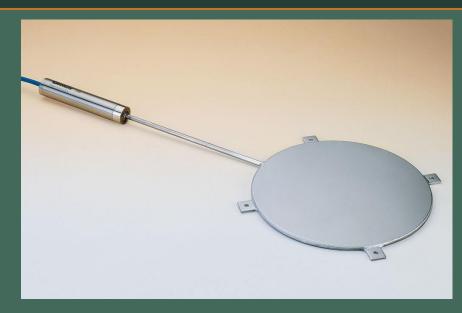
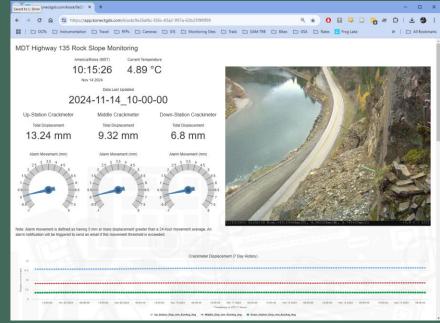
- Debris Flow Sensors
 - Earth Pressure Cells installed at Culvert Inlet (detect bedload + streamflow)
 - Piezometers (streamflow)
- Radio-telemetry capable dataloggers
- Transmitting data to a cellular modemequipped centralized datalogger(s)
- Obtain readings at close intervals (5 to 15 minutes)
- Send data to an interactive website
