US 76/SR 2 (Lookout Mountain Scenic Highway) Landslide Repair in Rabun County, GA

Eugene Utsalo, P.E.

Geotechnical Branch Chief
Office of Materials & Testing

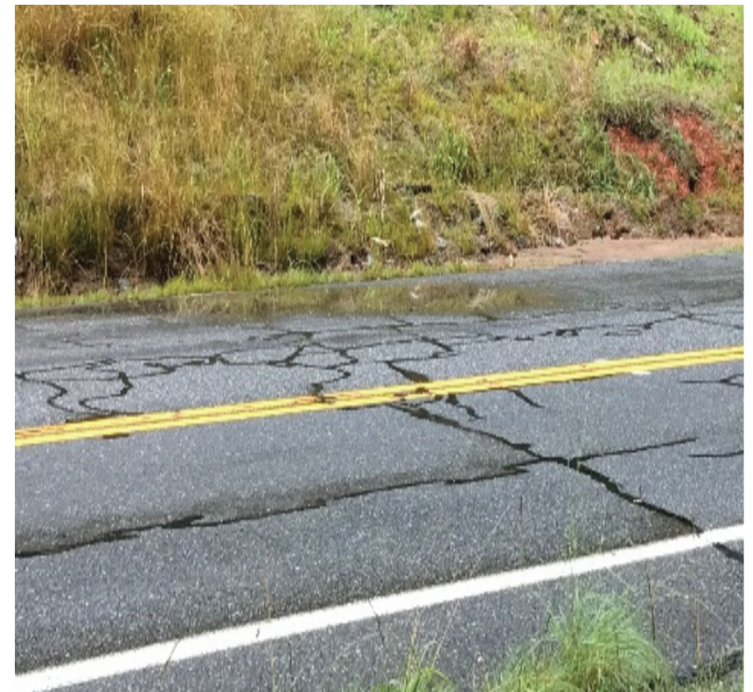
Project Background

- Roadway within project limits had a history of pavement distress repairs
- Significant pavement cracks, bulges & localized failures observed in May of 2019
- Landslide observed during field investigations
- Emergency project

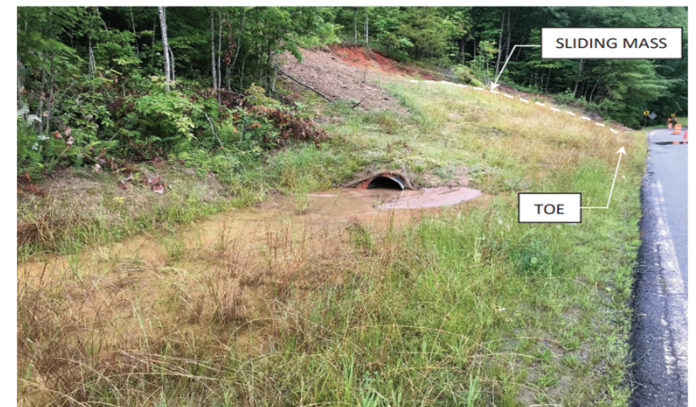
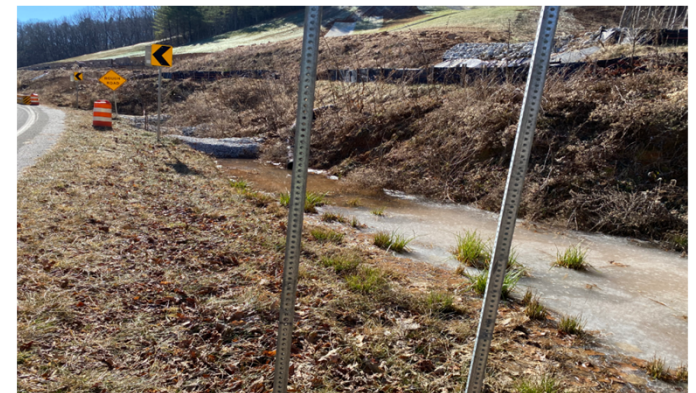
Landslide Cause

Caused by groundwater seepage

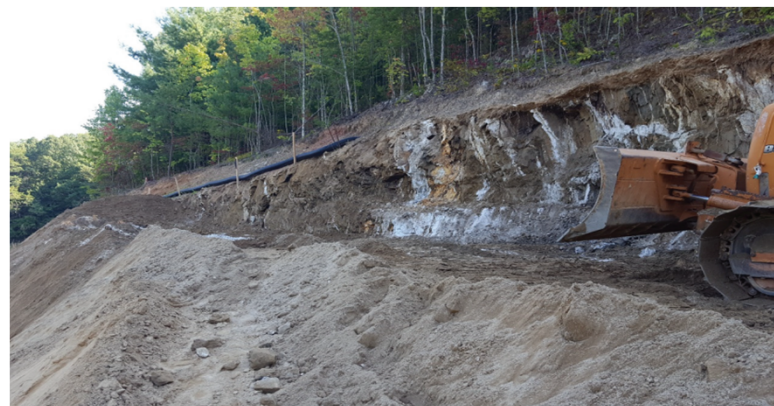
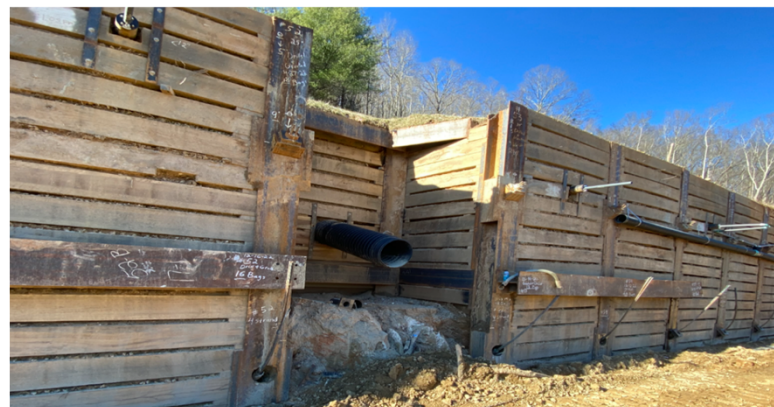
Tie-Back Wall Design

Excavation for wall installation

Soldier piles (14x89) - spaced 7 feet
& embedded 3 to 16 feet into mostly
PWR

Tie-back anchors embedded 10 to 12
feet into PWR & rock; bonded length
→ 40 to 90 feet

Horizontal drains - lower water table &
porewater pressures
