Testing of Drilled Shafts and Auger-Cast Piles for Assessments of Structural Integrity and Geotechnical Load Bearing Capacity

Southeastern Transportation Geotechnical Engineering Conference STGEC'2024 – Baton Rouge, Louisiana November 20, 2024

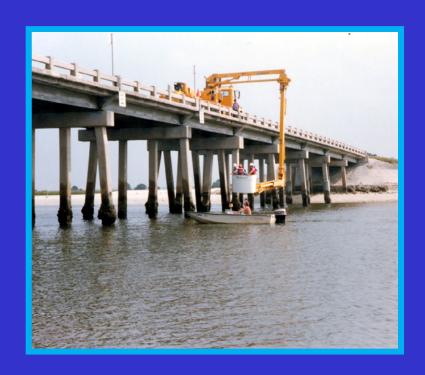
Testing for unknown pile length with PIT

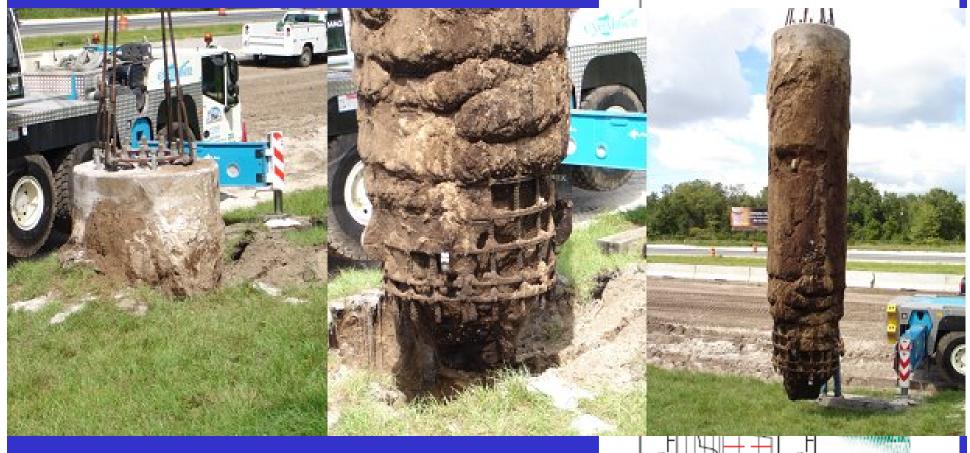
CSL test results.

Case Study: FDOT Shaft for a miscellaneous structure. PIT & CSL testing.
