Geotech EMS

Limited Geotechnical investigations in the aftermath of flooding

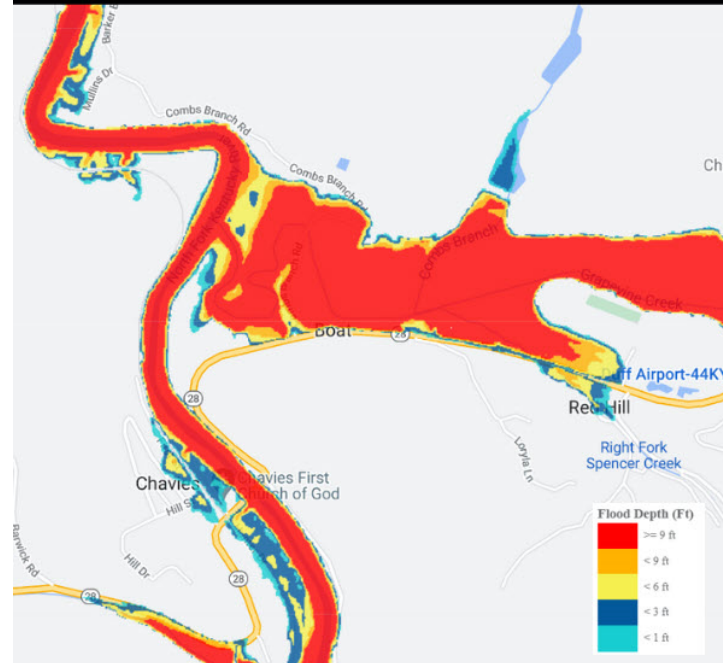
FlashFlood - Kentucky (USA) 2022 - Flood Inundation by ICEYE as of July 29

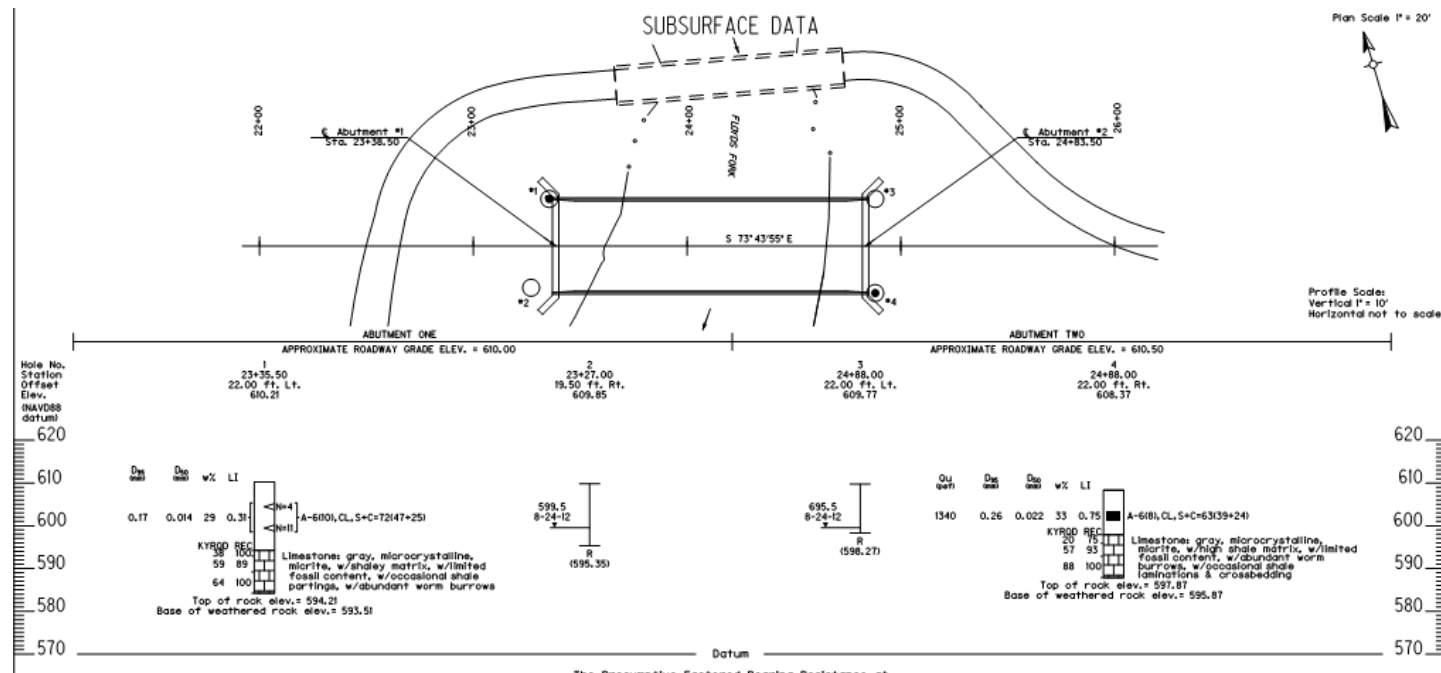
Standard investigation

- Single span 2 borings on each end 1 sample-core one sounding
- 2 span add core and sounding at pier

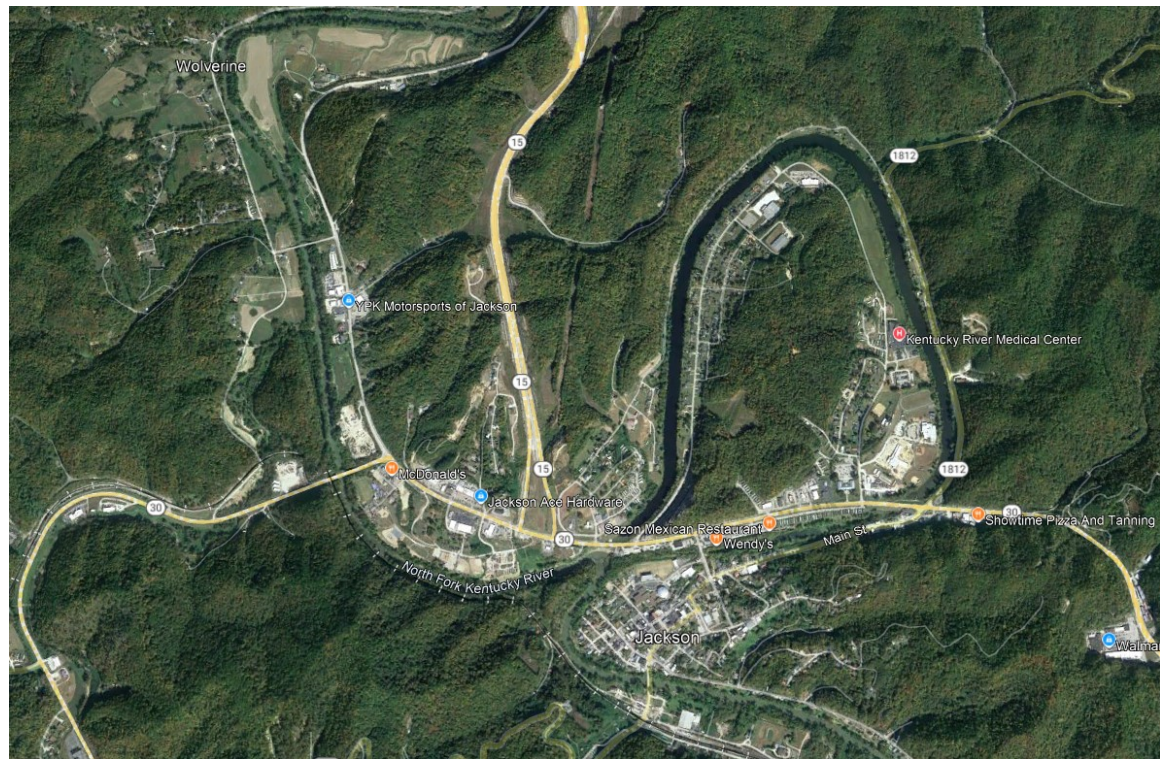
Panbowl Lake

Panbowl history

- Oxbow lake formed from Kentucky River
- KY 15 is located on both dams of the lake
- Kentucky River on the other side of the western dam
- Design project underway to correct water infiltration issue at the time of flooding
- Water noted flowing from KY river side into the lake during flood

Panbowl repairs

- Sheet pile wall designed and bid for west dam
- Secant pile wall of drilled shafts VE used
- Wall constructed in 2023
- Additional work began on the east dam and over flow areas in 2024

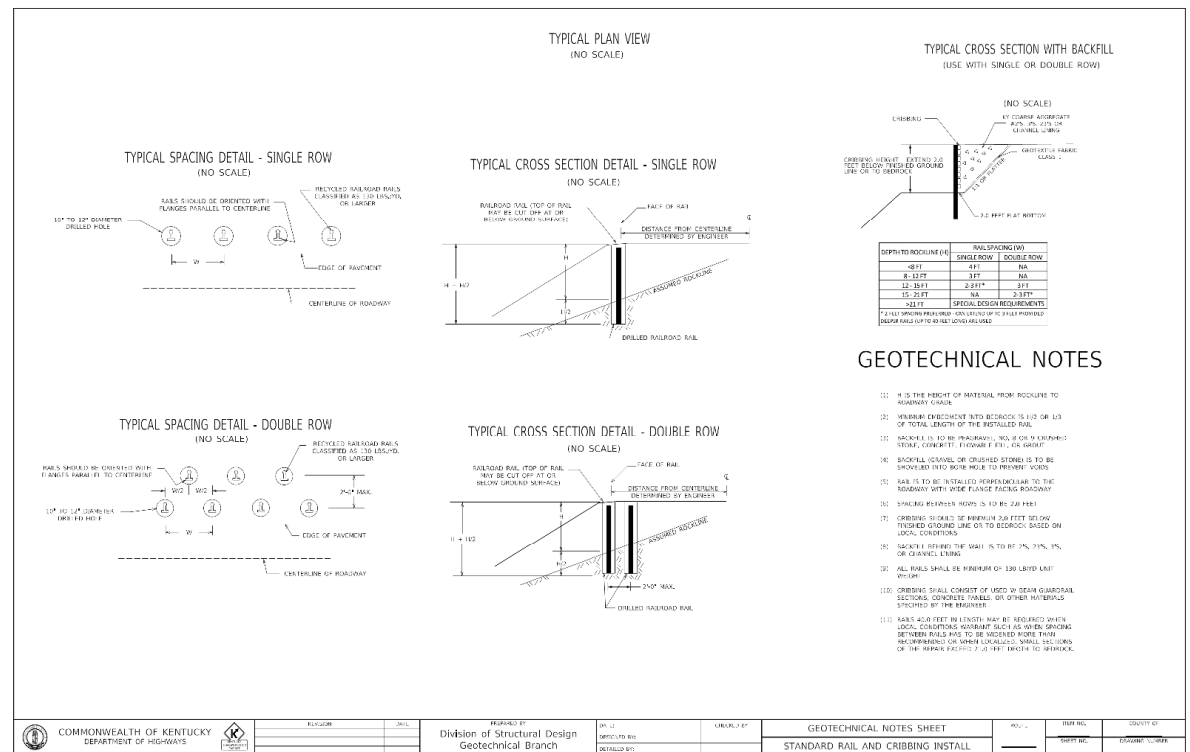
Typical Rail Install

<https://transportation.ky.gov/Highway-Design/Standard%20Drawings%20DGNS%202020/Sepia031.pdf>
