Alligator River Bridge Replaceme nt

NCDOT Eastern Region Geotechnical Group

STGEC '24 Baton Rouge - LADOTE

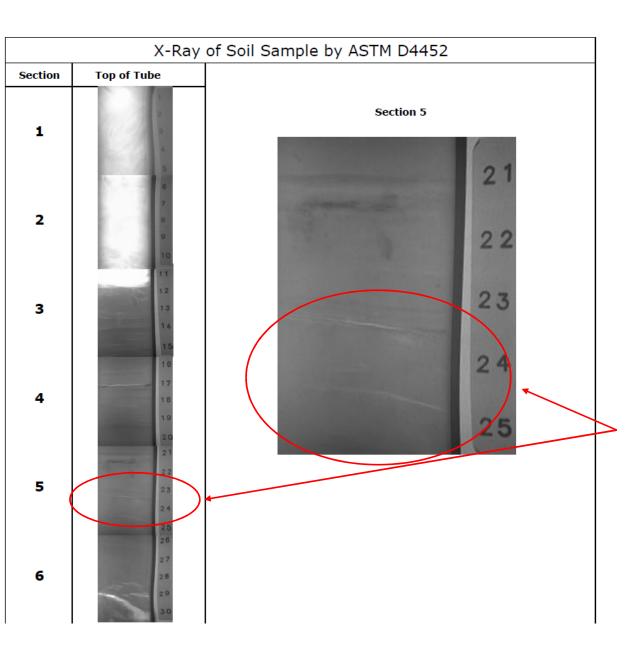
Typical X-Ray

Disturbance? - Yes

We had many with better results – X-Rays proved helpful

- Incremental consolidation
- Constant rate of strain consolidation
- CU Triaxial Estimate OCR (SHANSEP and research by brilliant minds before us)
- X-ray all tubes

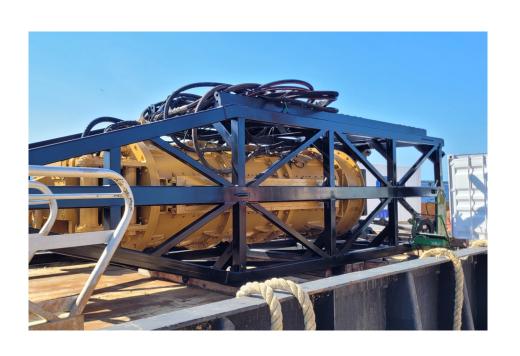
Hammers

- APE D180 Ram Weight 39.7 kips, OED
- APE D220 Ram Weight 48.5 kips, OED
- APE 40-5 Ram Weight 80 kips, Hydraulic

- APE D180
 - Most reliable
 - Tension stress problems, couldn't start due to soft soils
- APE D220
 - They got a "lemon"
 - Lots of problems starting and keeping it running
 - Tension stress problems

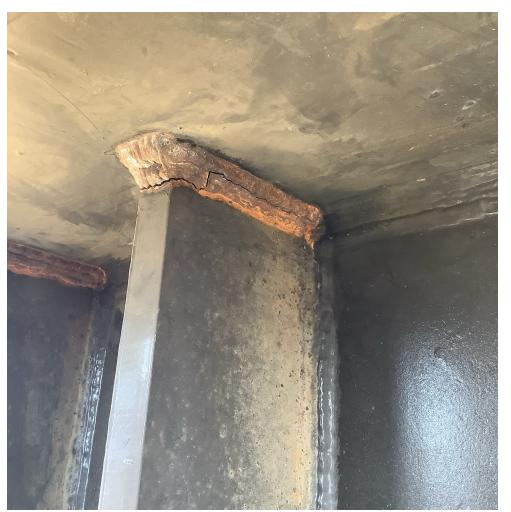
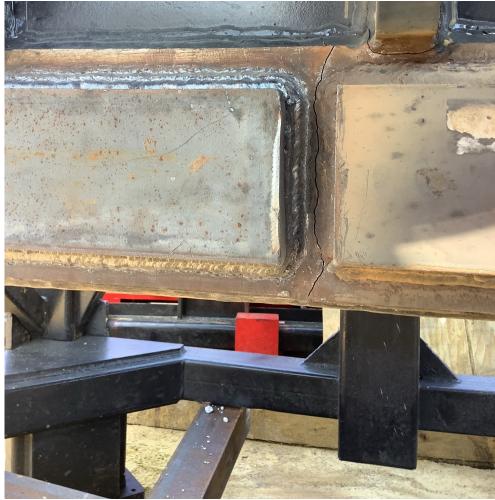
APE 40-5

- Used some during installation once the pile had adequate penetration – too big, too heavy to use at start
- All final re-strikes used this hammer with a 3.5-foot stroke
- We achieved greater than 240 Equiv. BPF on 6 out of 11 piles
- Helmet cracked multiple times (welded it back together)
