Vetiver Grass for Stabilizing Highway Slope Failures in Mississippi

Ian LaCour, P.E.
State Geotechnical Engineer
Mississippi Department of Transportation

Overview

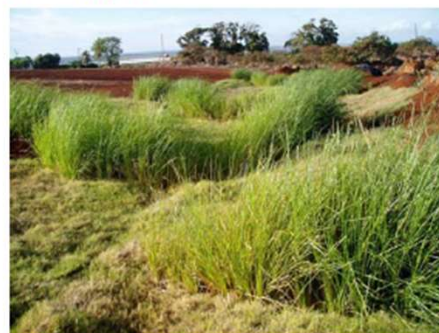
Michael Robotham, USDA NRCS Pacific Islands Area State Office.
'Sunshine' with Bermudagrass used to stabilize waterway.

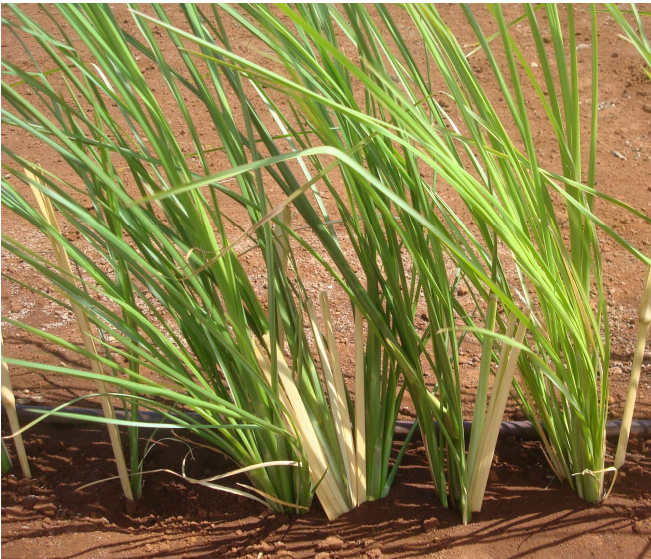
Vetiver Grass Plant and Root System

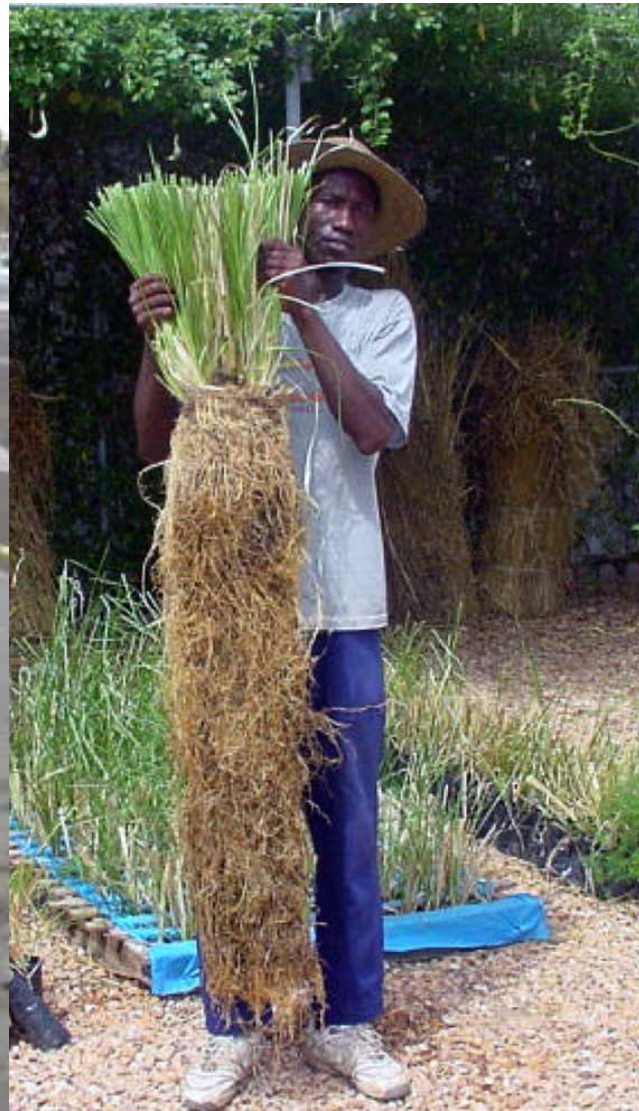
**Uprooted Older Vetiver
Grass Plant**

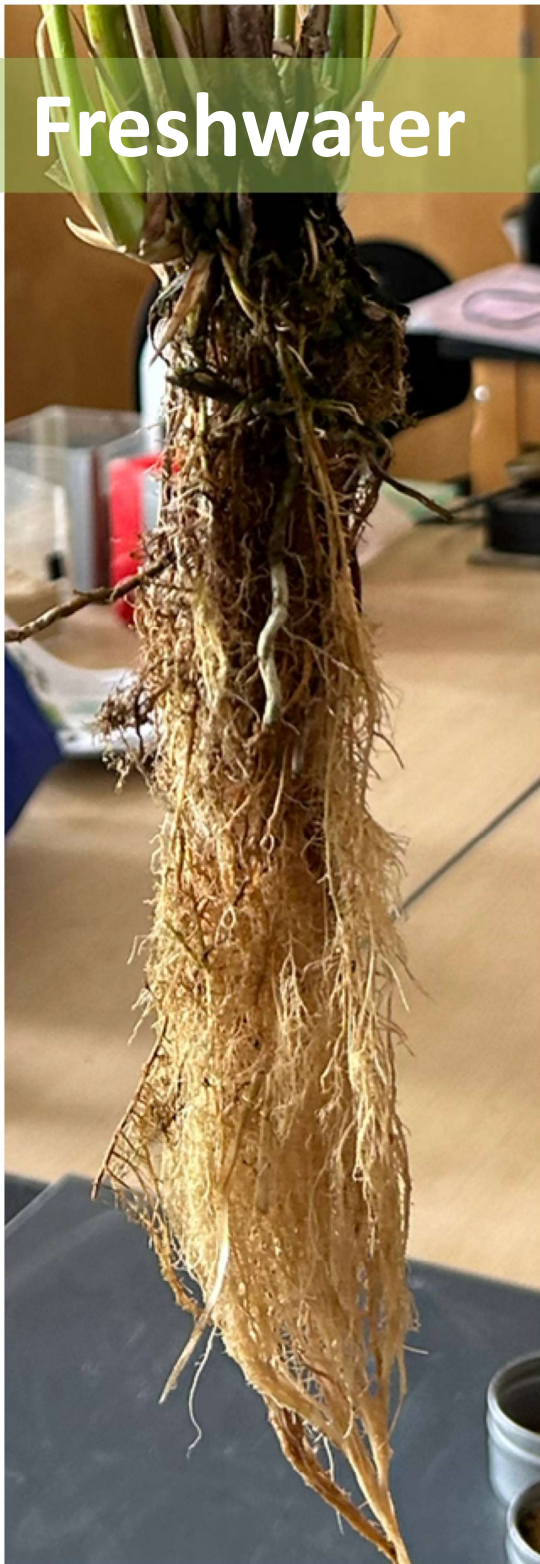
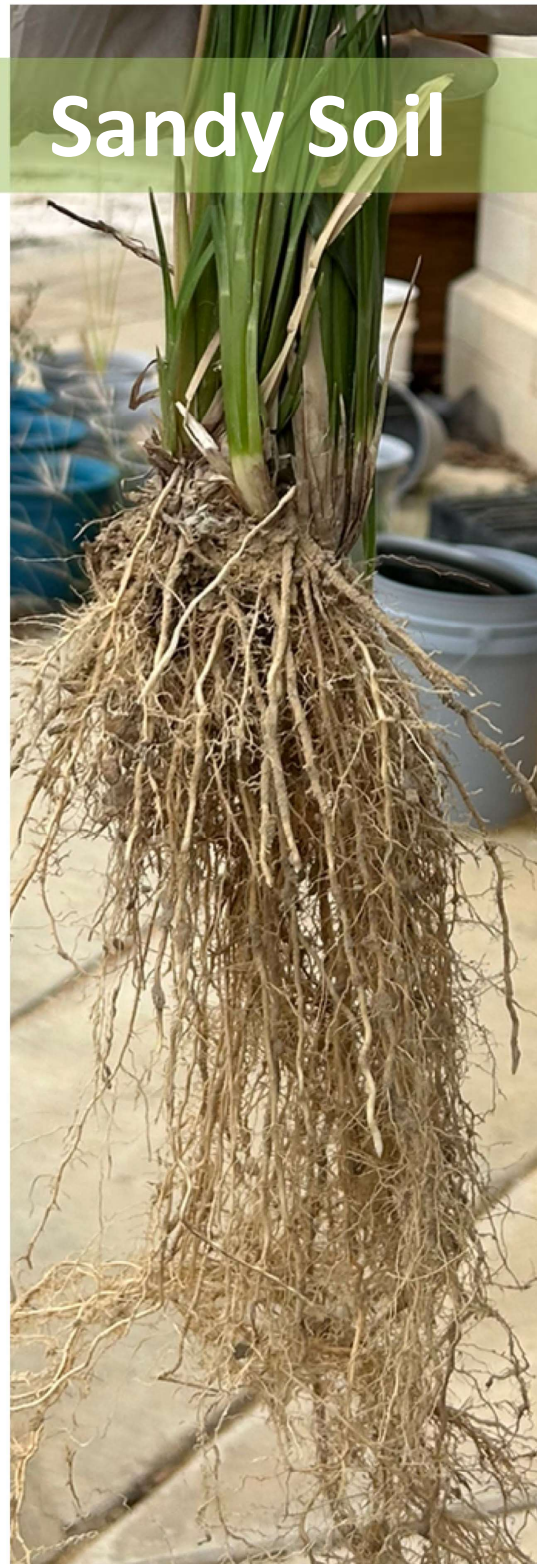
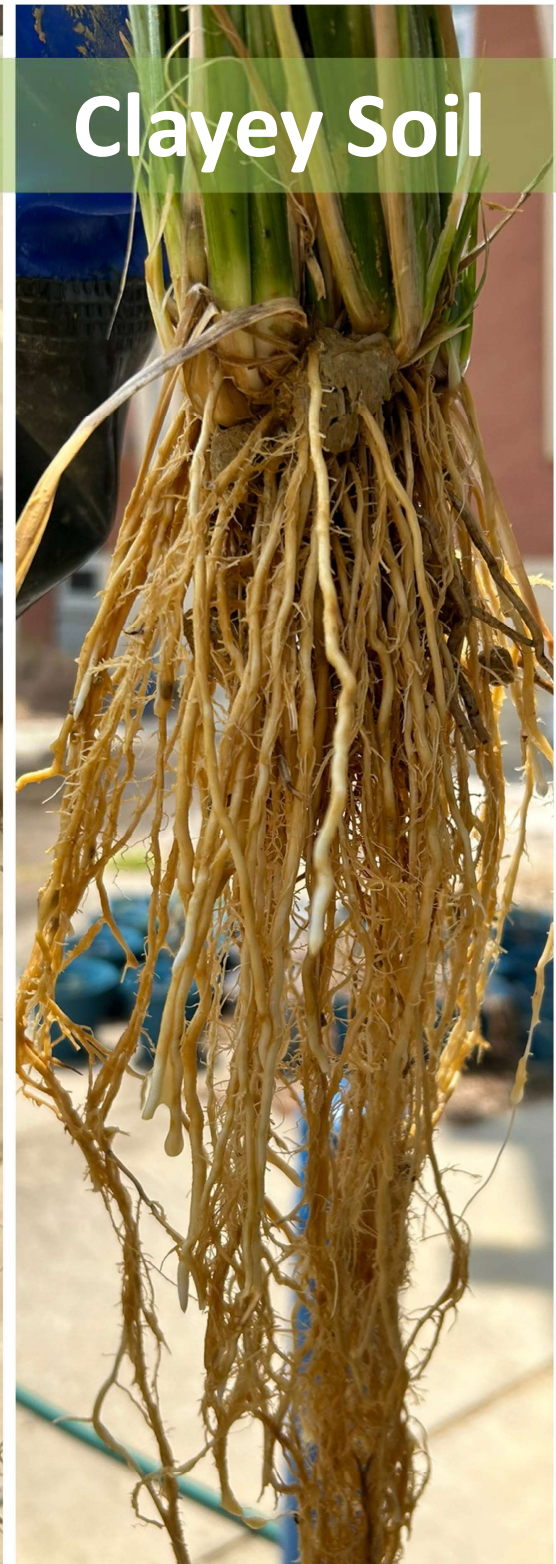
**6-Month Old Vetiver
Plant Root System**

Freshwater

Sandy Soil

Clayey Soil

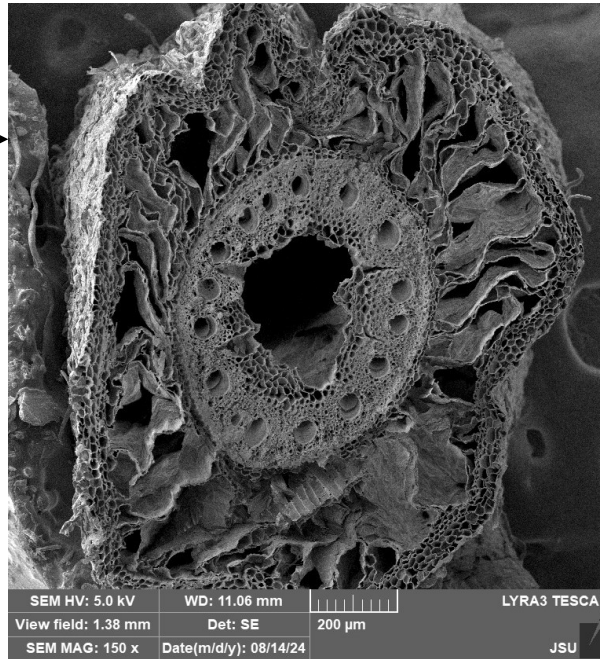
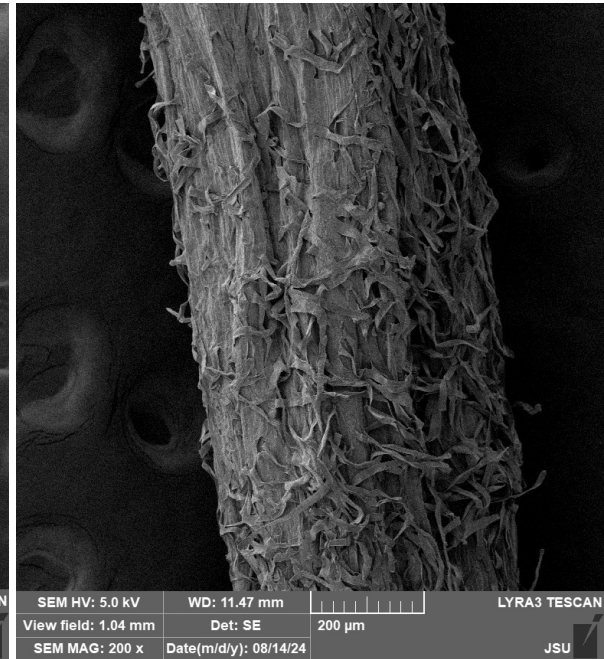
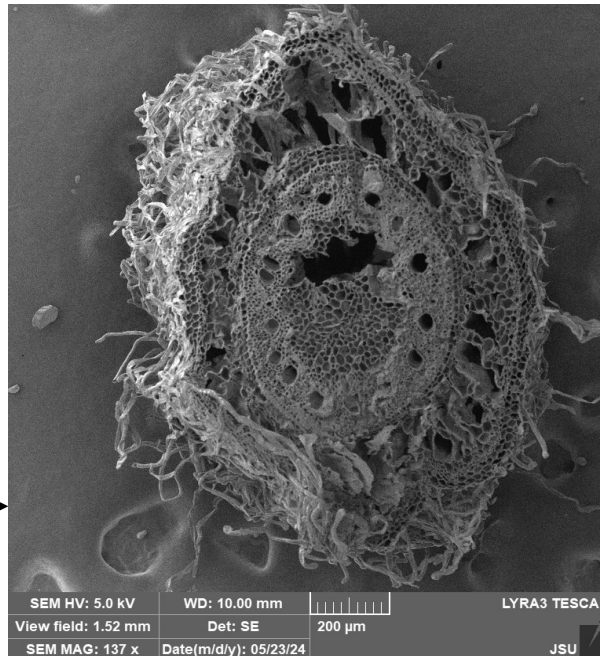
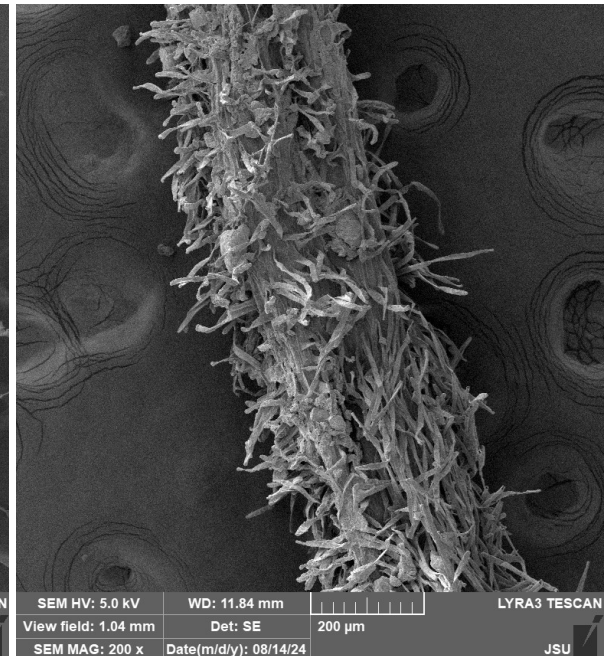
SEM of Root Structure

Clay →

Sand →

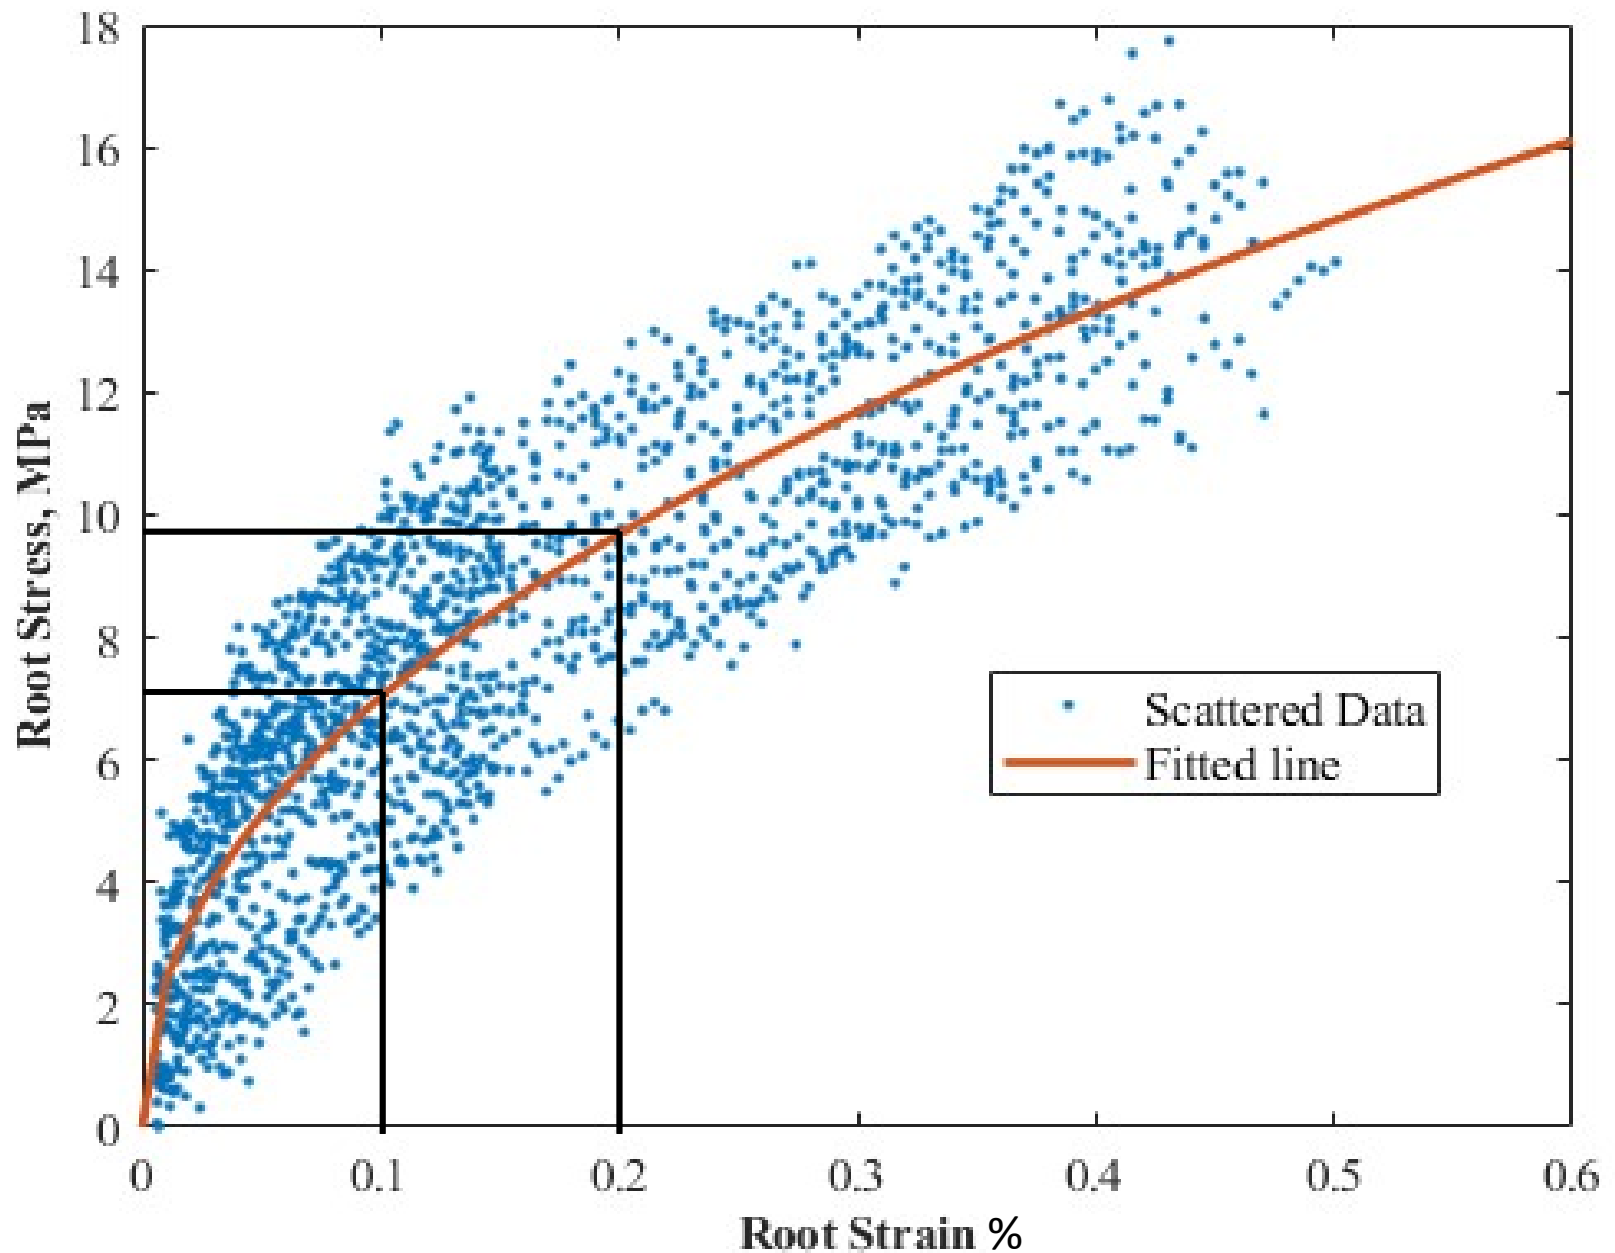
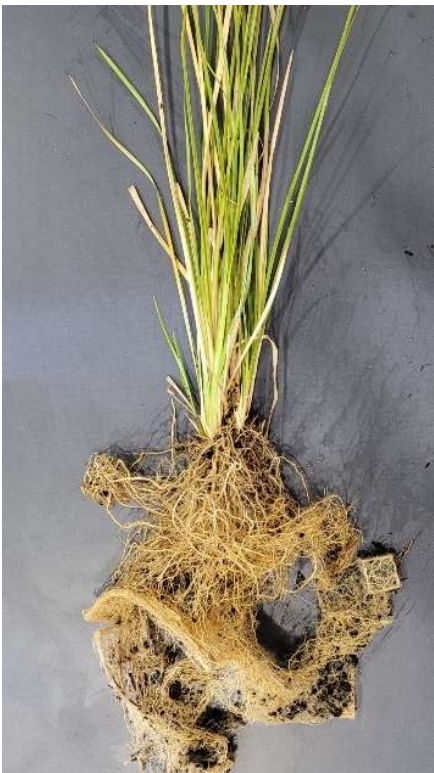
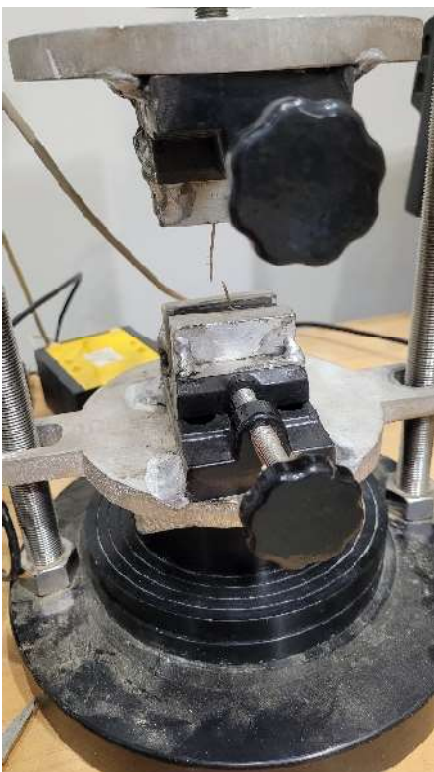
Tensile Strength of Vetiver Roots

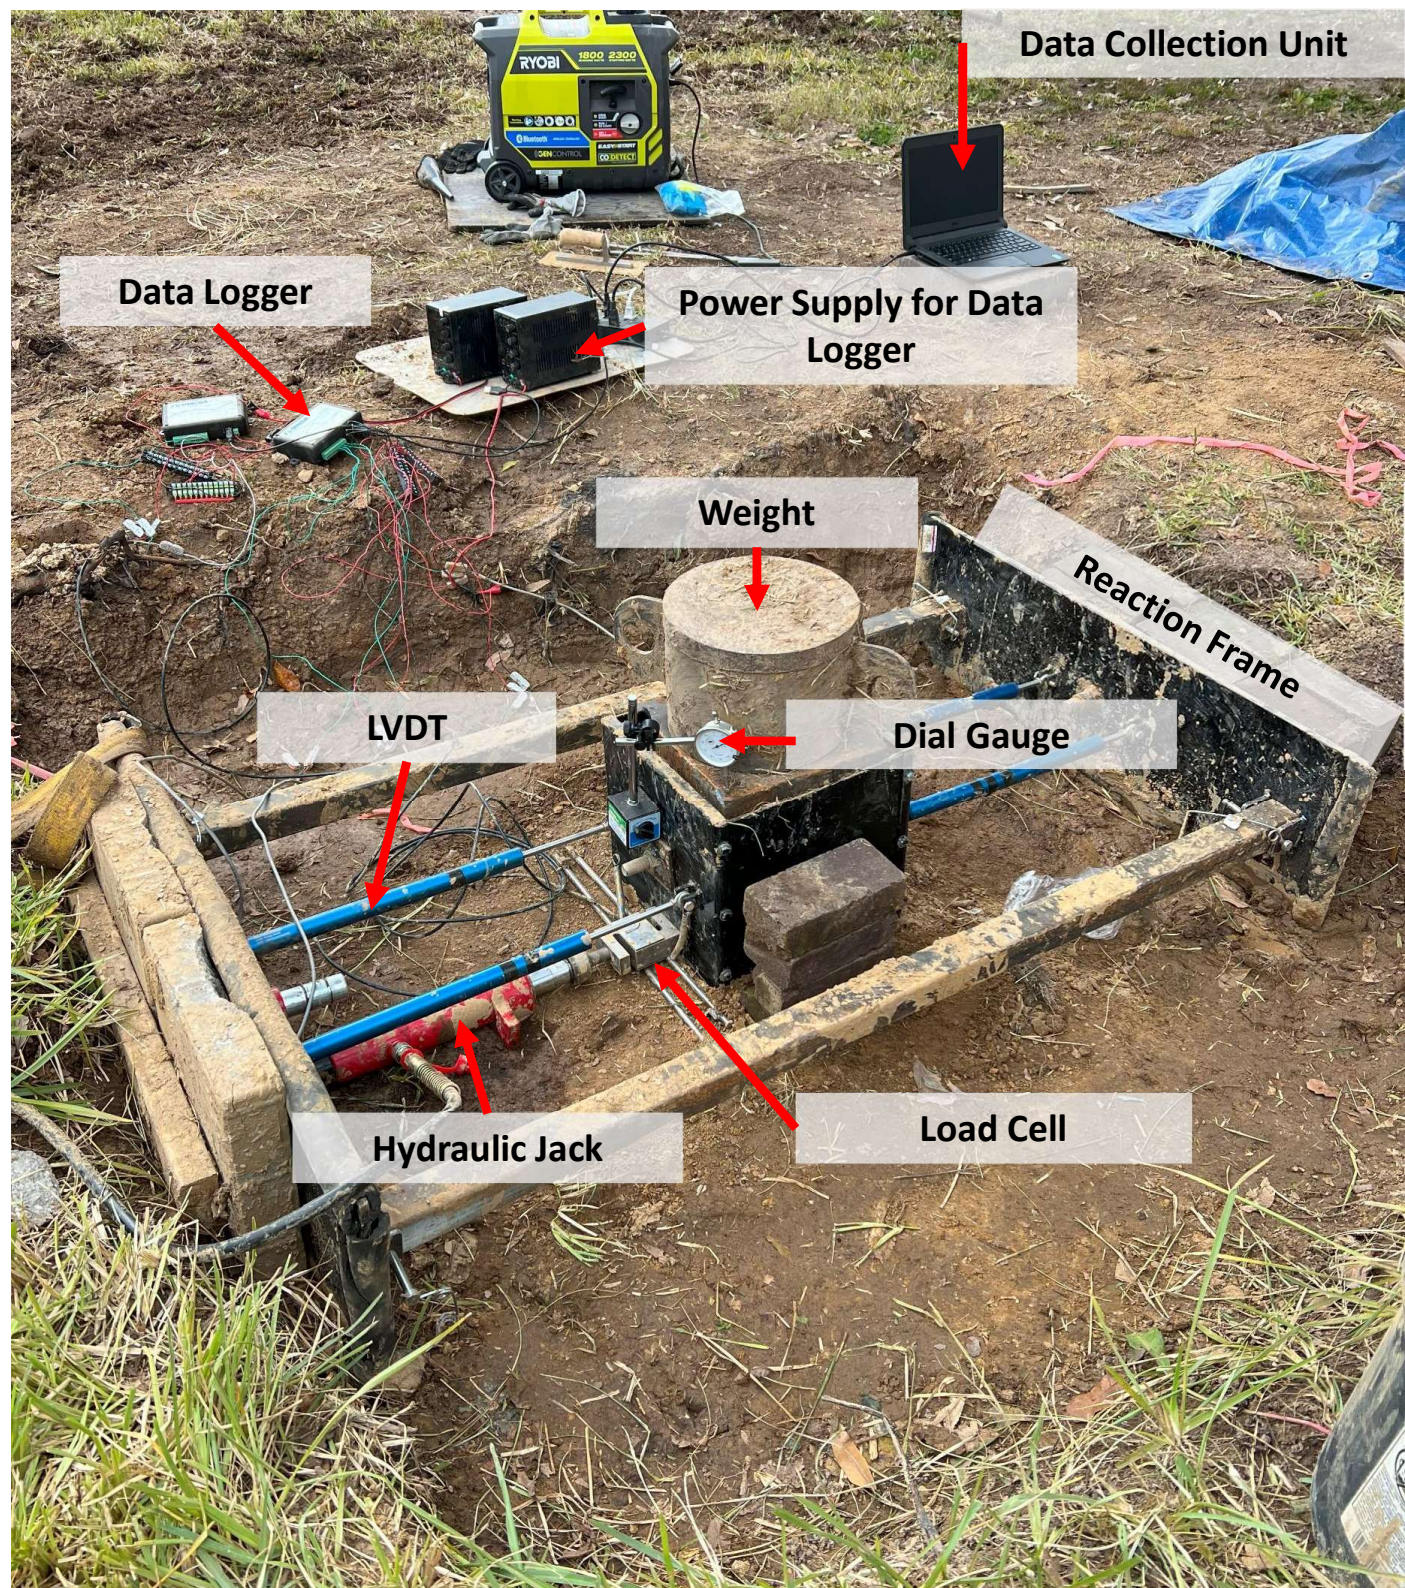
Field Direct Shear Device

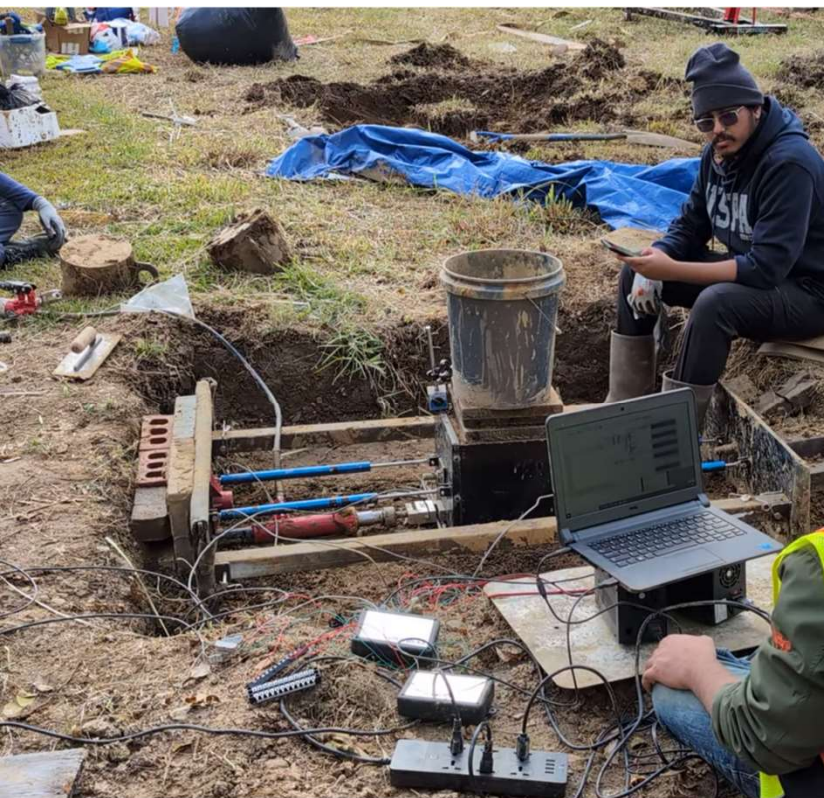
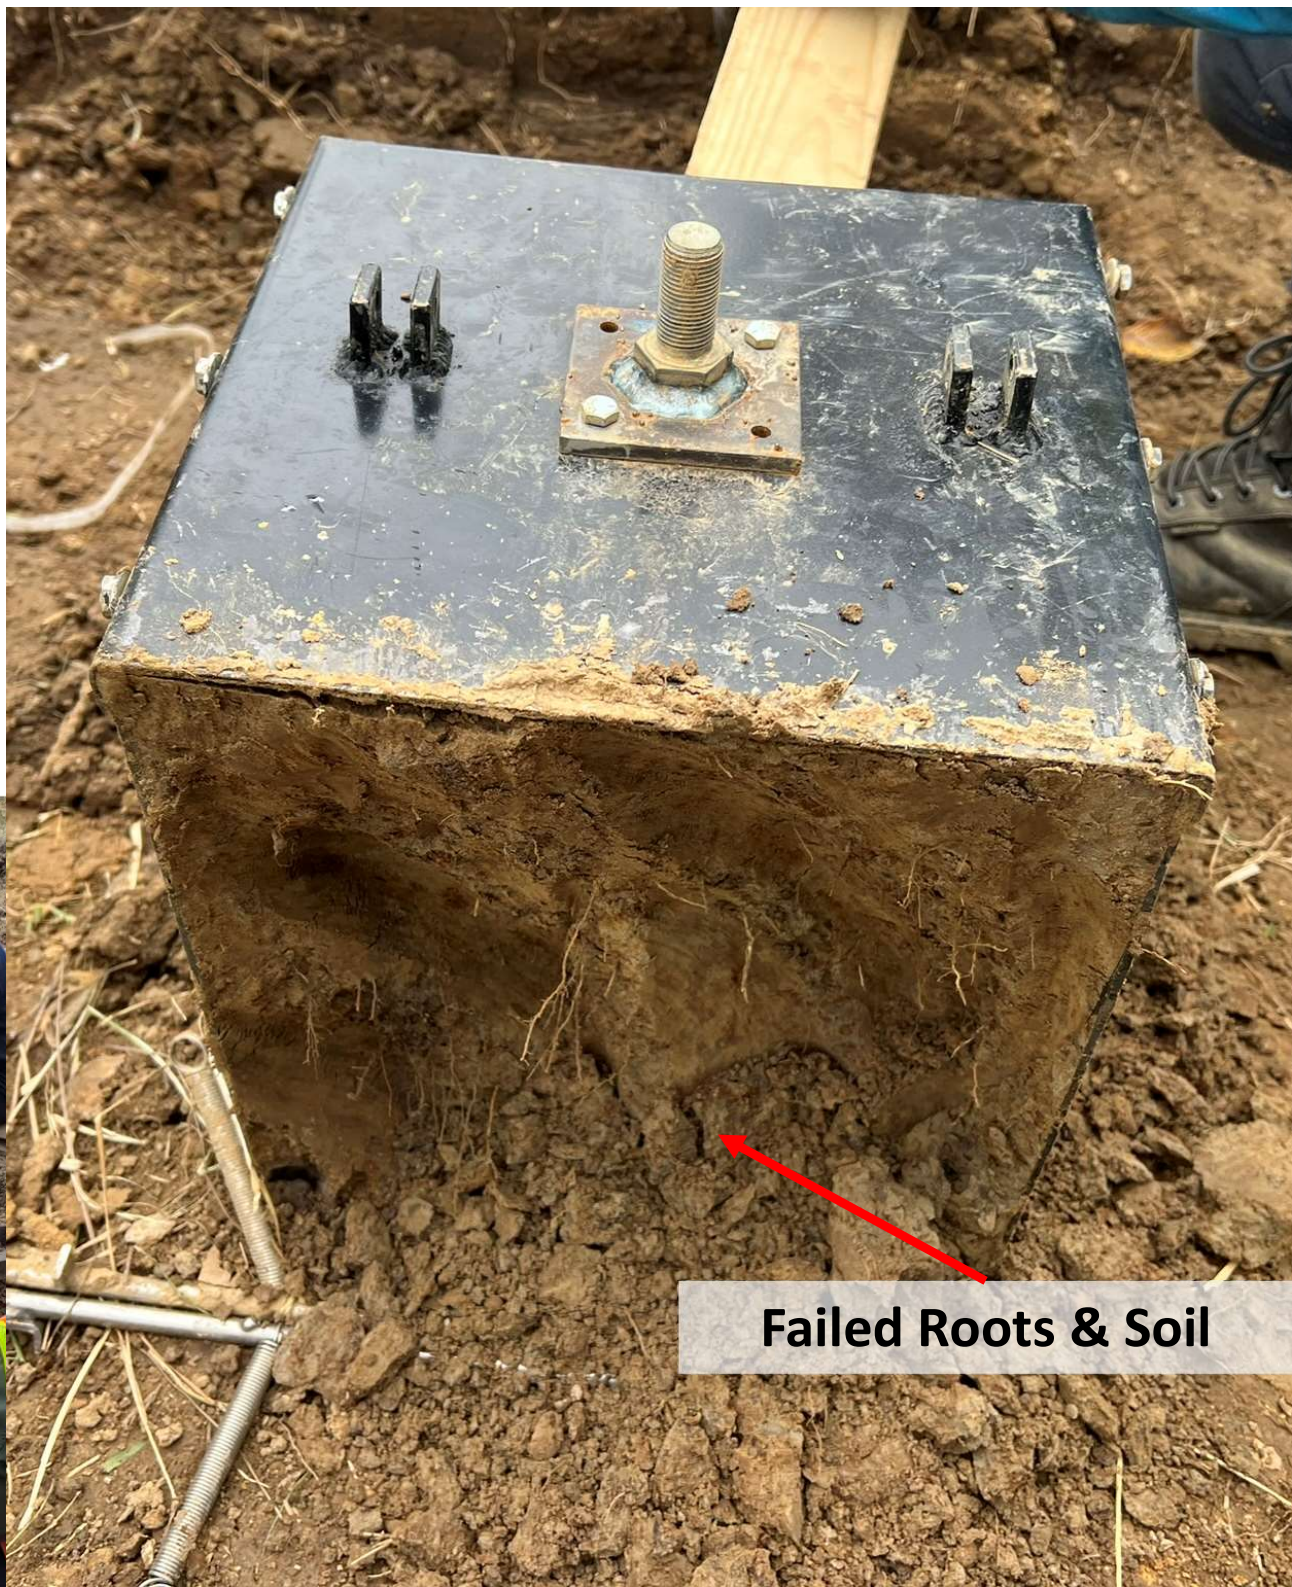
Field Direct Shear Test

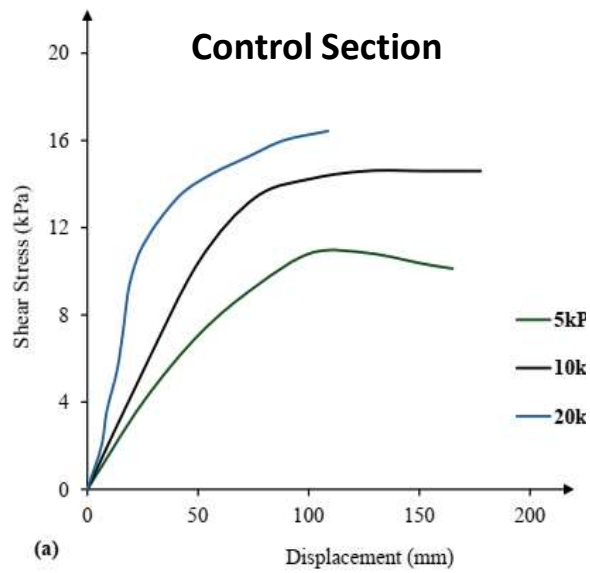
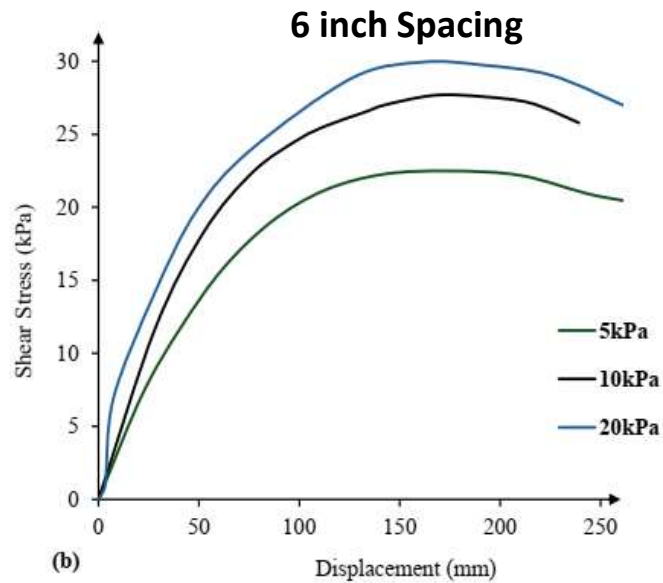
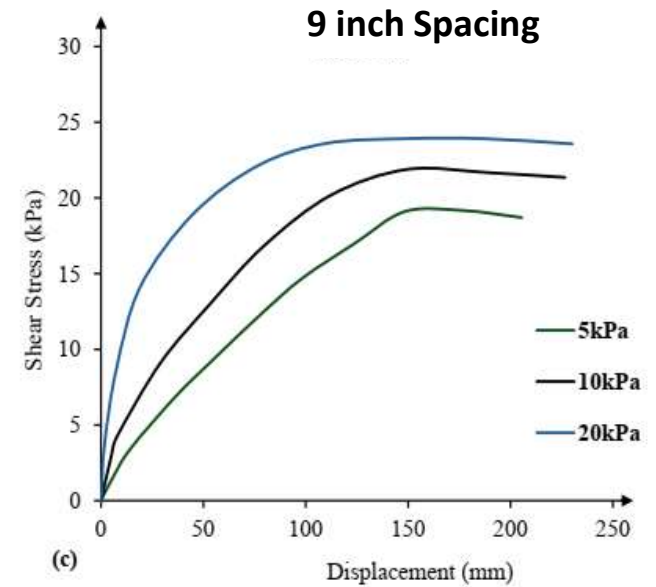
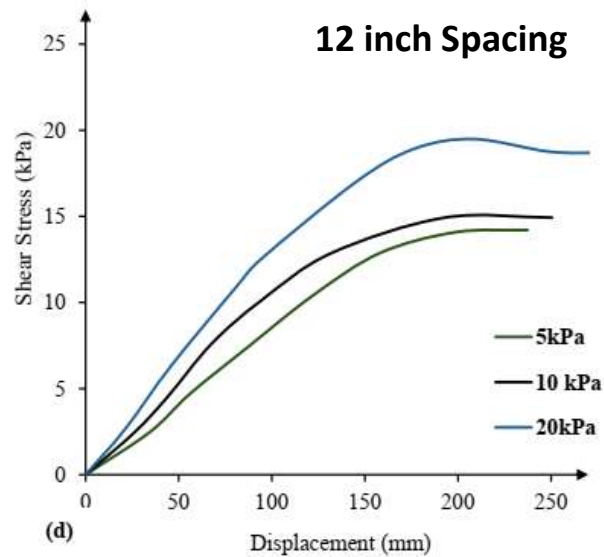
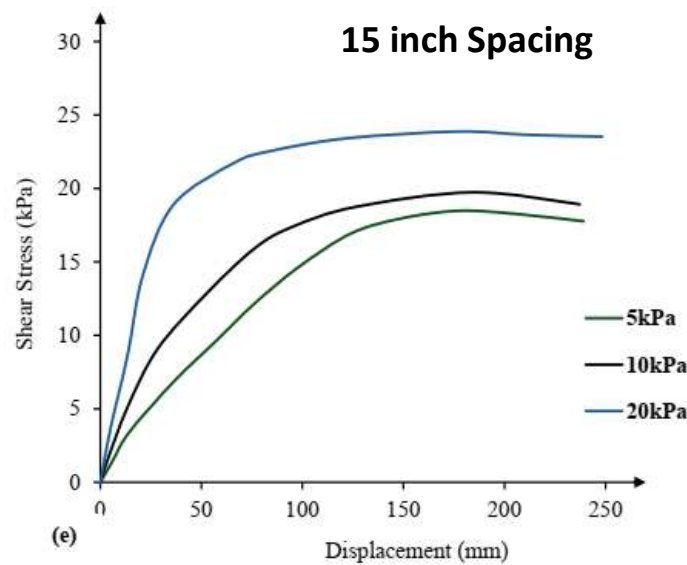
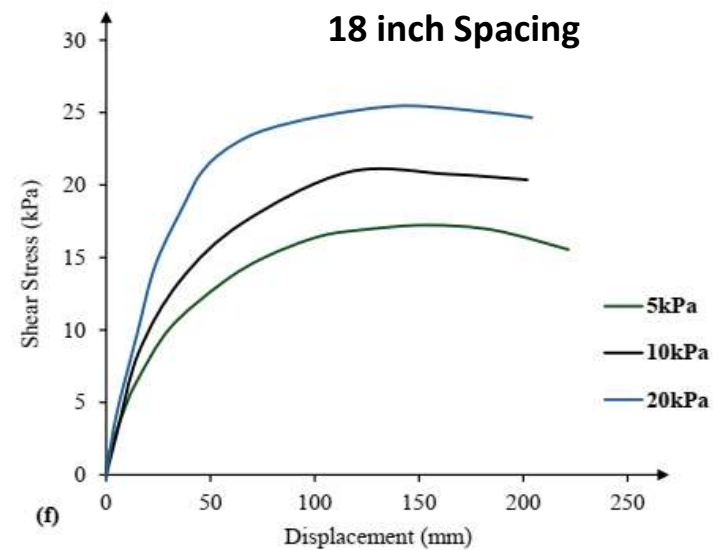
Field Direct Shear Results

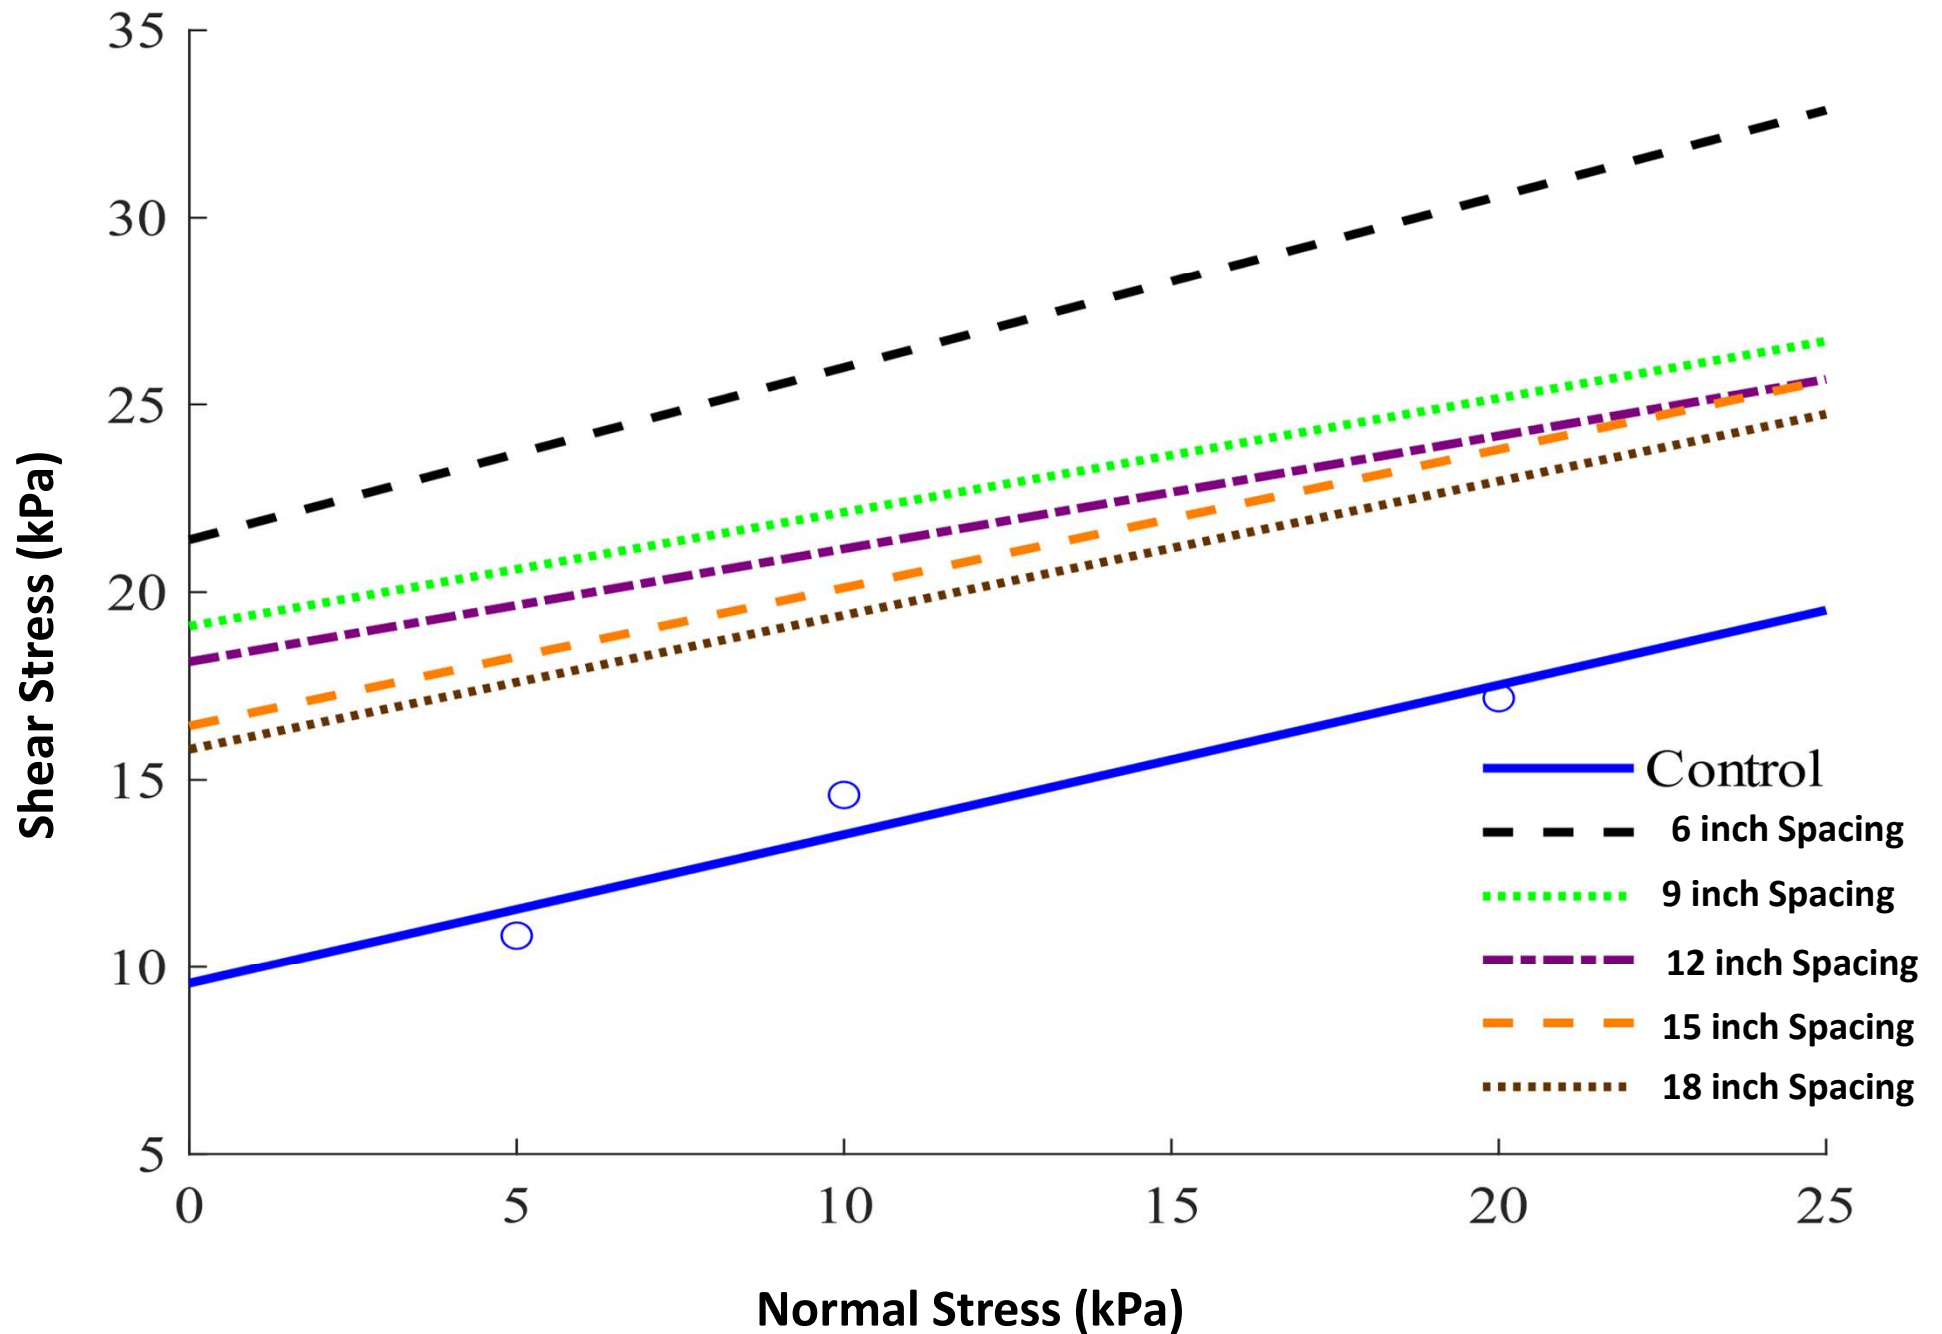
Field Direct Shear Results

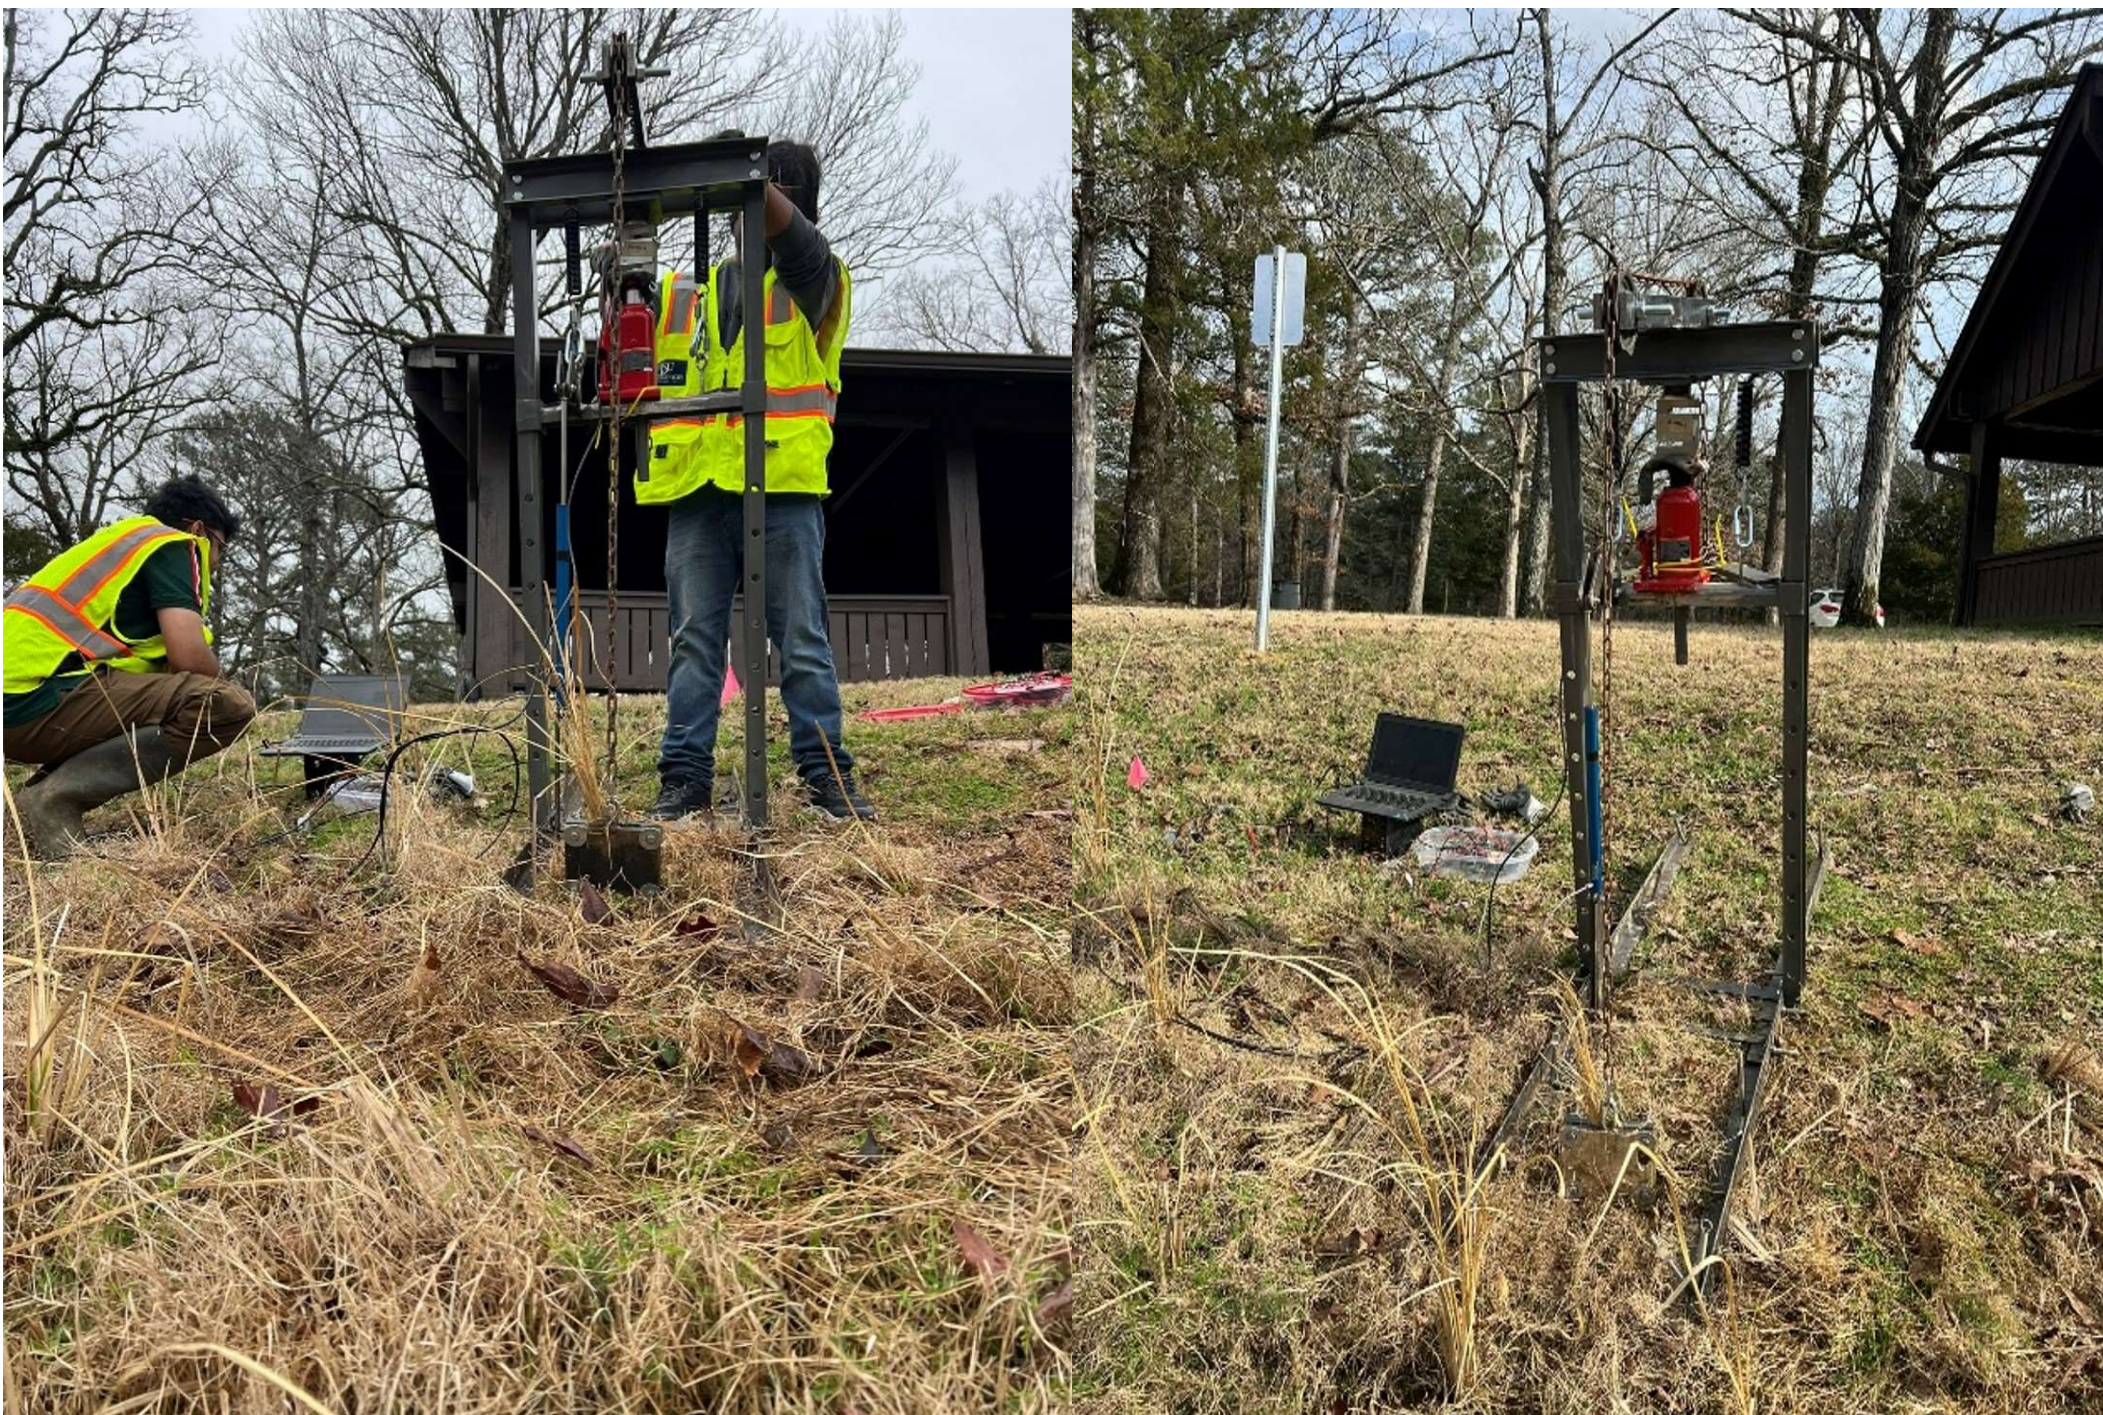
Field Pullout Test

Field Pullout Test Device
