Vetiver Grass for Stabilizing Highway Slope Failures in Mississippi

Ian LaCour, P.E.
State Geotechnical Engineer
Mississippi Department of Transportation

Overview

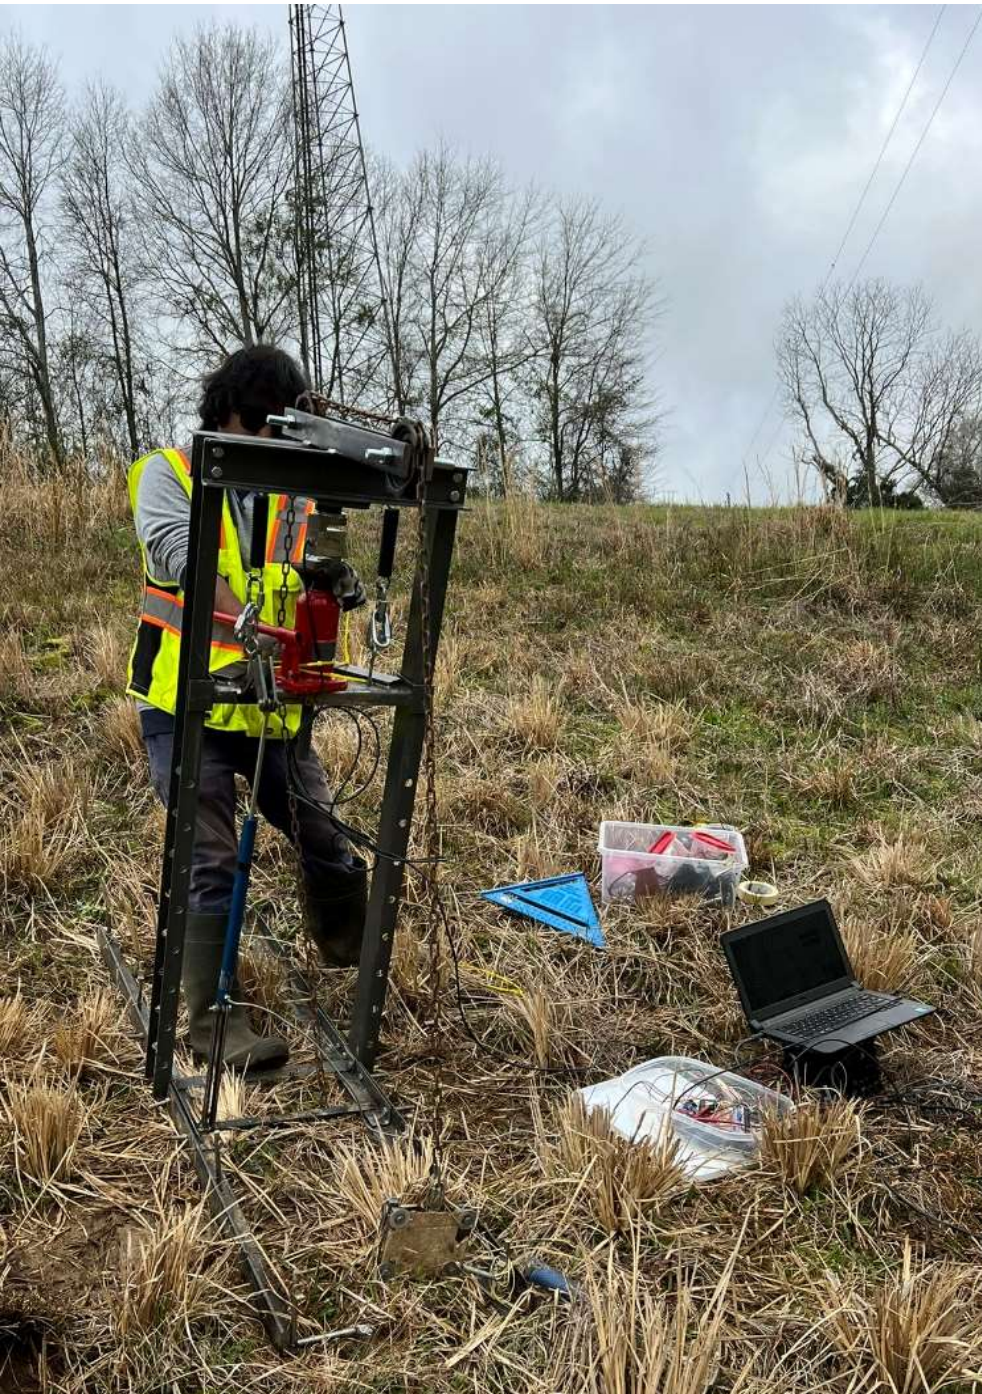
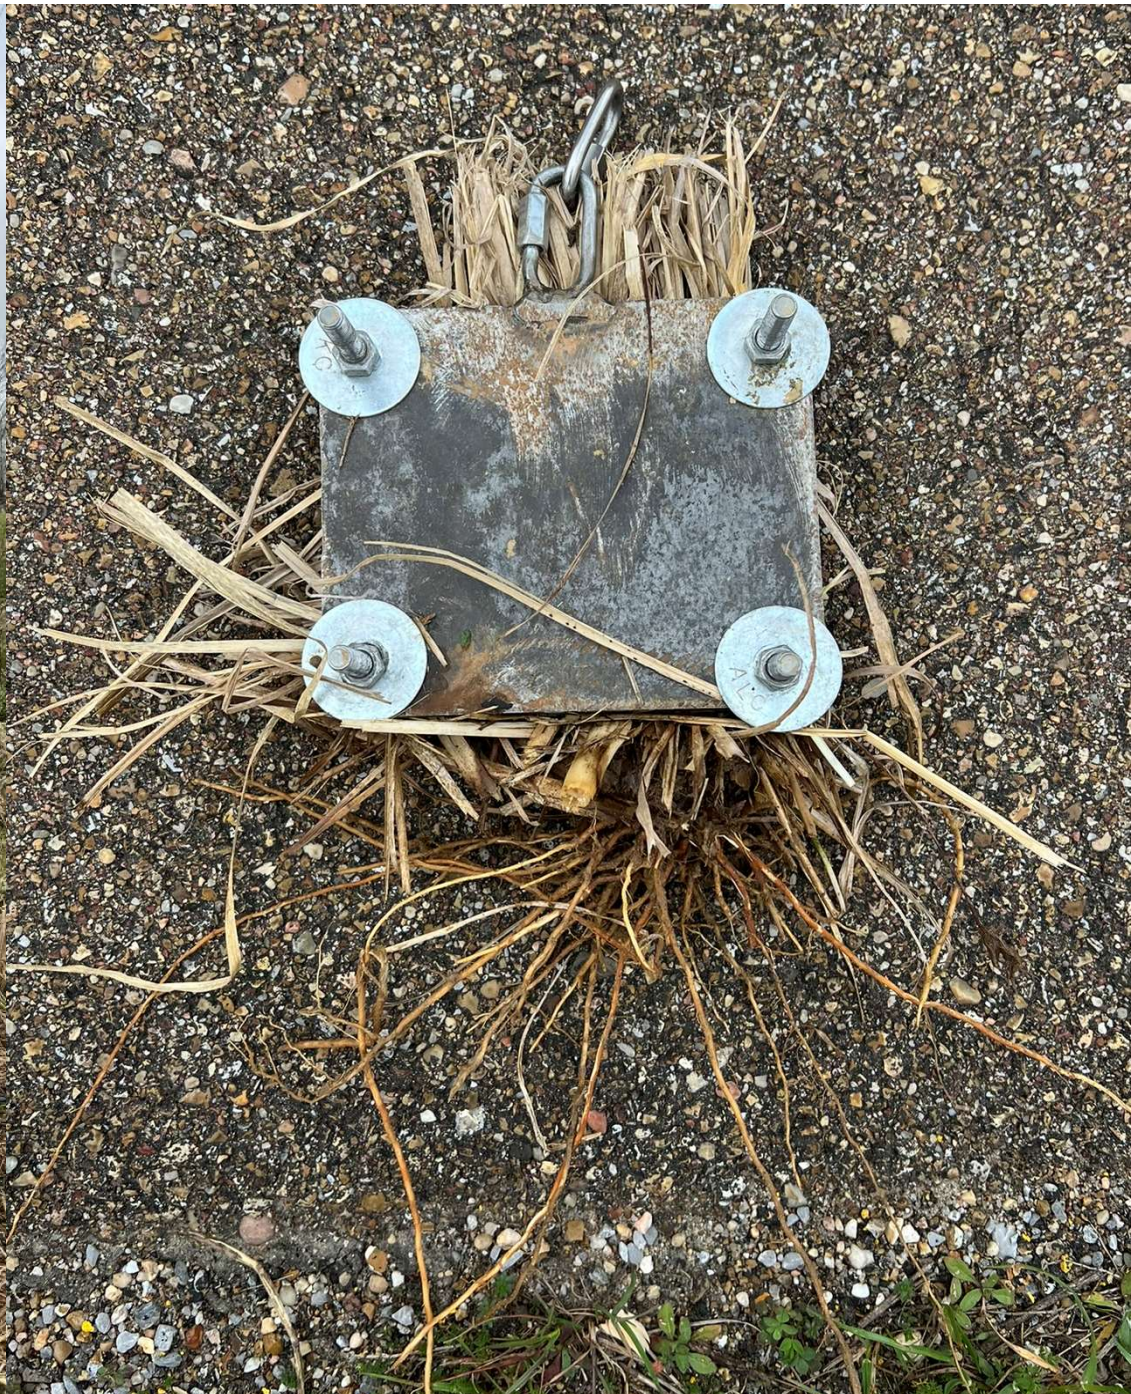
Field Pullout Test

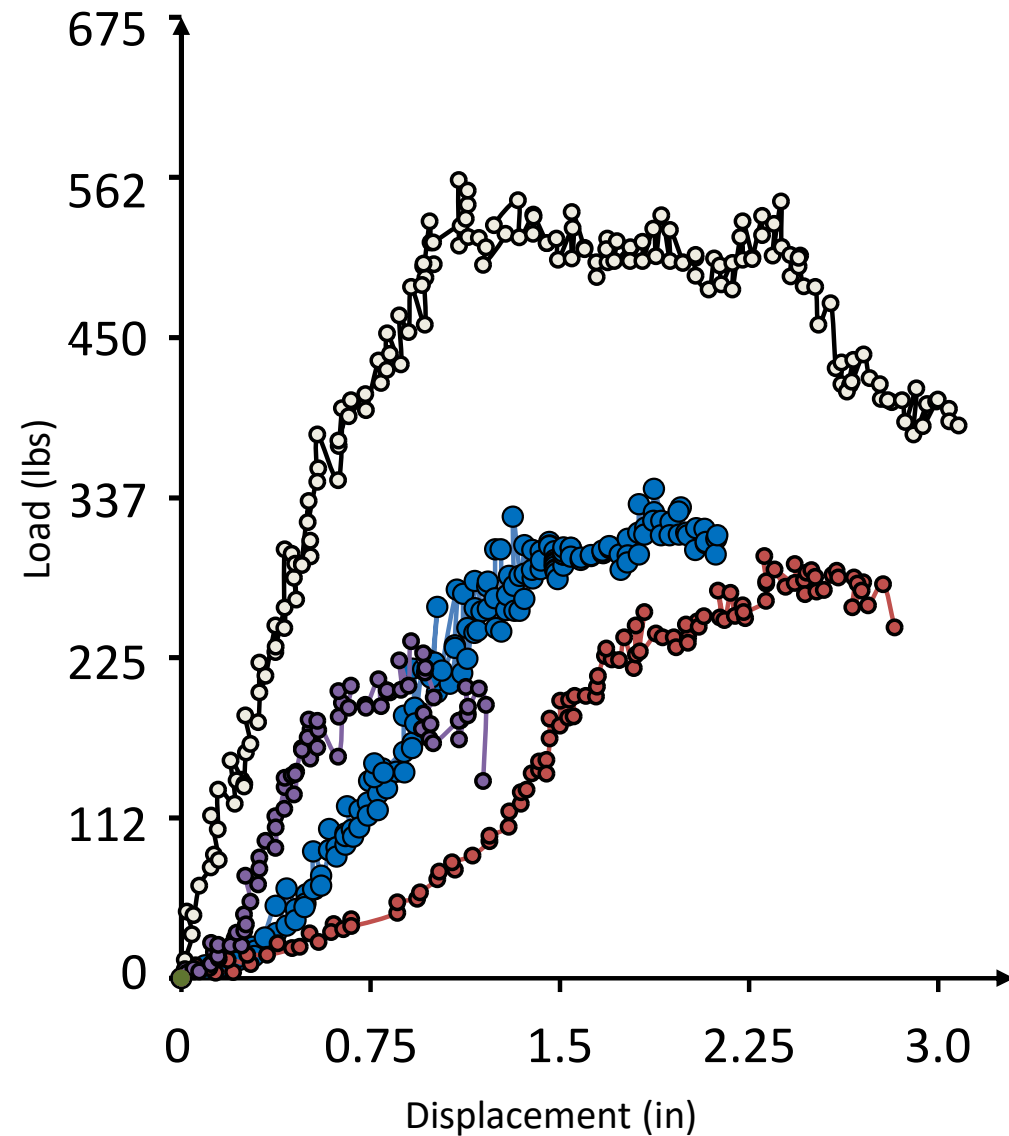
Field Tensile Strength of Vetiver Roots

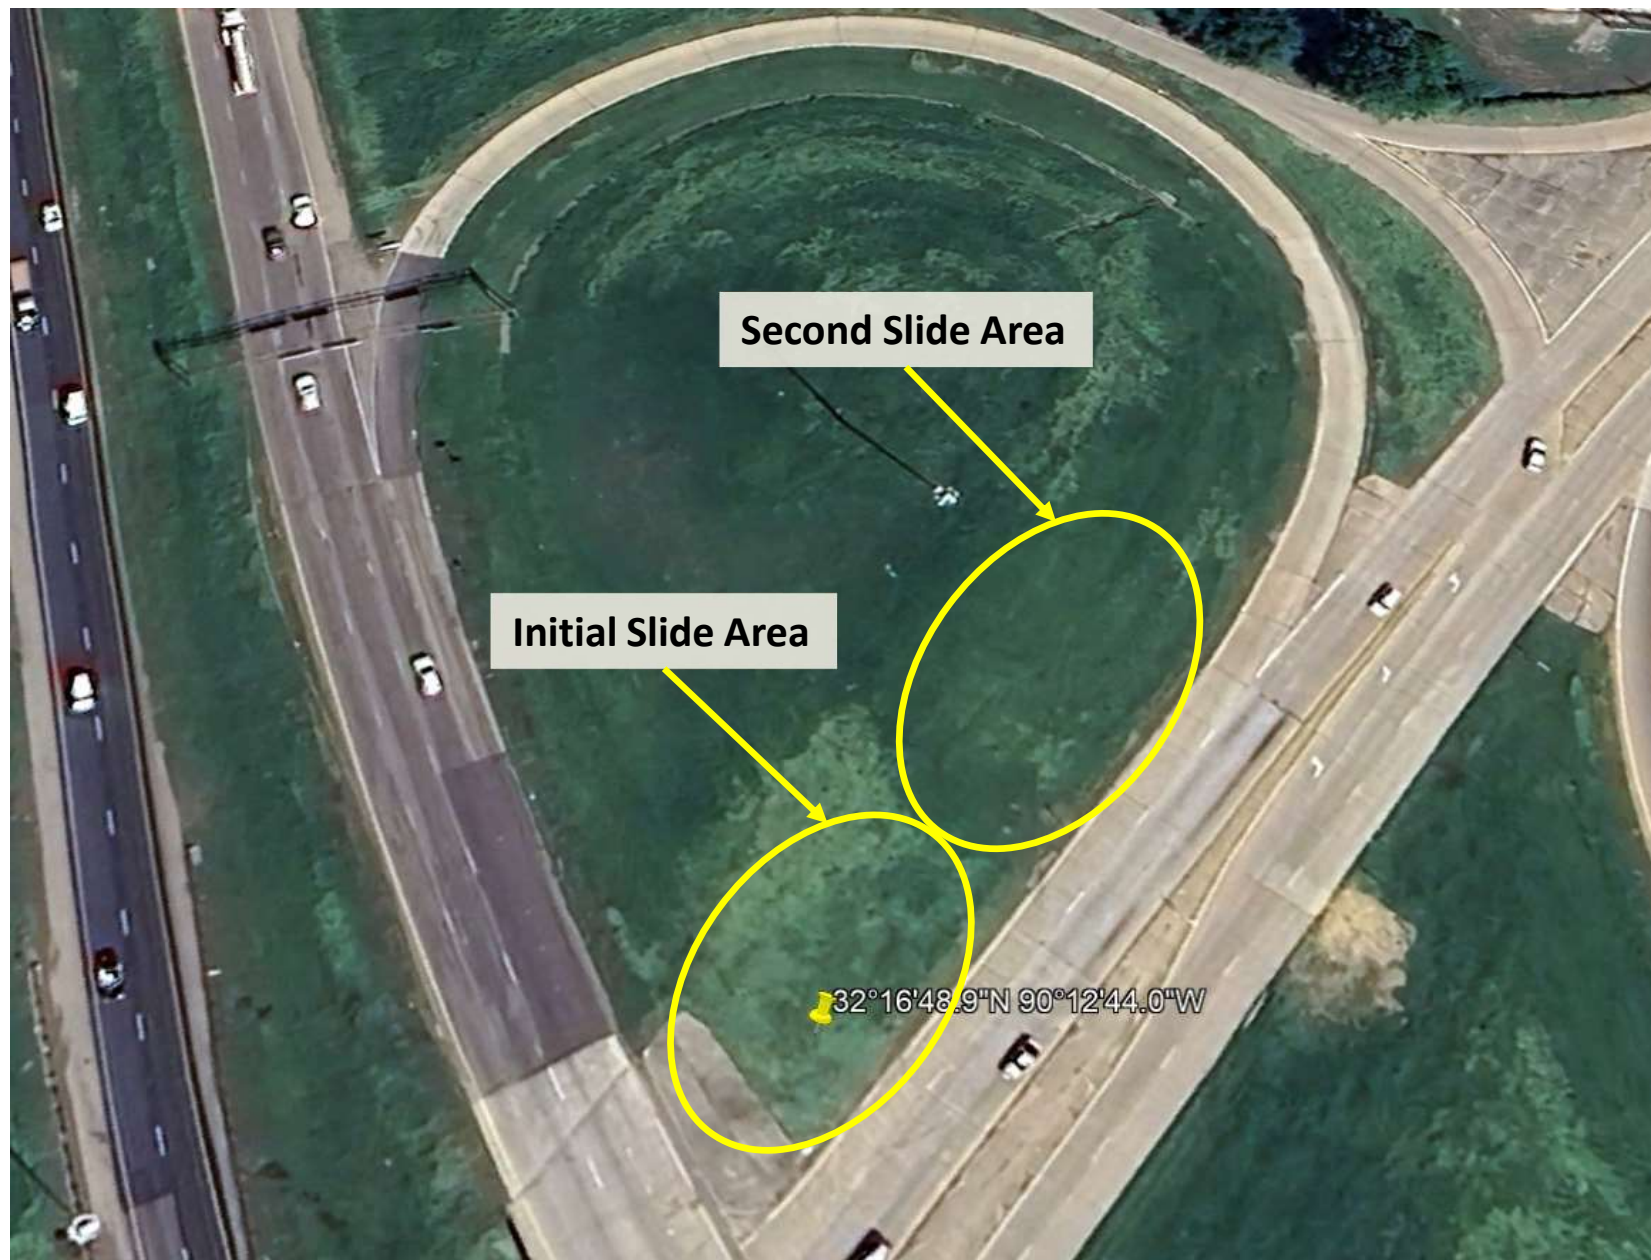
I-20W near Jackson

- 15 ft high - 3.5:1 - 4:1 slope
- Repair Area: 1500ft²
- 1,000 Vetiver Plants

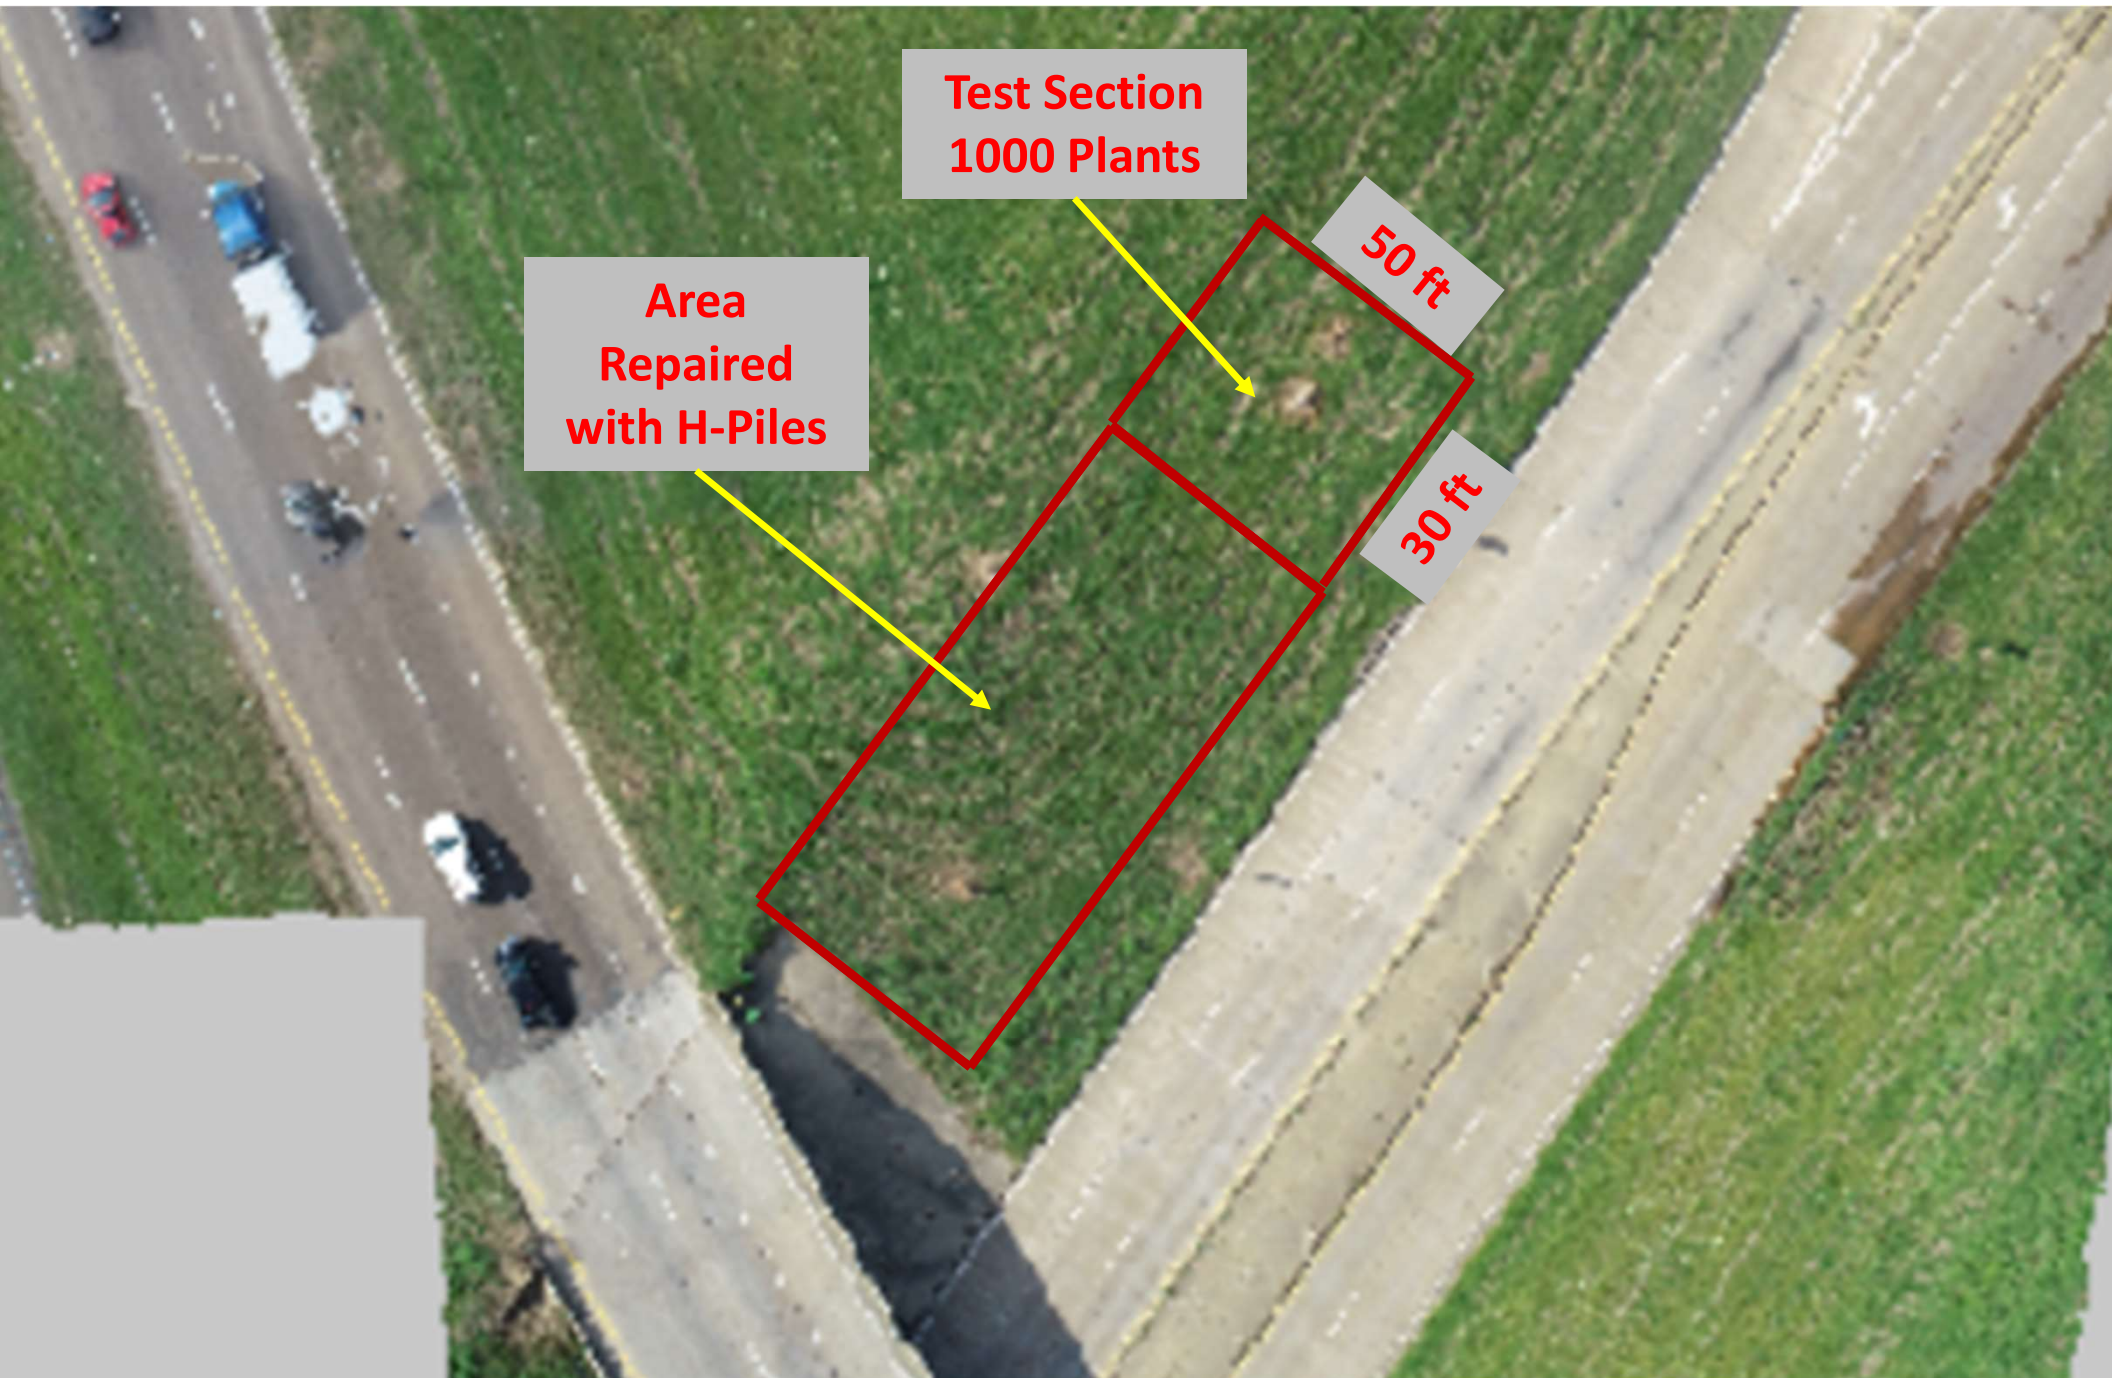
I-20W Vetiver Layout

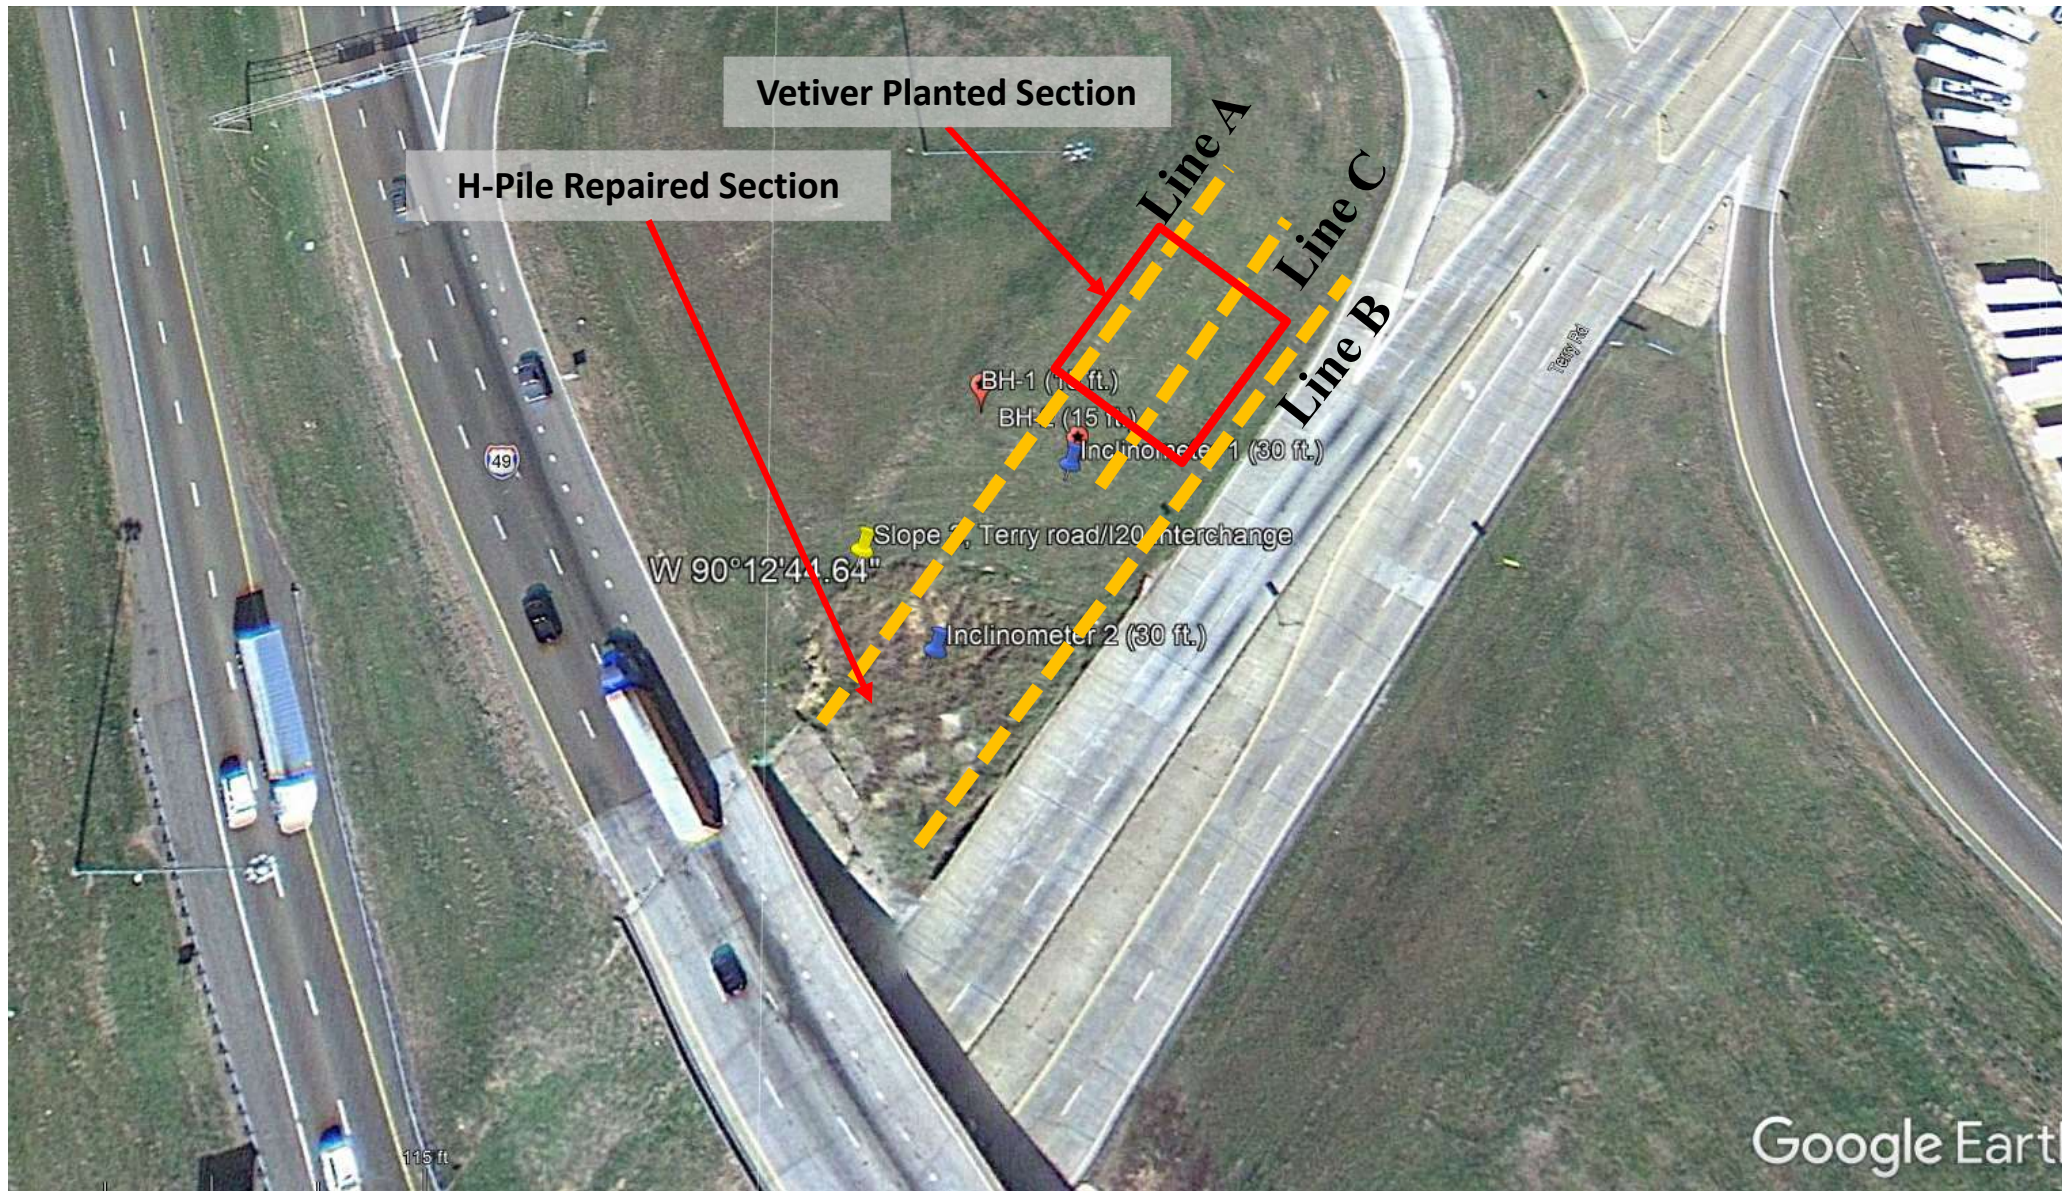
I-20W Site ERI Lines

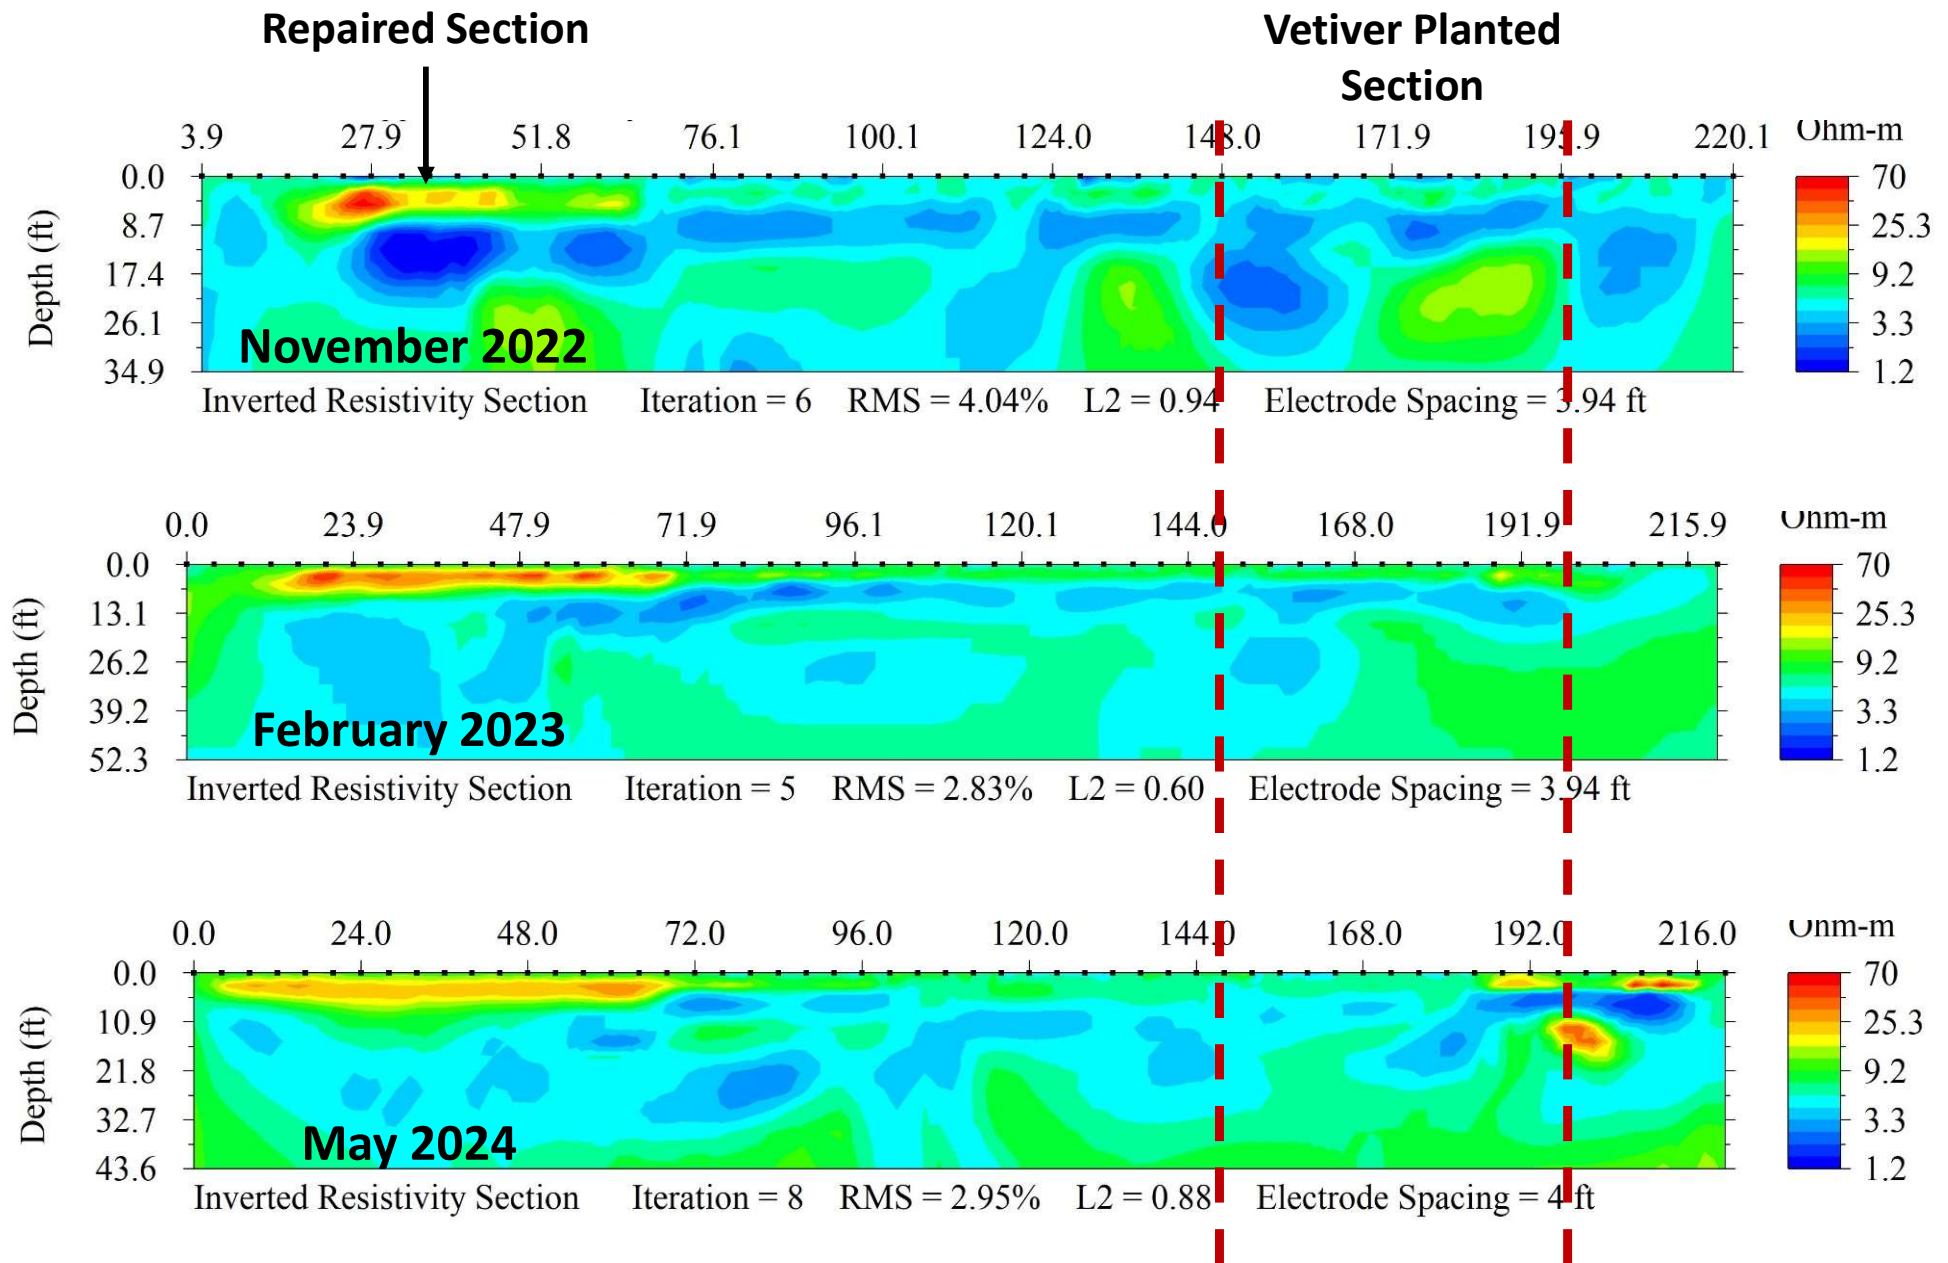
I-20W Site ERI Results

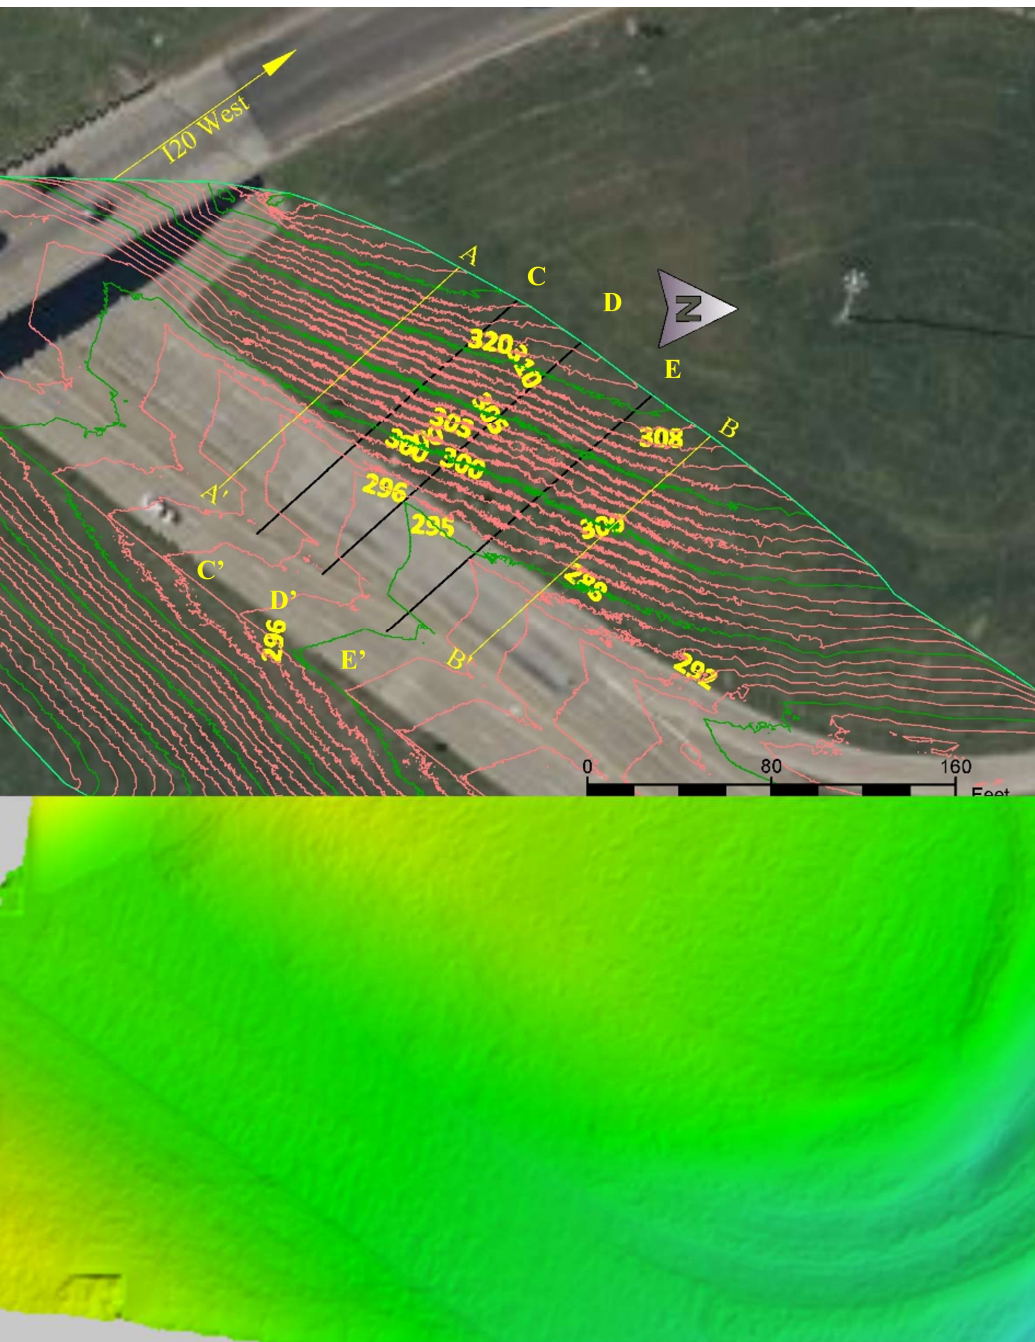
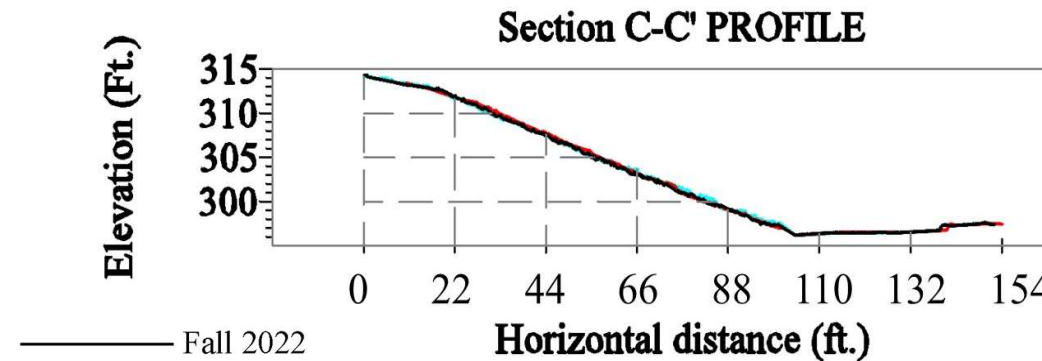
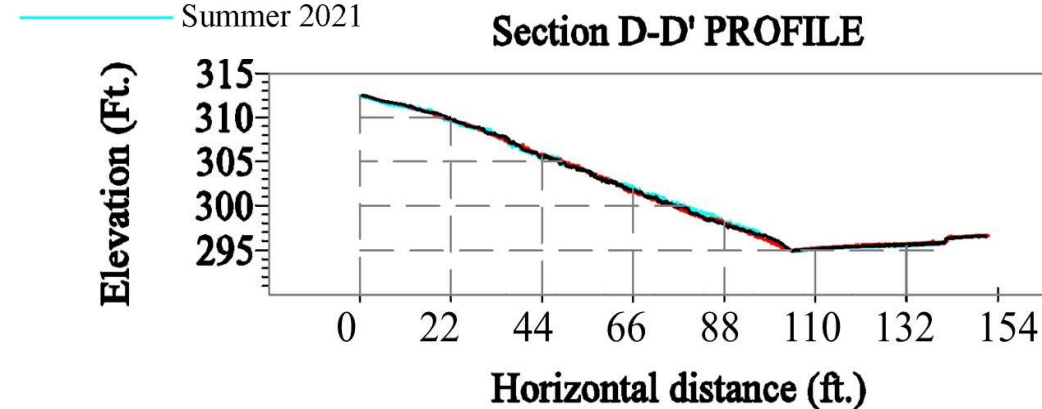
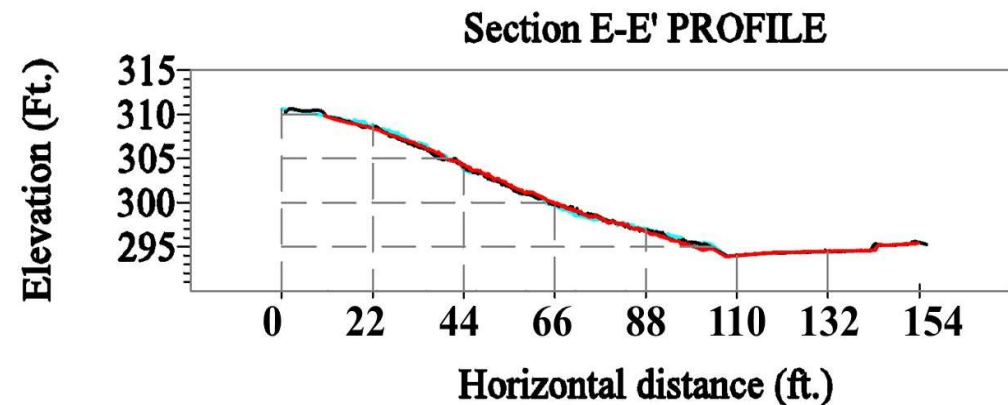
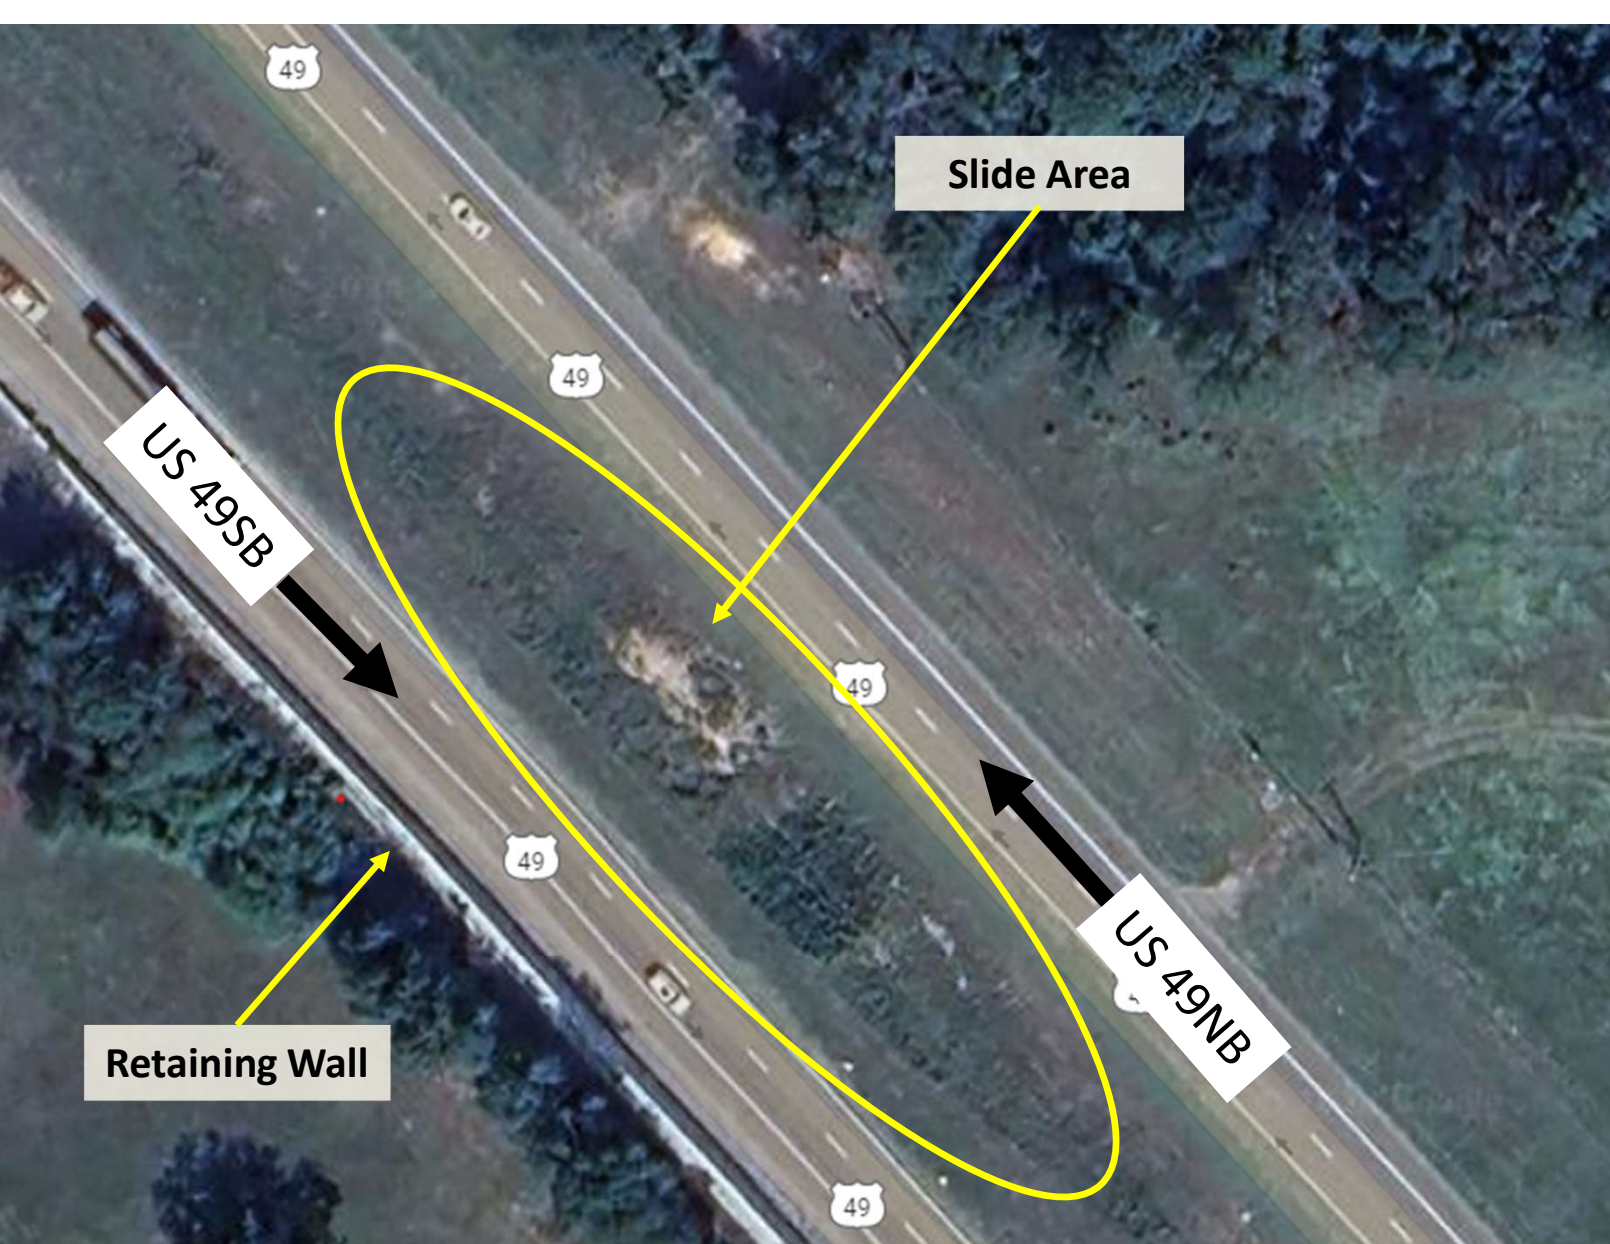
I-20W LiDAR Survey Results

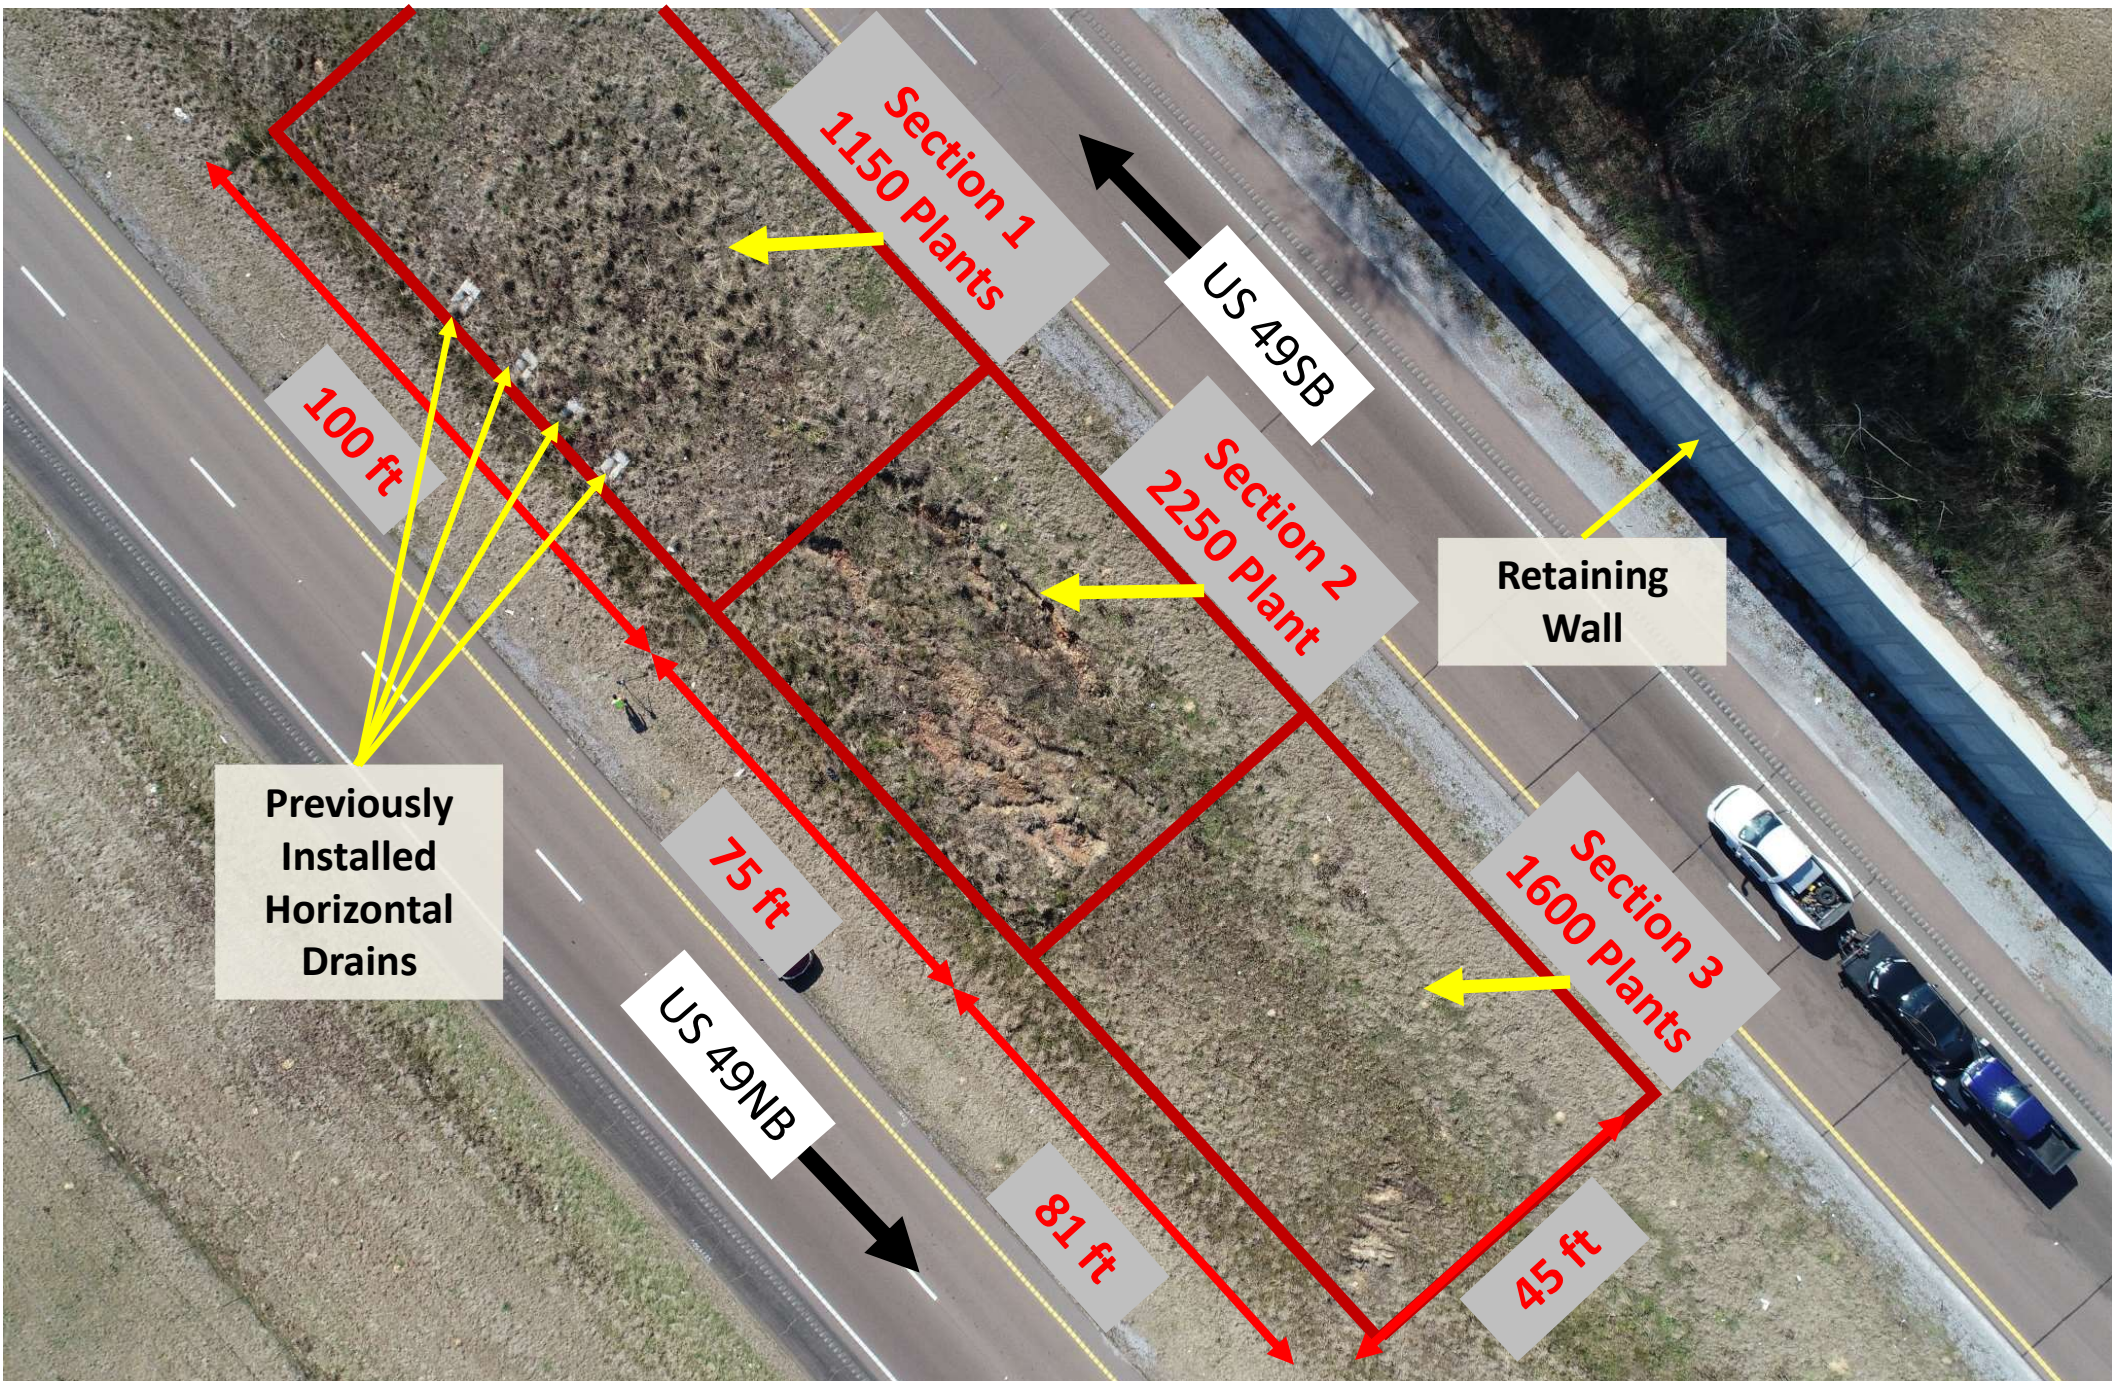
- 20 ft high - 3:1 slope
- Repair Area: 11,520ft²
- 5,000 Vetiver Plants

US 49 Vetiver Layout
