Vetiver Grass for Stabilizing Highway Slope Failures in Mississippi

Ian LaCour, P.E.
State Geotechnical Engineer
Mississippi Department of Transportation

Overview

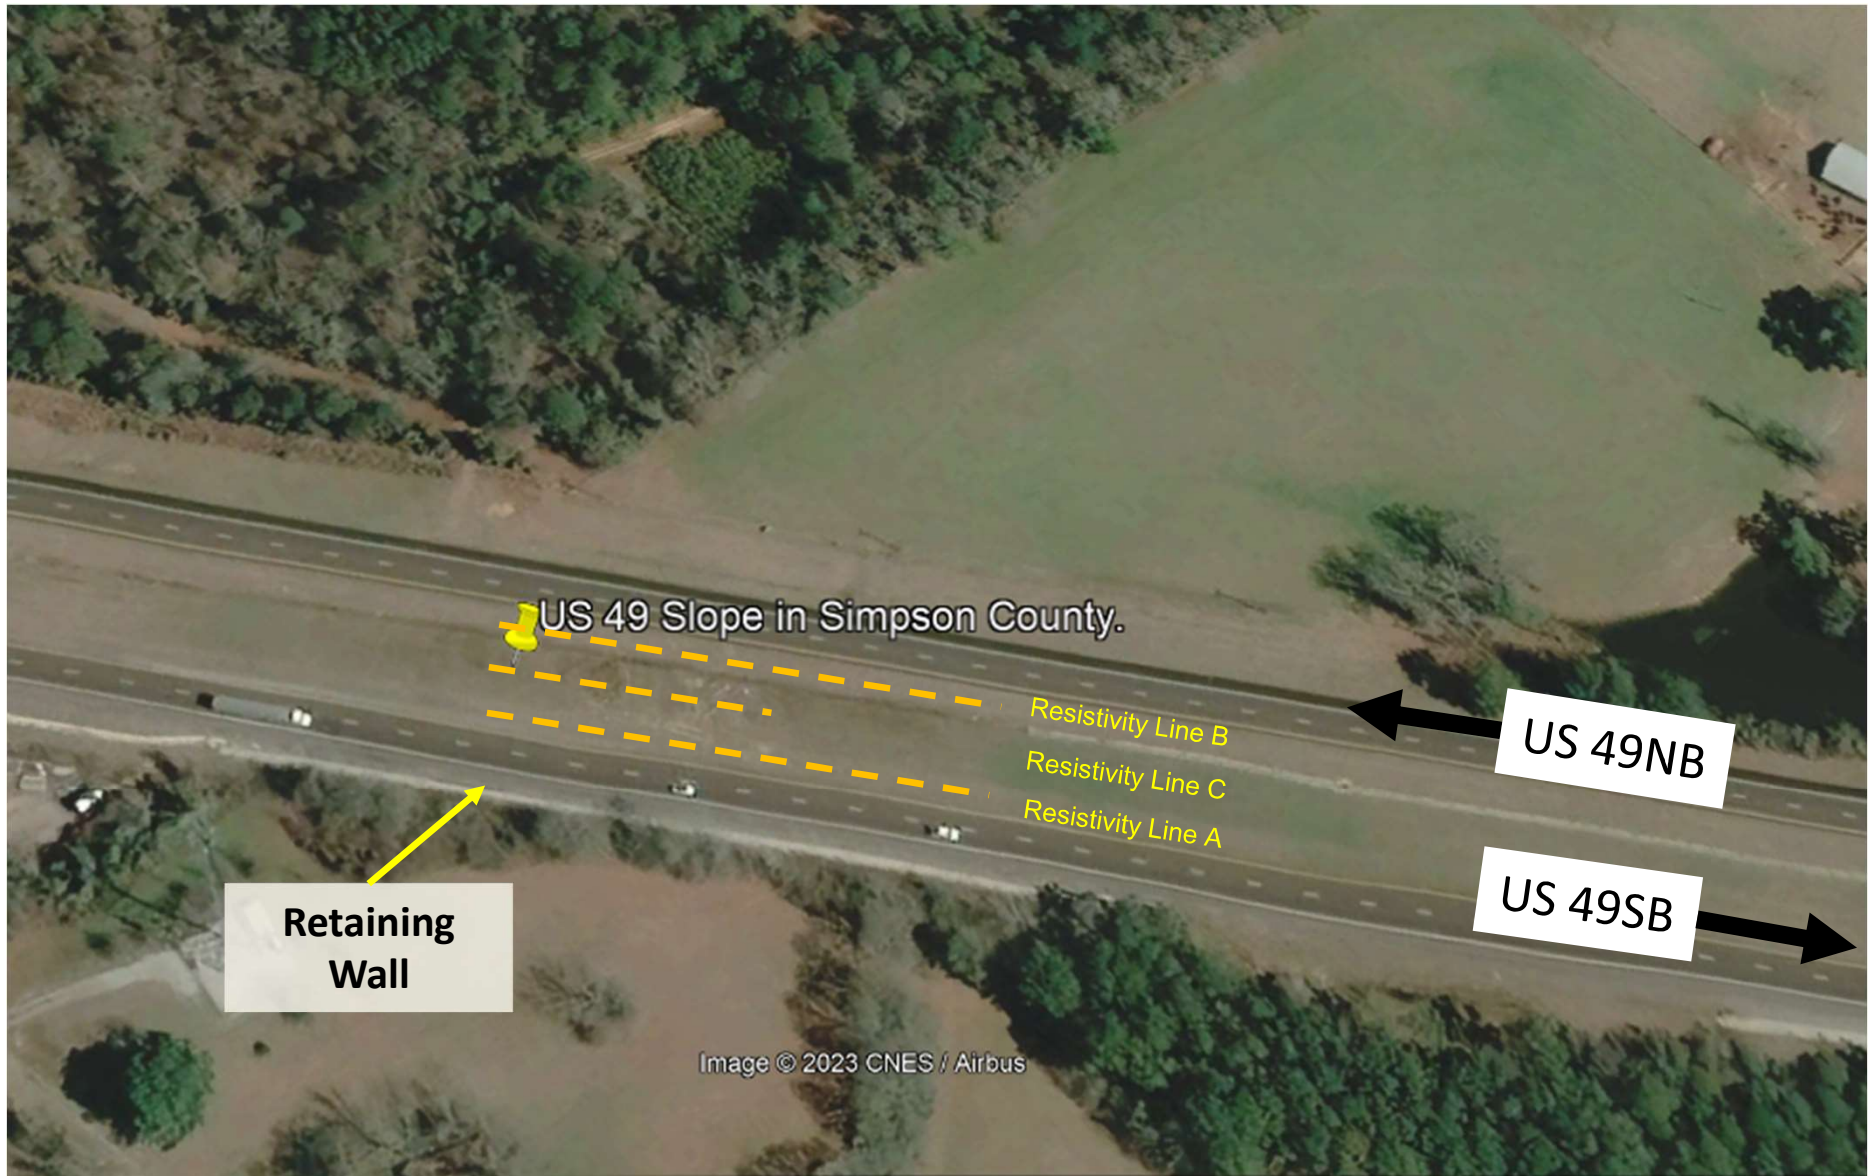
US 49 Site ERI Lines

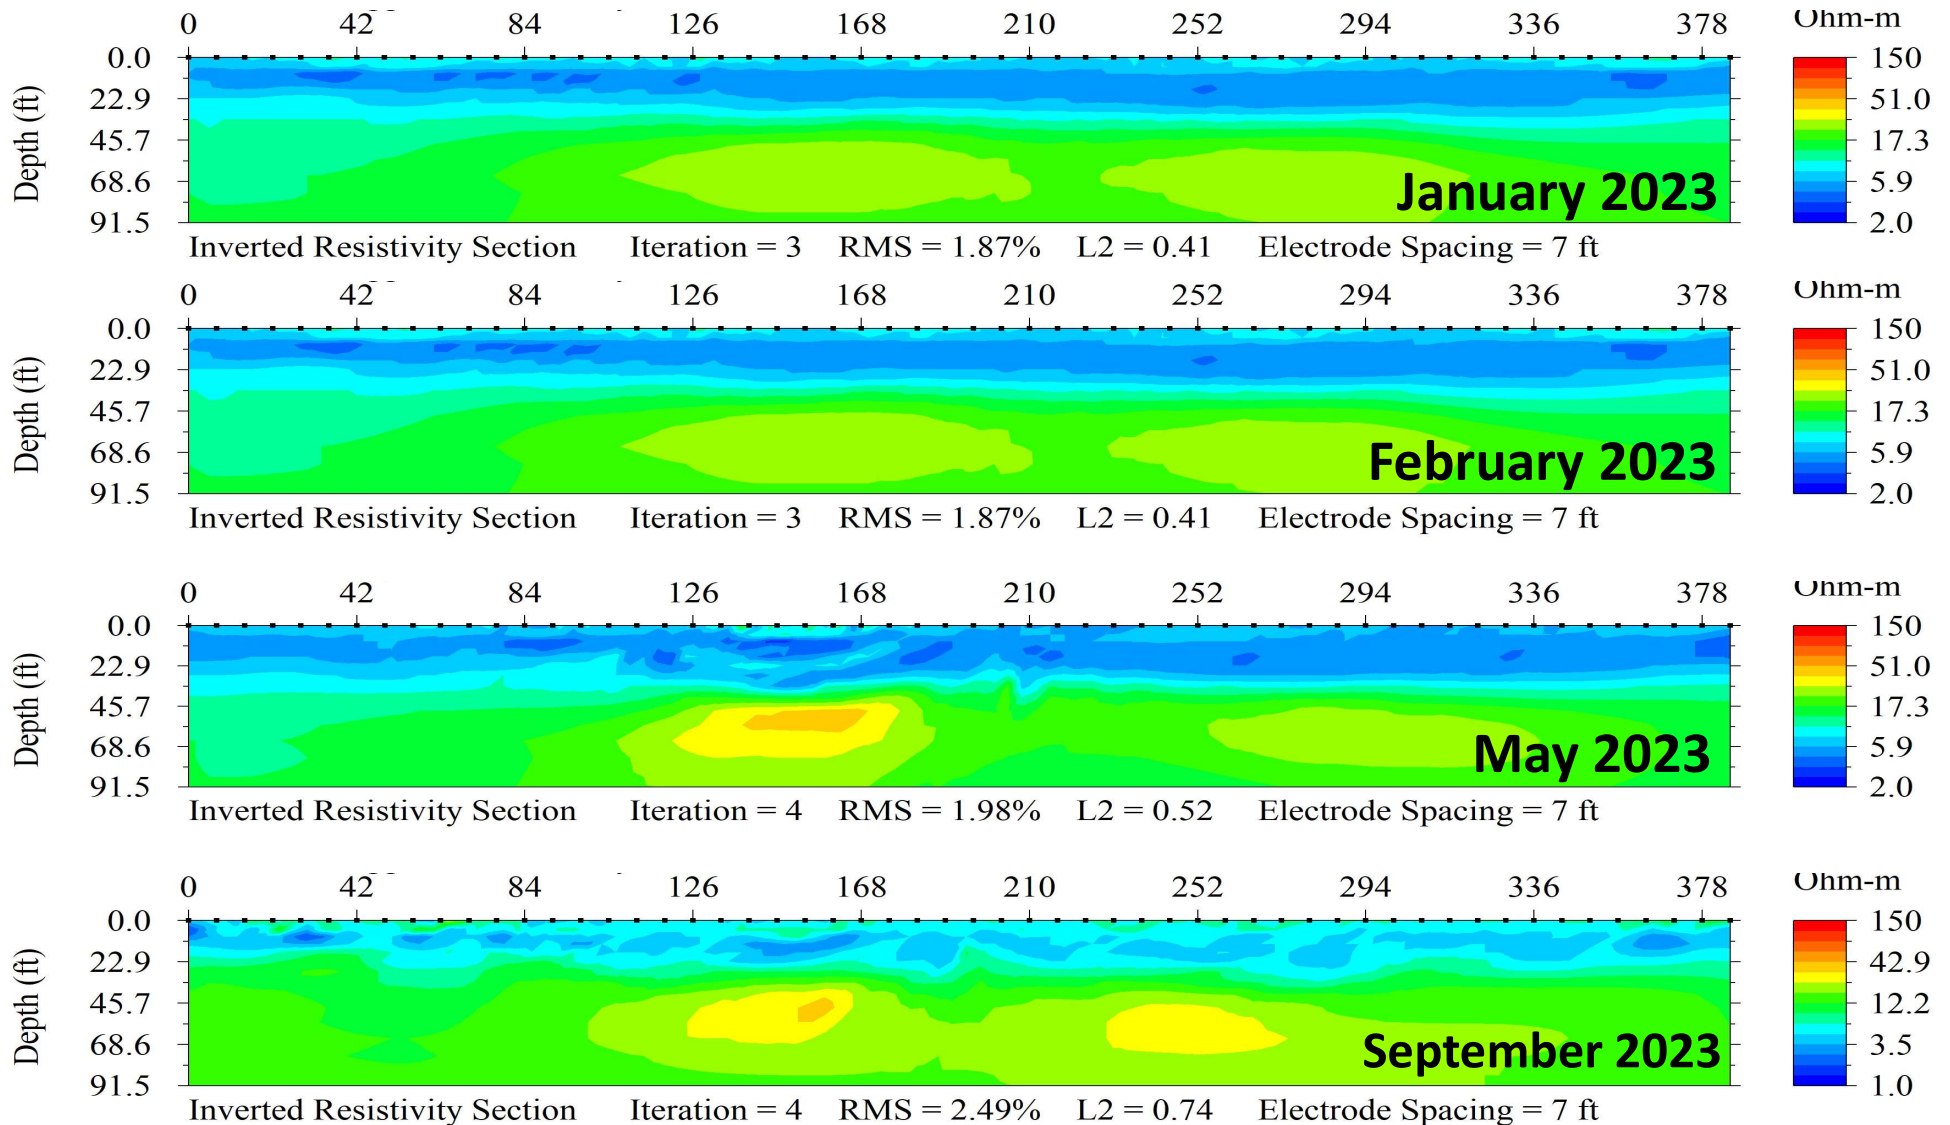
US 49 Site ERI Results

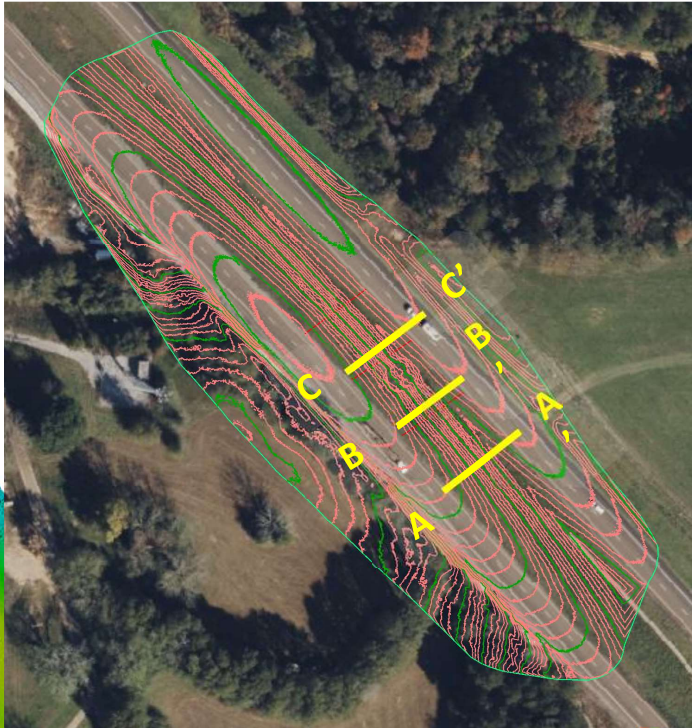
US 49 LiDAR Survey Result

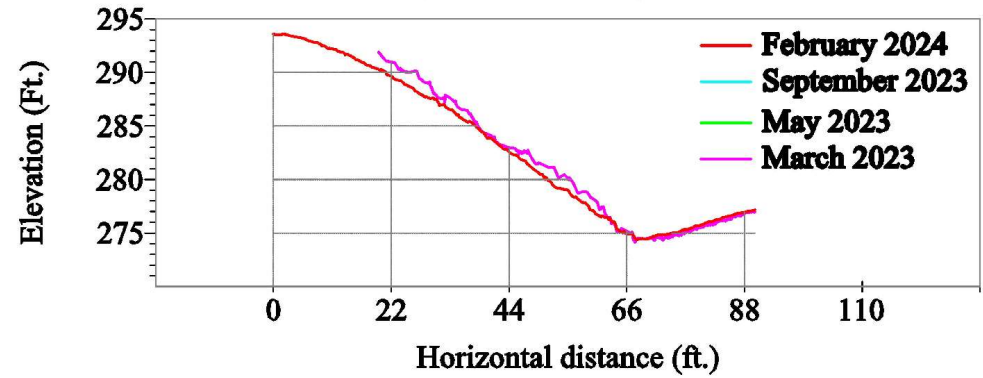
Section A-A' PROFILE

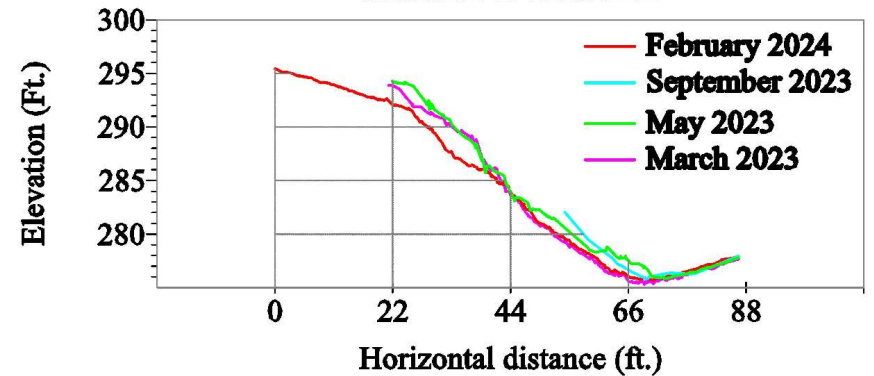
Section B-B' PROFILE

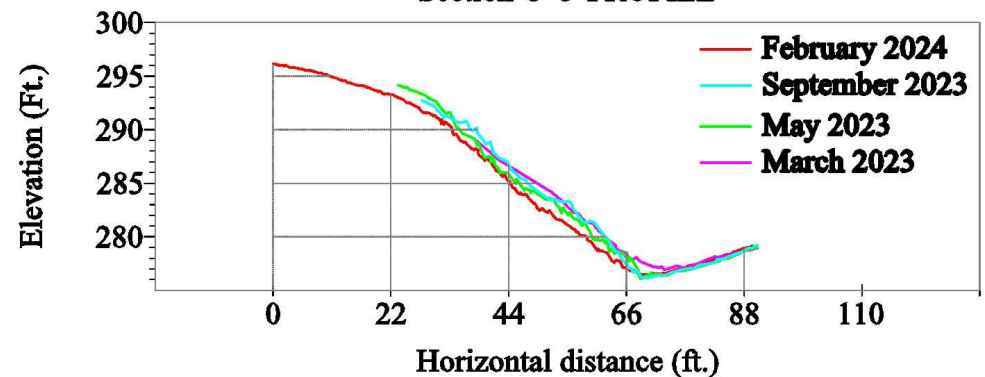
Section C-C' PROFILE

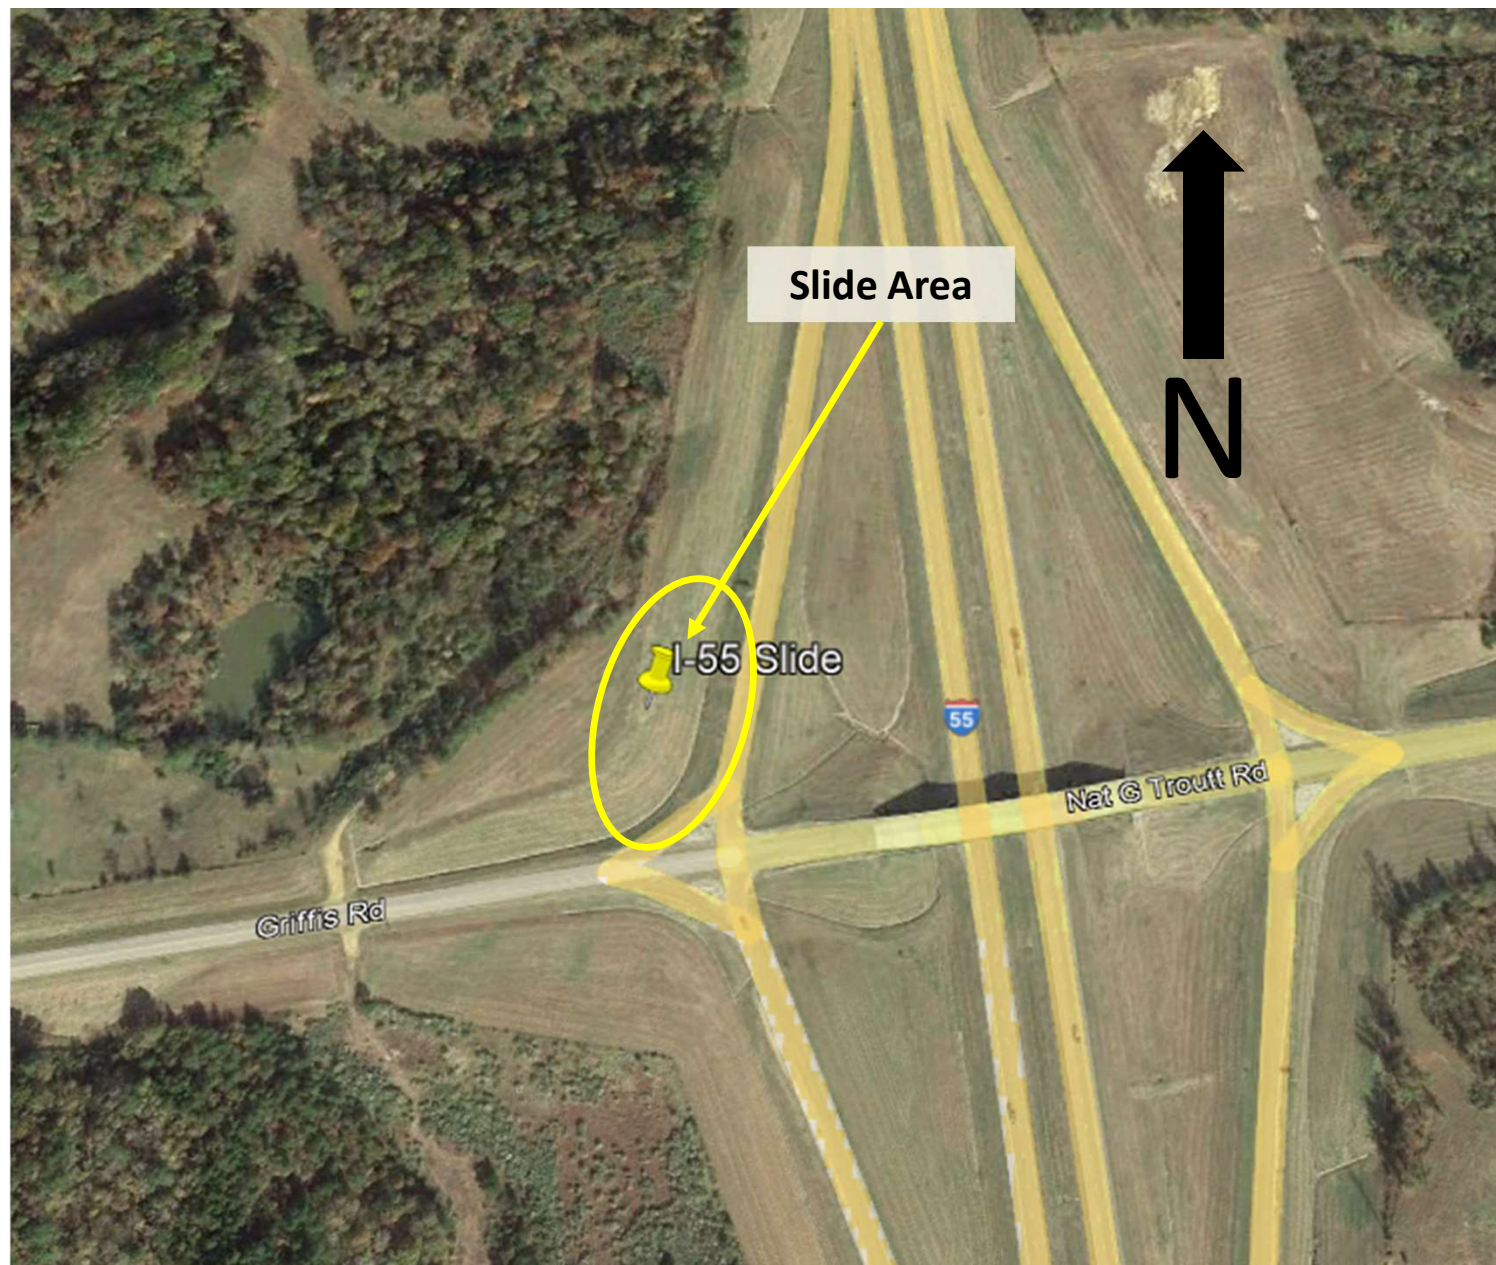
I-55 near Grenada

- 30 ft high - 3:1 slope
- Repair Area: 4000ft²
- 4,949 Vetiver Plants

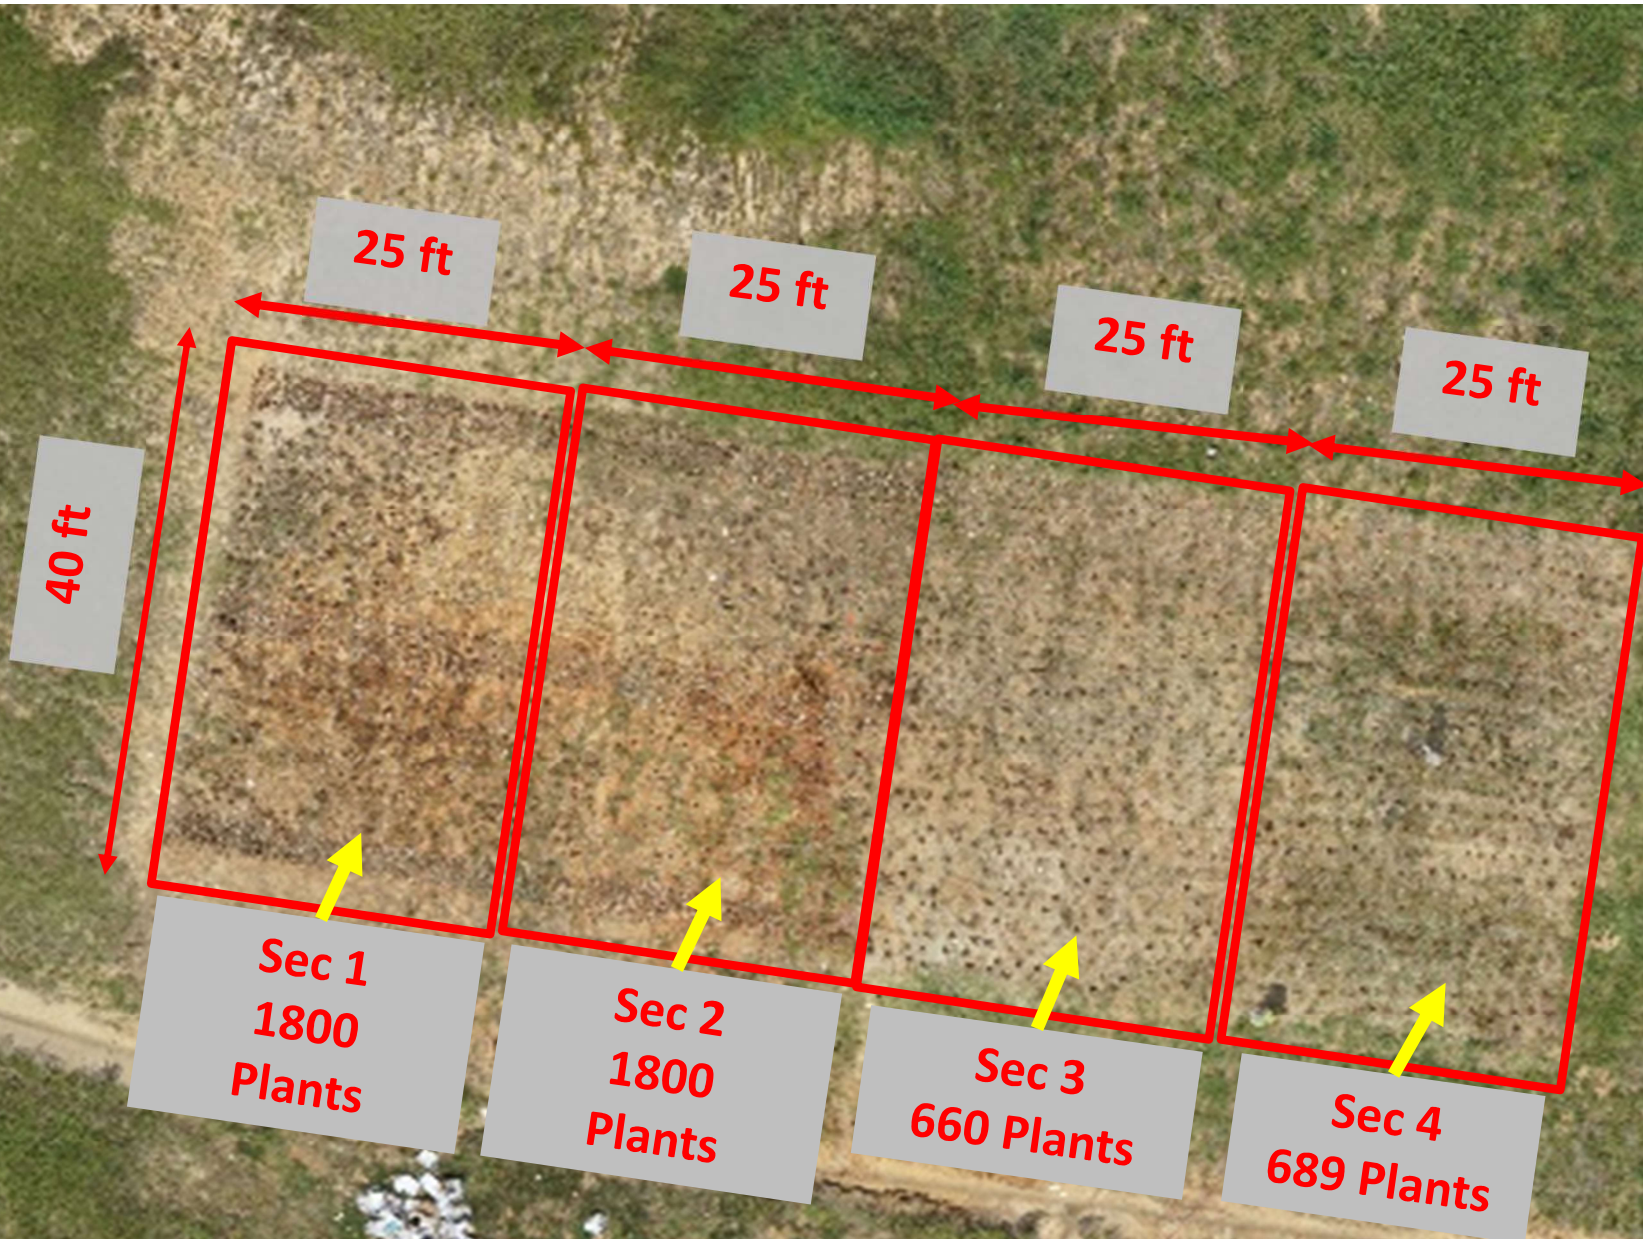
I-55 Vetiver Layout

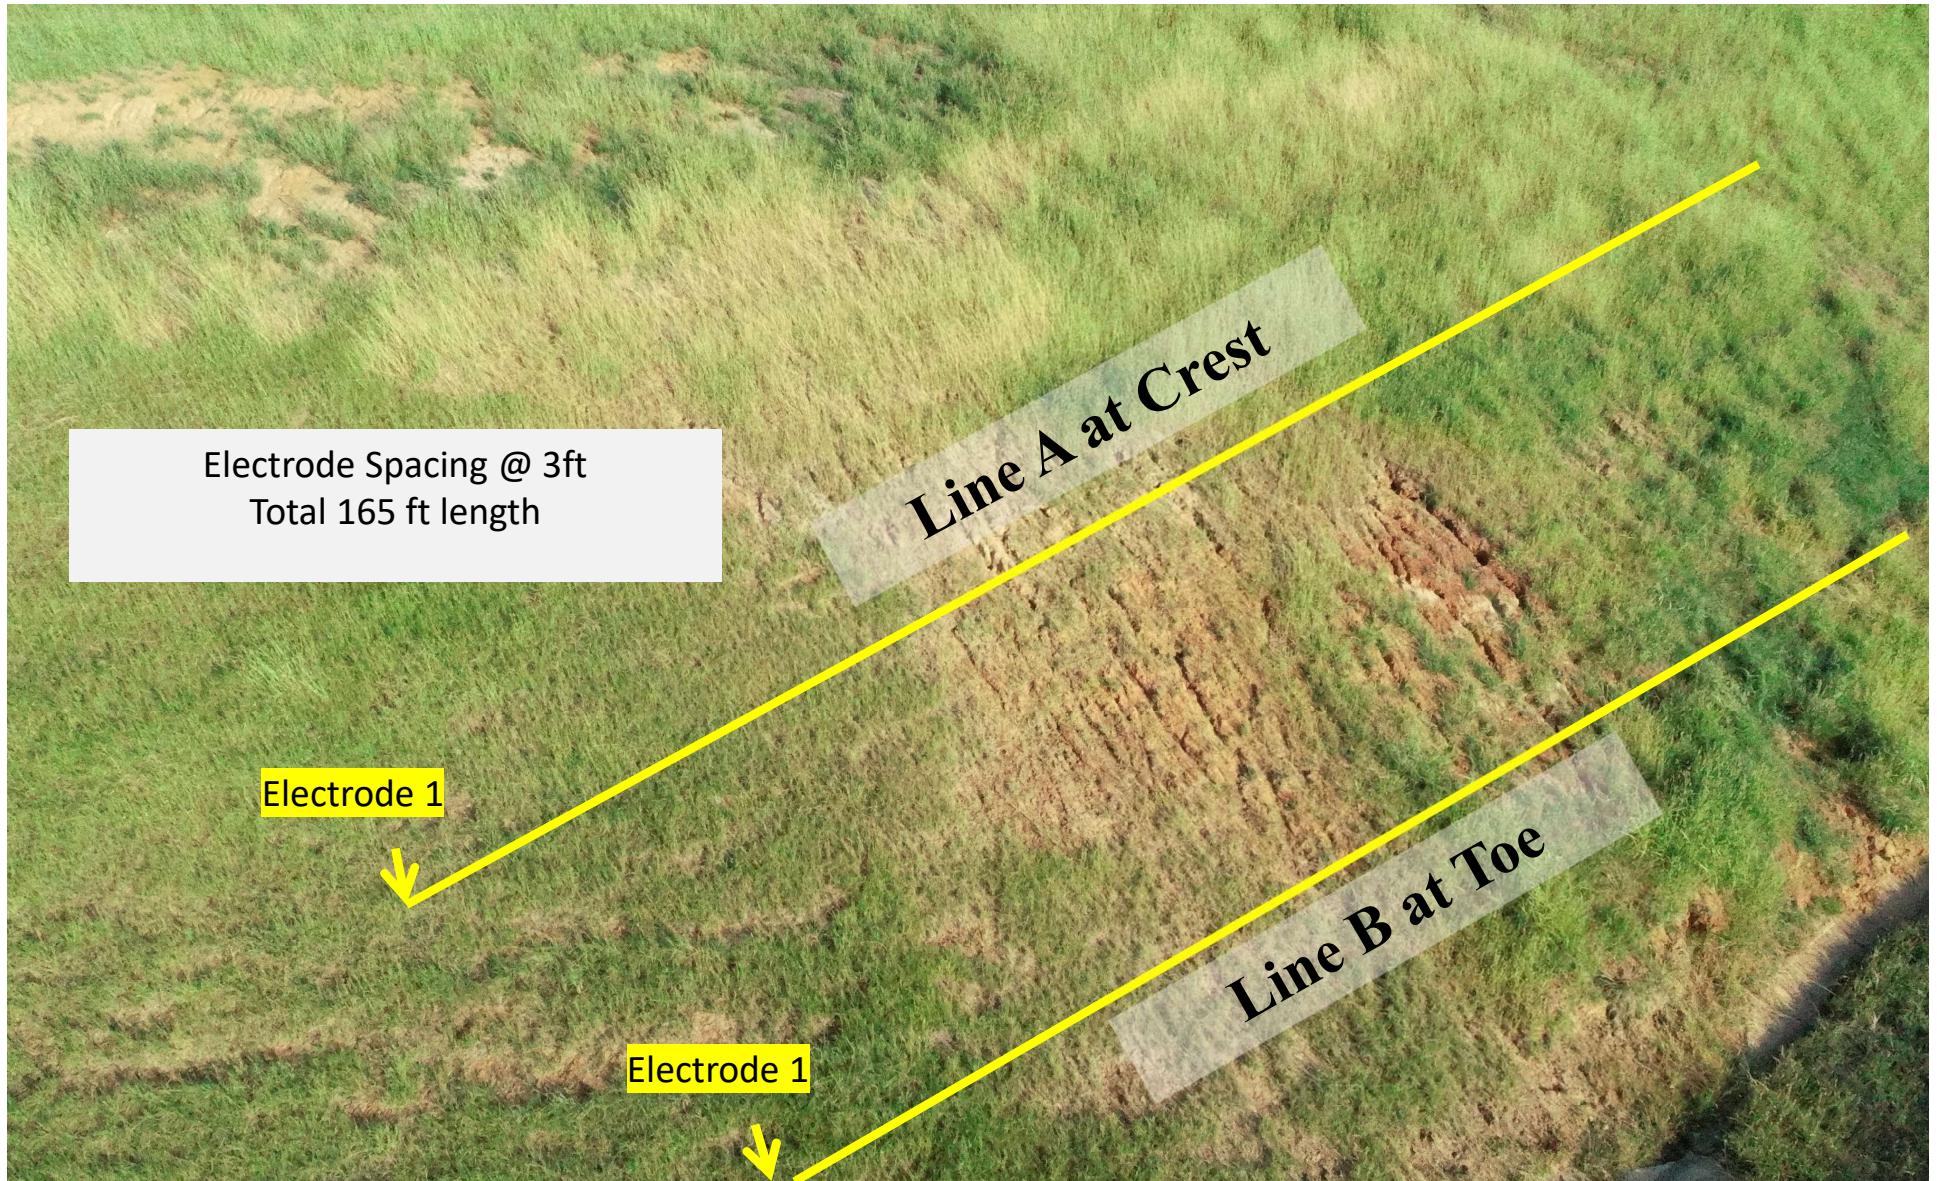
I-55 Site ERI Lines

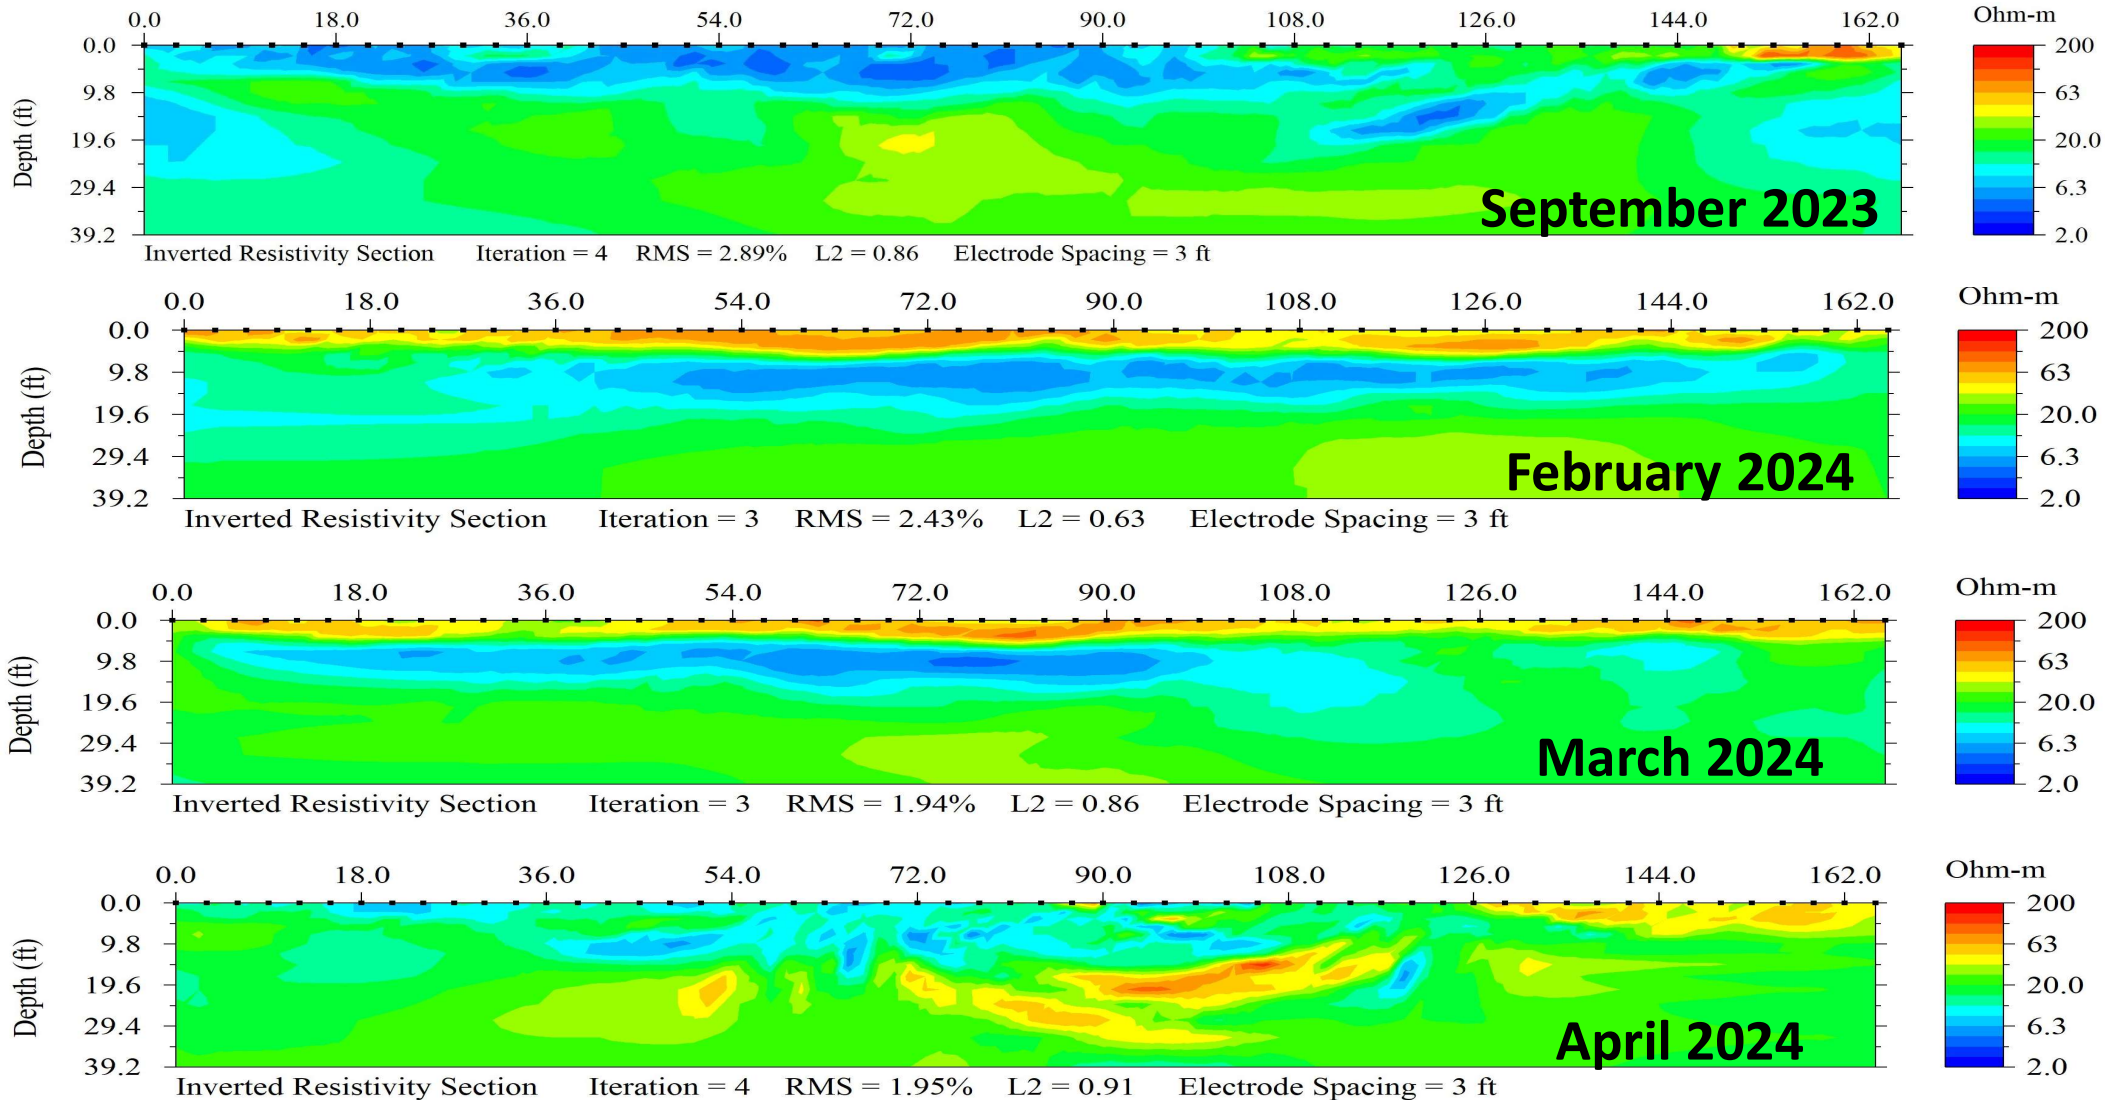
I-55 Site ERI Results

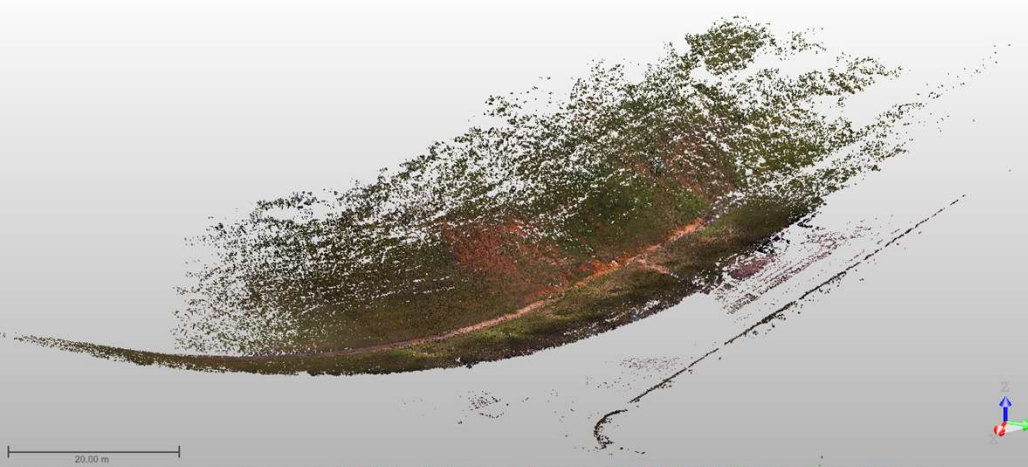
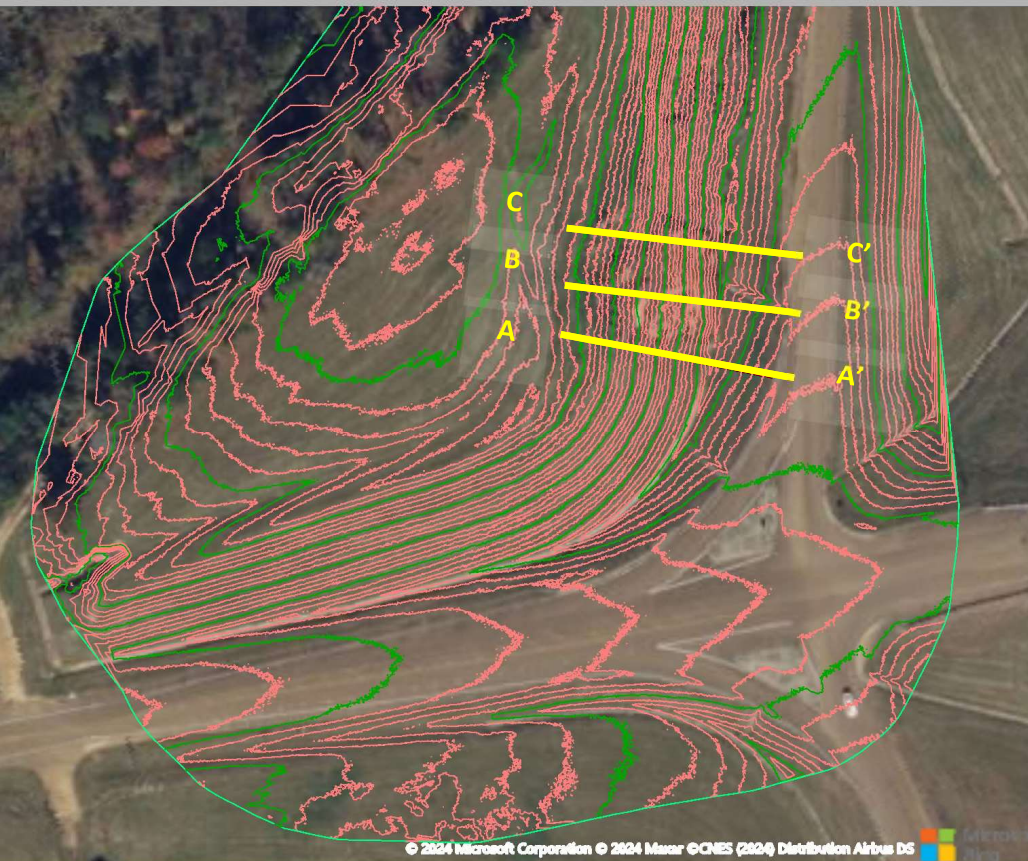
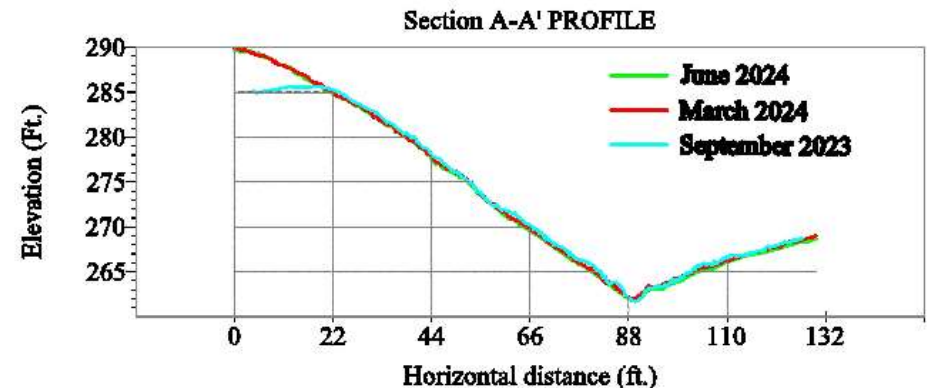
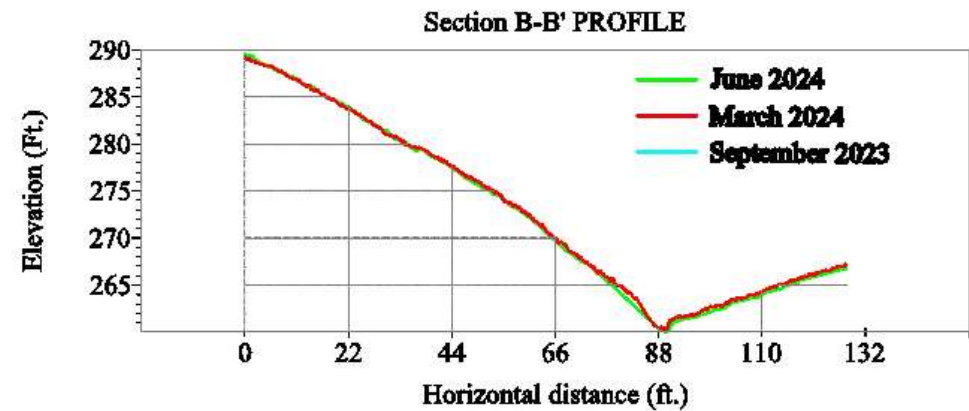
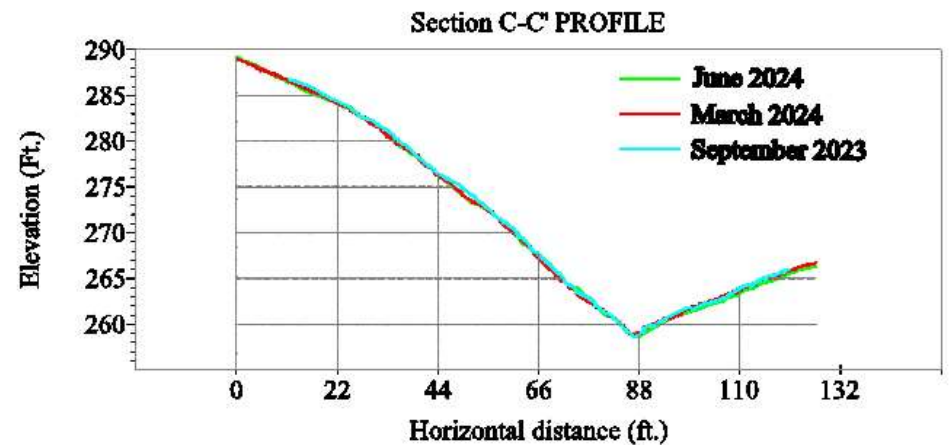
LiDAR Survey Result
