# Alligator River Bridge Update

Nick Tuttle

NCDOT Eastern Region  
Geotechnical Group

NORTH CAROLINA DEPARTMENT OF TRANSPORTATION  
GeoTechnical Engineering Unit

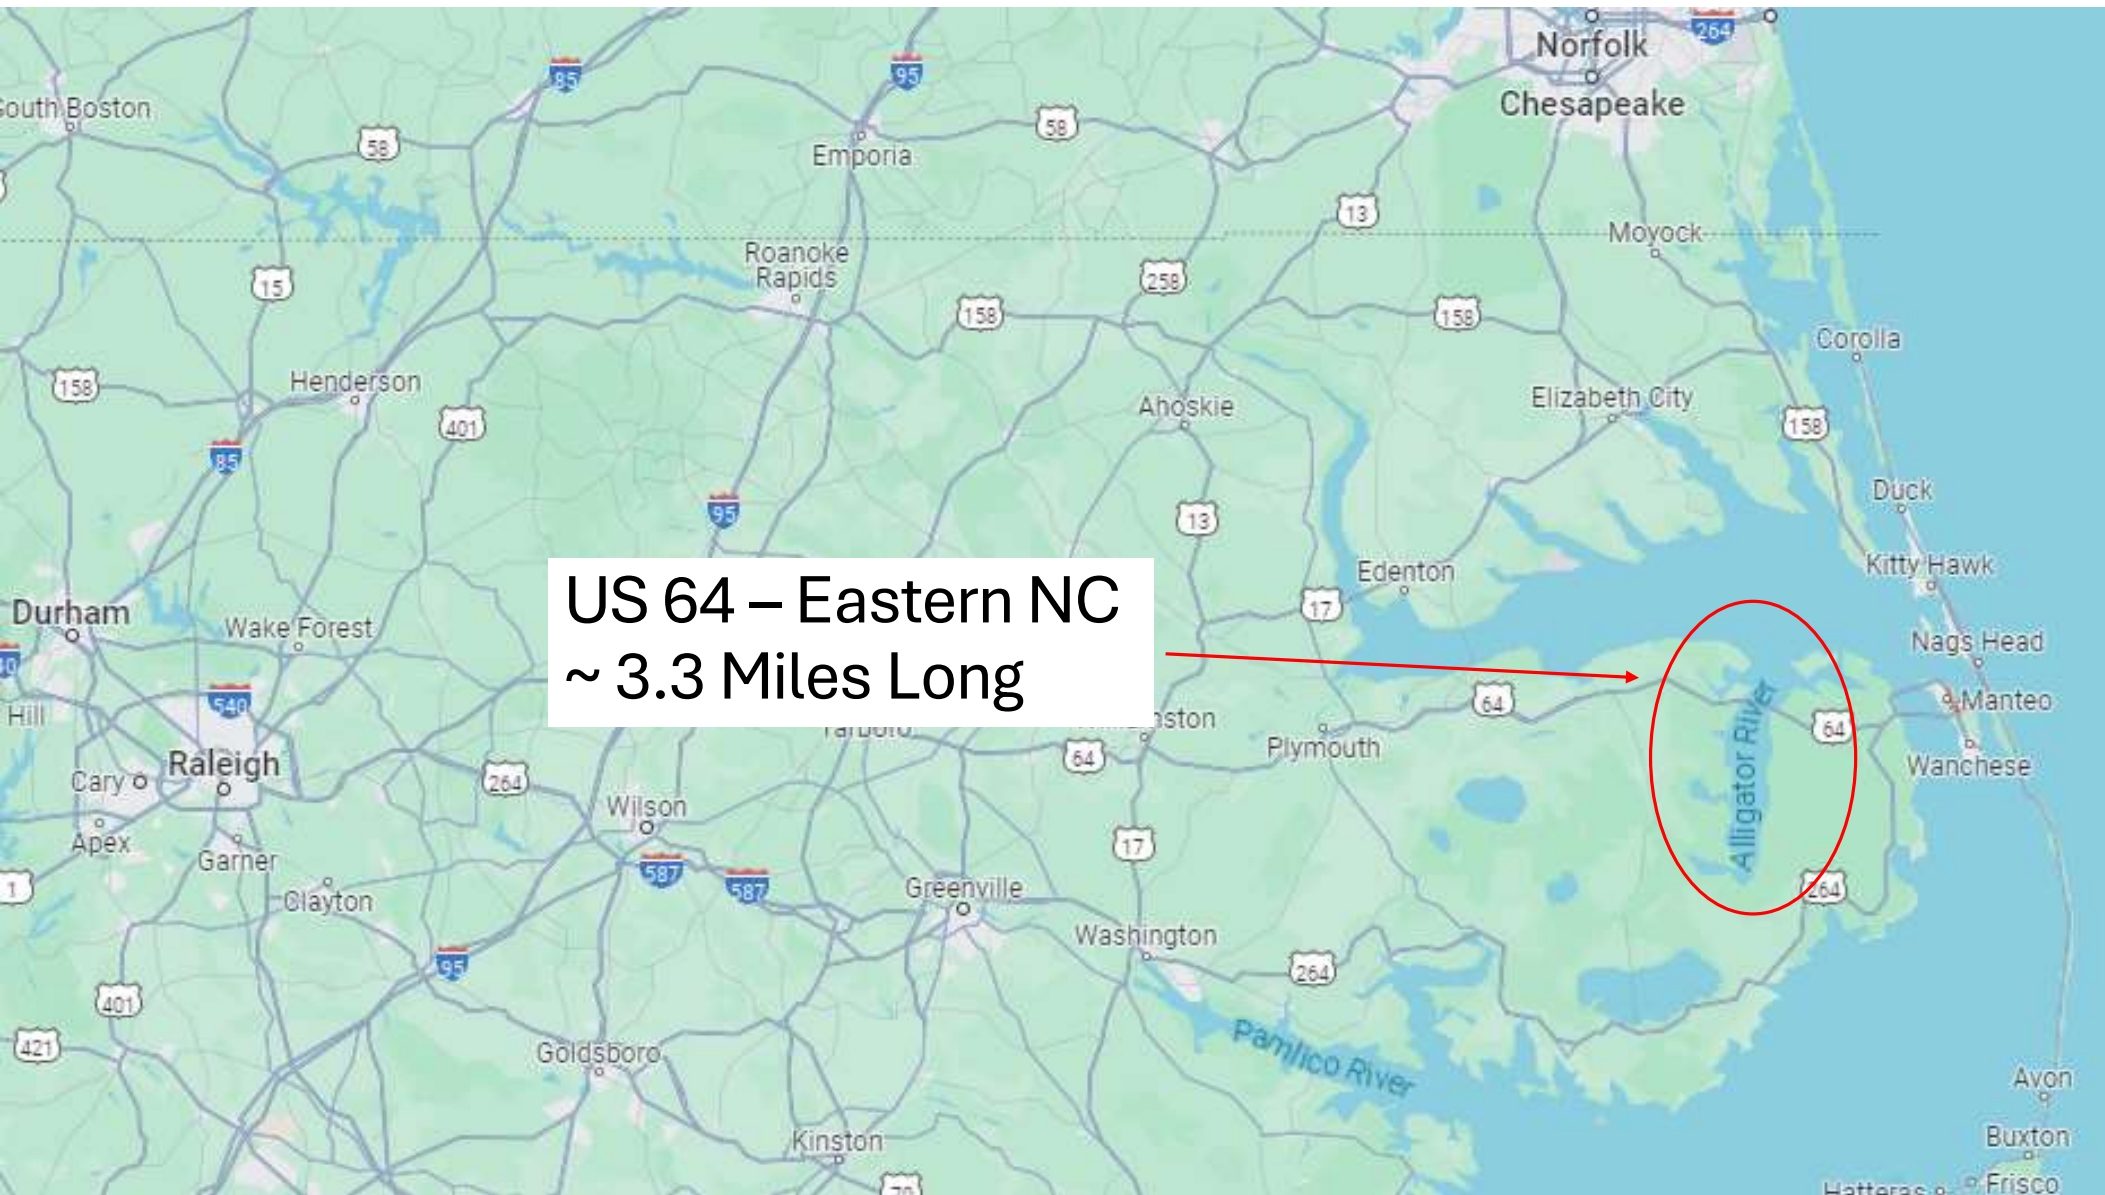
US 64 – Eastern NC  
~ 3.3 Miles Long

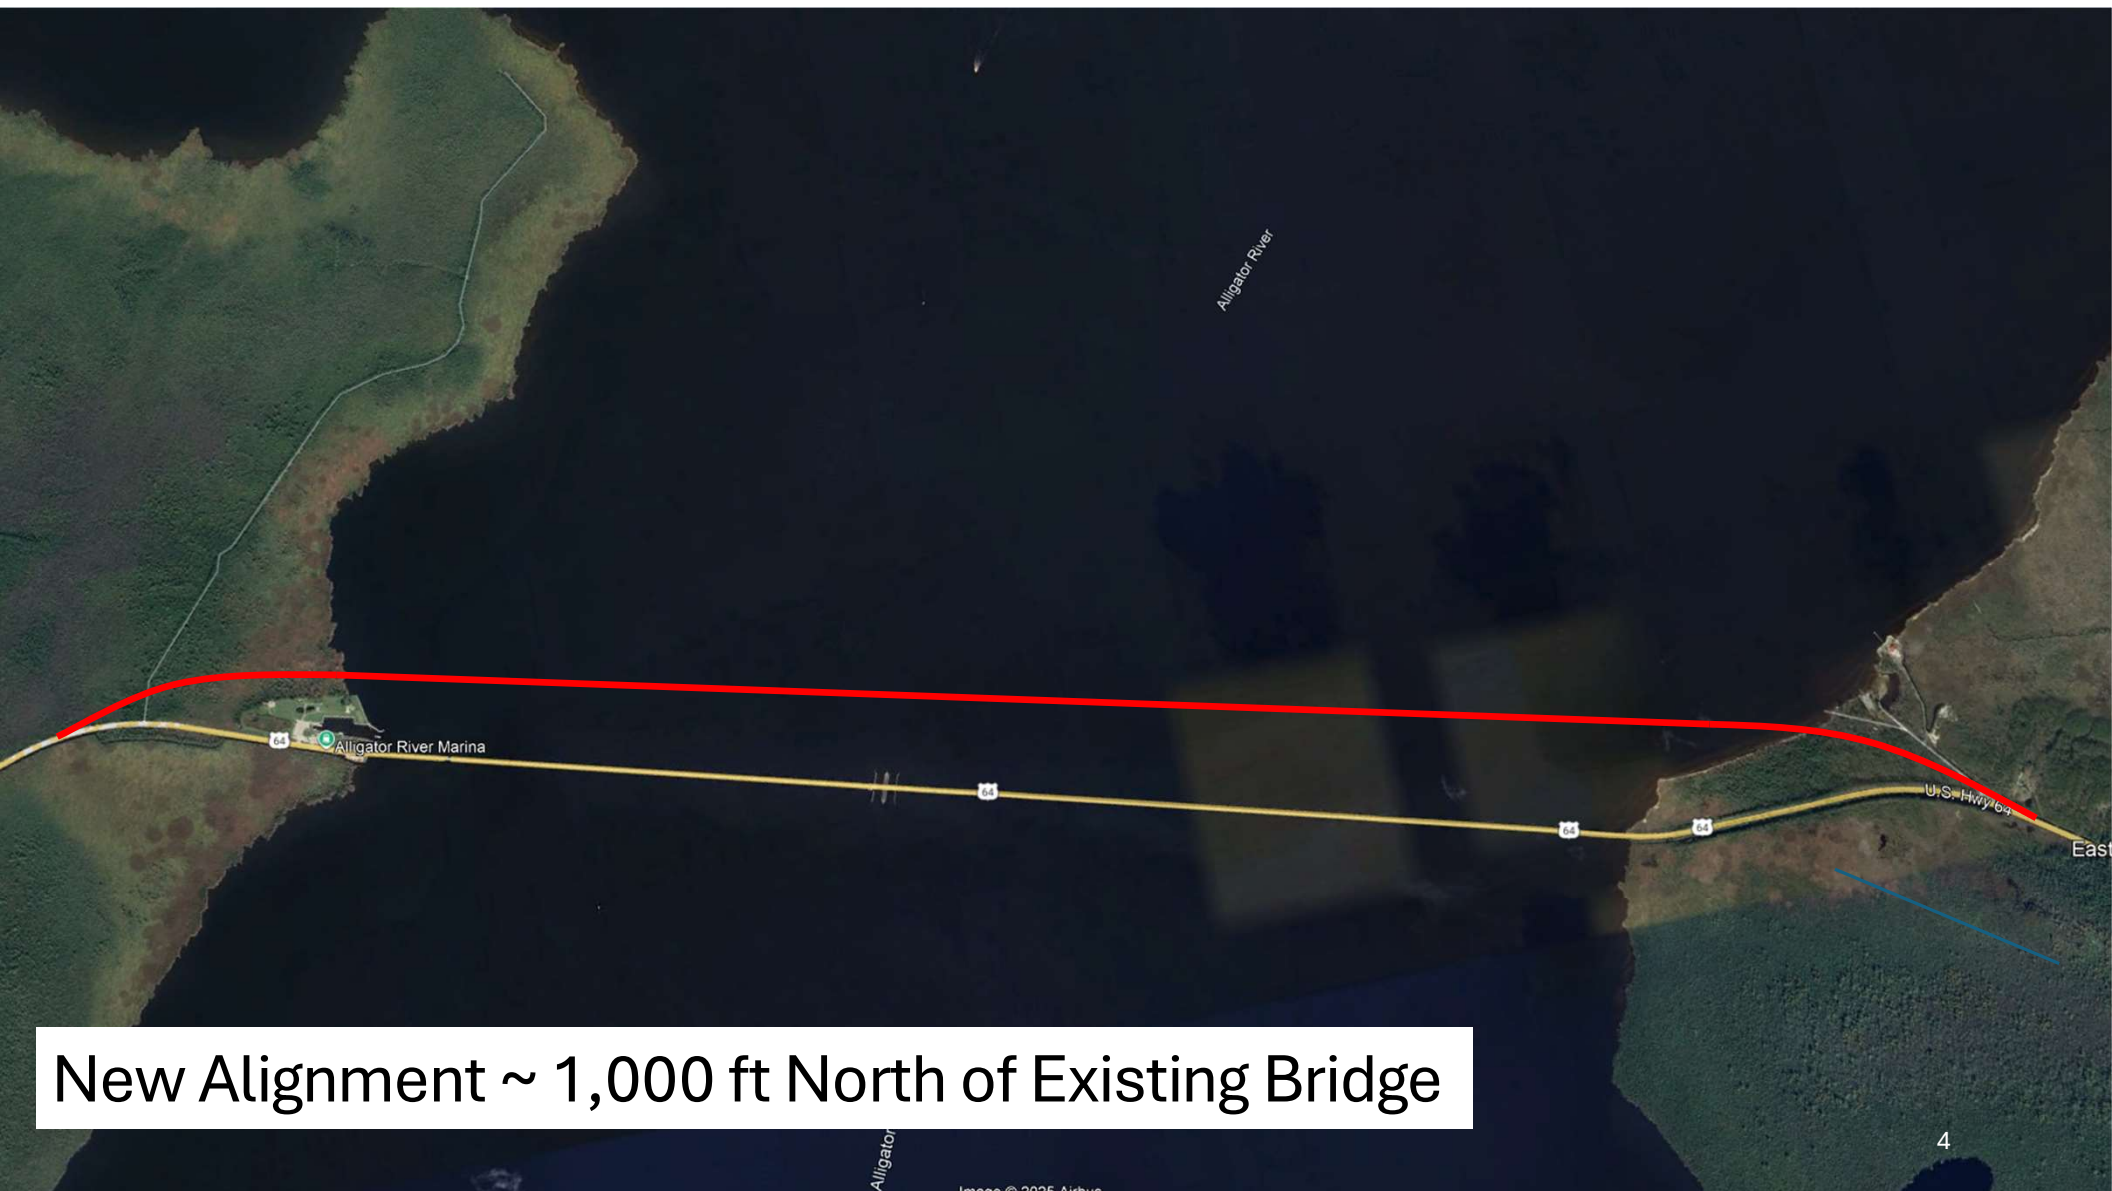
New Alignment ~ 1,000 ft North of Existing Bridge

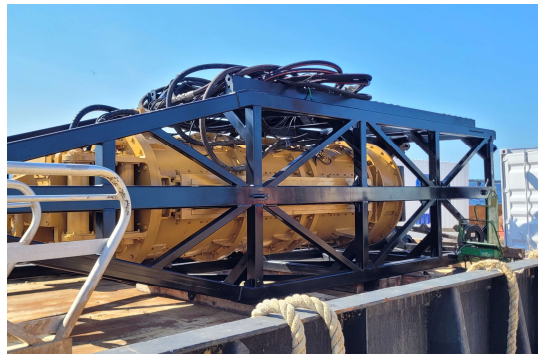
- Eleven 36” Square PCP driven (165’ to 185’)
- Spread out along bridge alignment
- One pile driven to lower very dense sand layer
- Casing/pile excavation attempted
- APE D180, APE D220, APE 40-5 hammers used

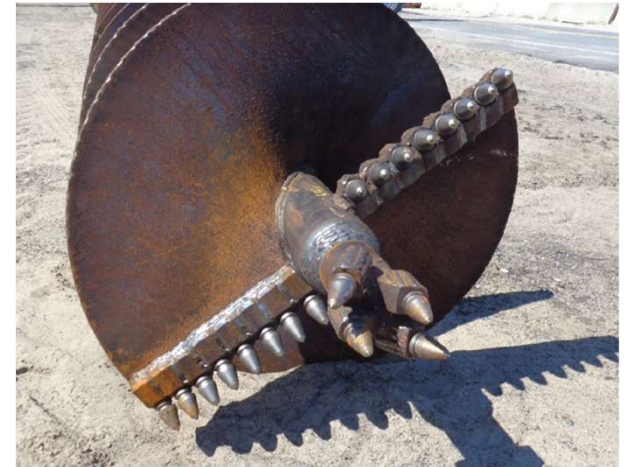
- High rise portion changed to cylinder piles after test pile program
  - More capacity than expected
  - Reduced number of piles to drive
- Concerns based on Rodanthe bridge construction
  - Similar driving through a very dense sand layer
  - Broke 10 cylinder piles
  - Pre-drilling through pile

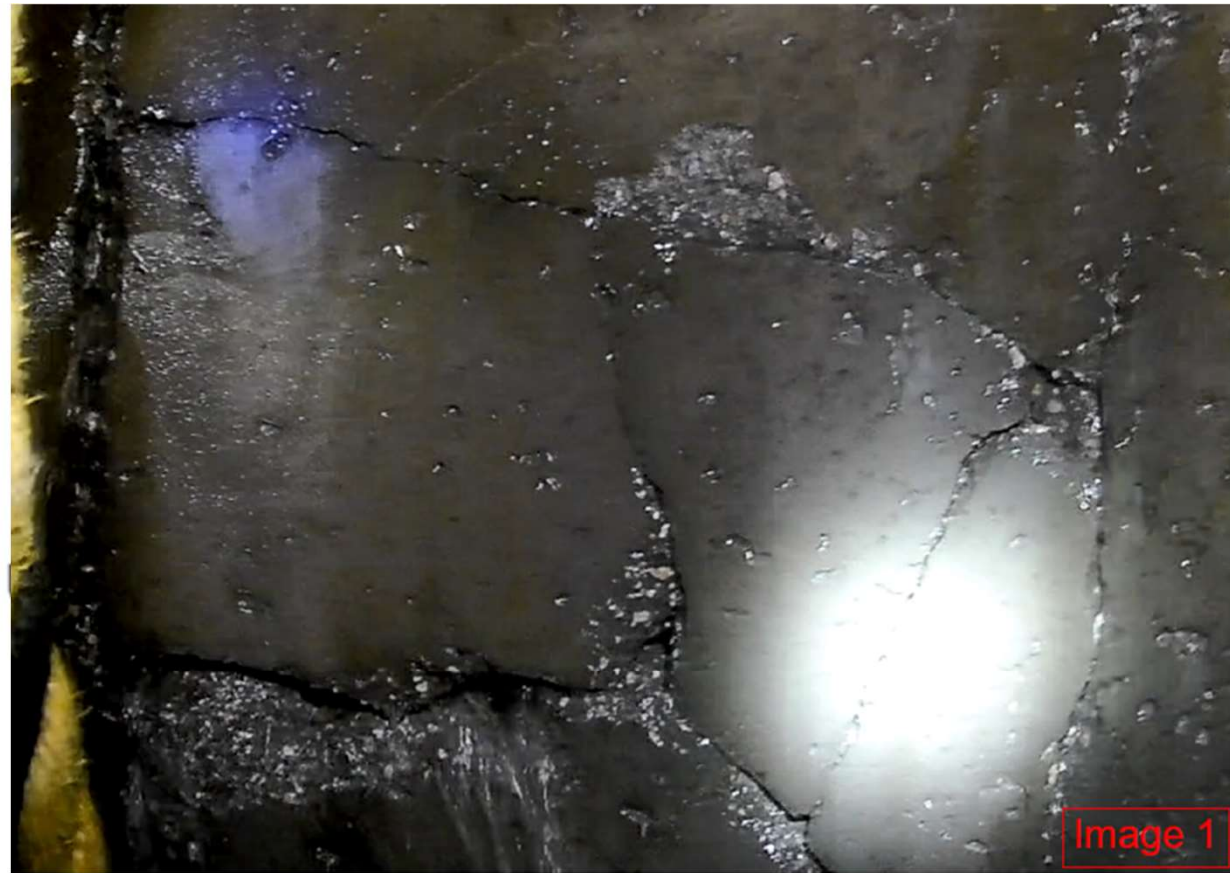
Image 1 taken at approximate elevation -14ft. Vertical and horizontal cracking with . Water intrusion is evident.

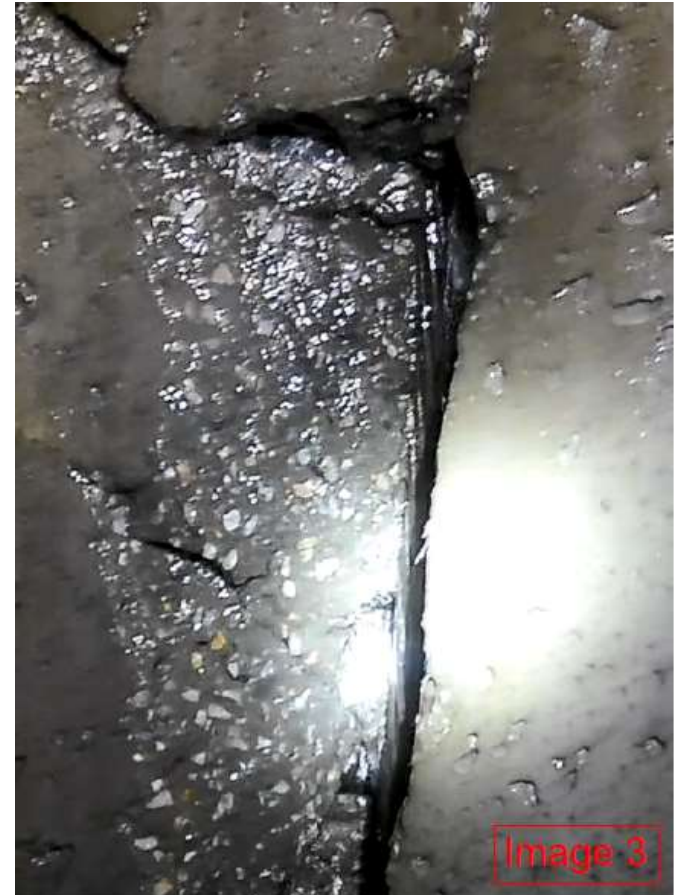
Image 3 taken at approximate elevation -17ft.

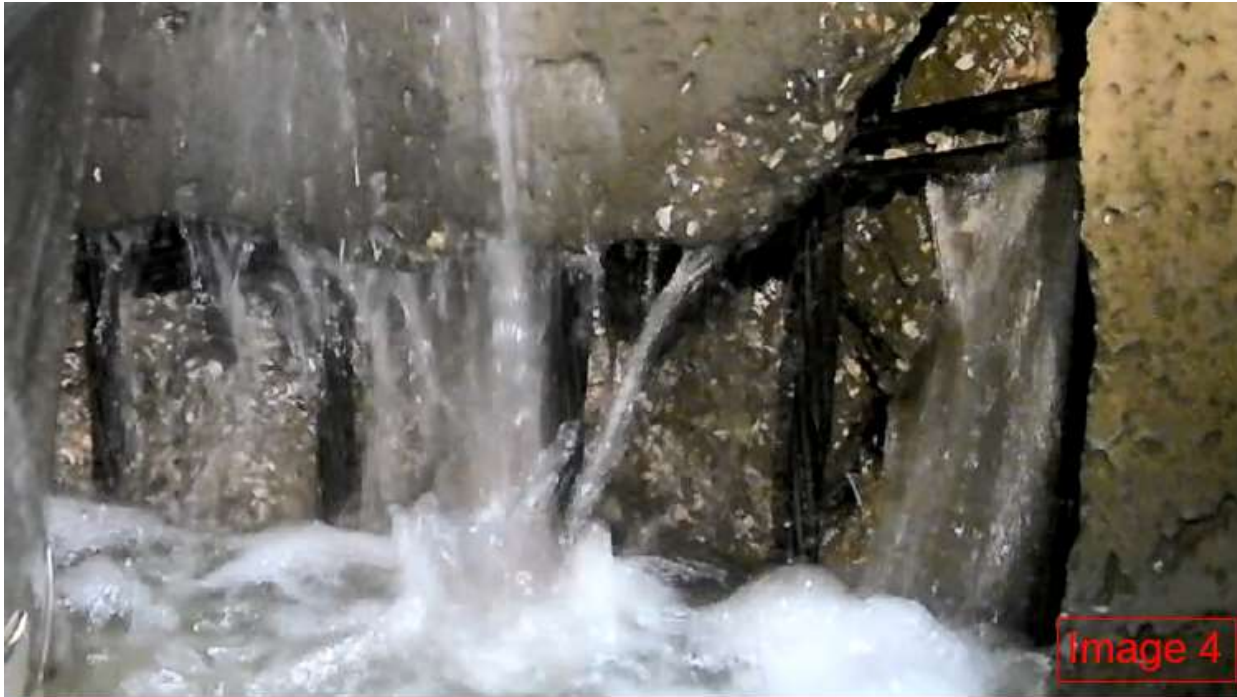
Image 4 taken at approximate elevation -18ft to -19ft.

Multiple reinforcing strands and spirals exposed.

Unable to excavate lower than this elevation with current equipment setup.

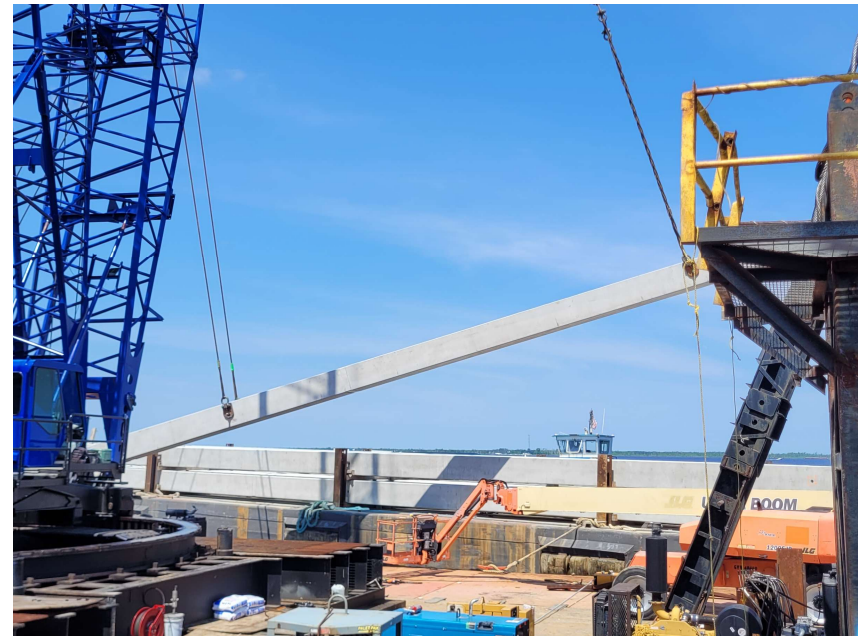
- Pile design
  - 10,000 psi concrete used
  - 36-0.6" dia. CFRP Strands, 41kip pull
  - Maximized pull and concrete strength for stress limits
- Stress limits
  - Squares-solid
    - 7.6 ksi compression
    - 1.2 ksi tension
  - Cylinders
    - 2.7 ksi compression
    - 1.5 ksi tension

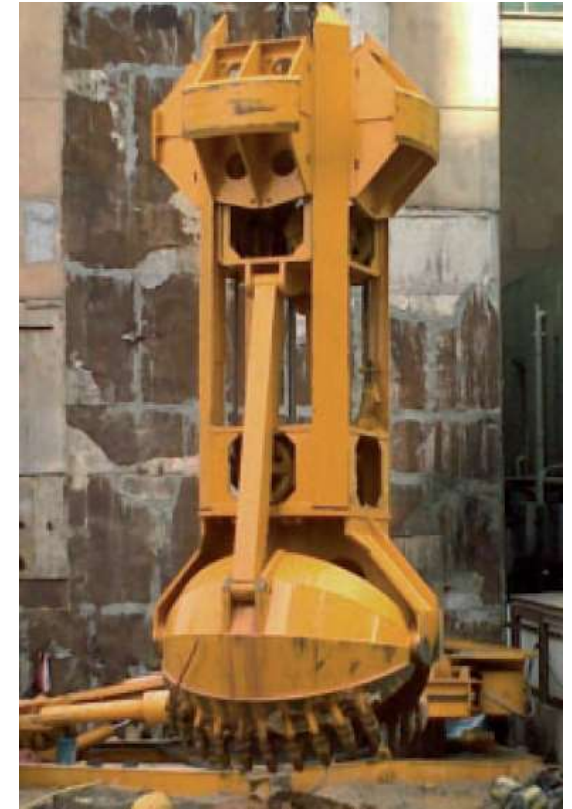
- Stand and drive
- APE D180
- 3 or 4 DPTs per pile footing
- Compression stress restriction
- If BPF reached 120 remove soil plug

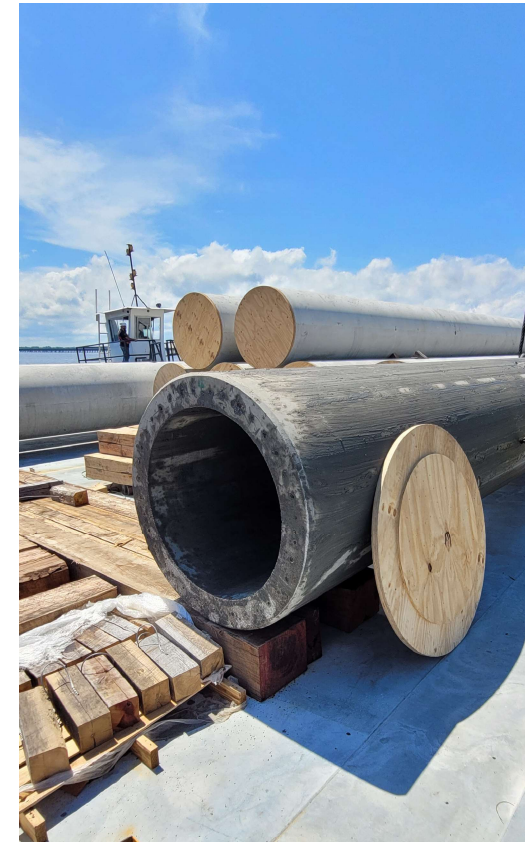
- 2.25” thick plywood pile cap used
  - Typically broke once hammer placed
- Compression limit reached during hammer startup
  - Mitigated by lowering fuel pressure
- RDR reached on all cylinder test piles

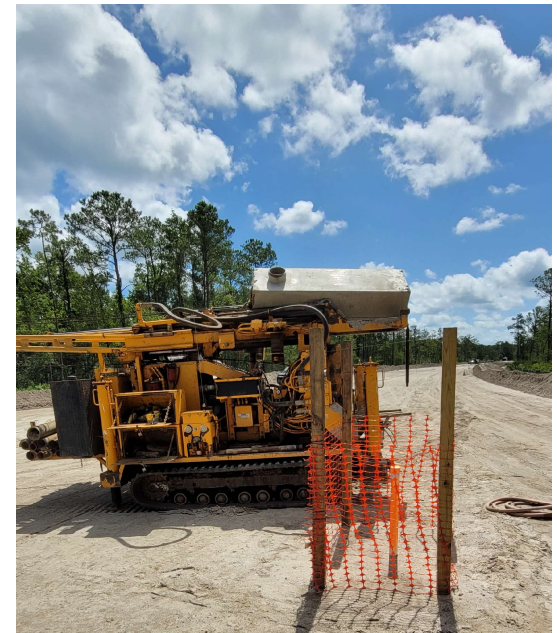
- Magnet extensometers
- Settlement gauges
- VW piezometers
- Vertical Inclinometers
