SR 24 Washington County Georgia Landslide

Project Background

The landslide occurred between Stations 308+00 to 320+00. This was a new, four-lane alignment section to replace the two-lane existing alignment. Embankment construction began in 2011 and paved in 2013.

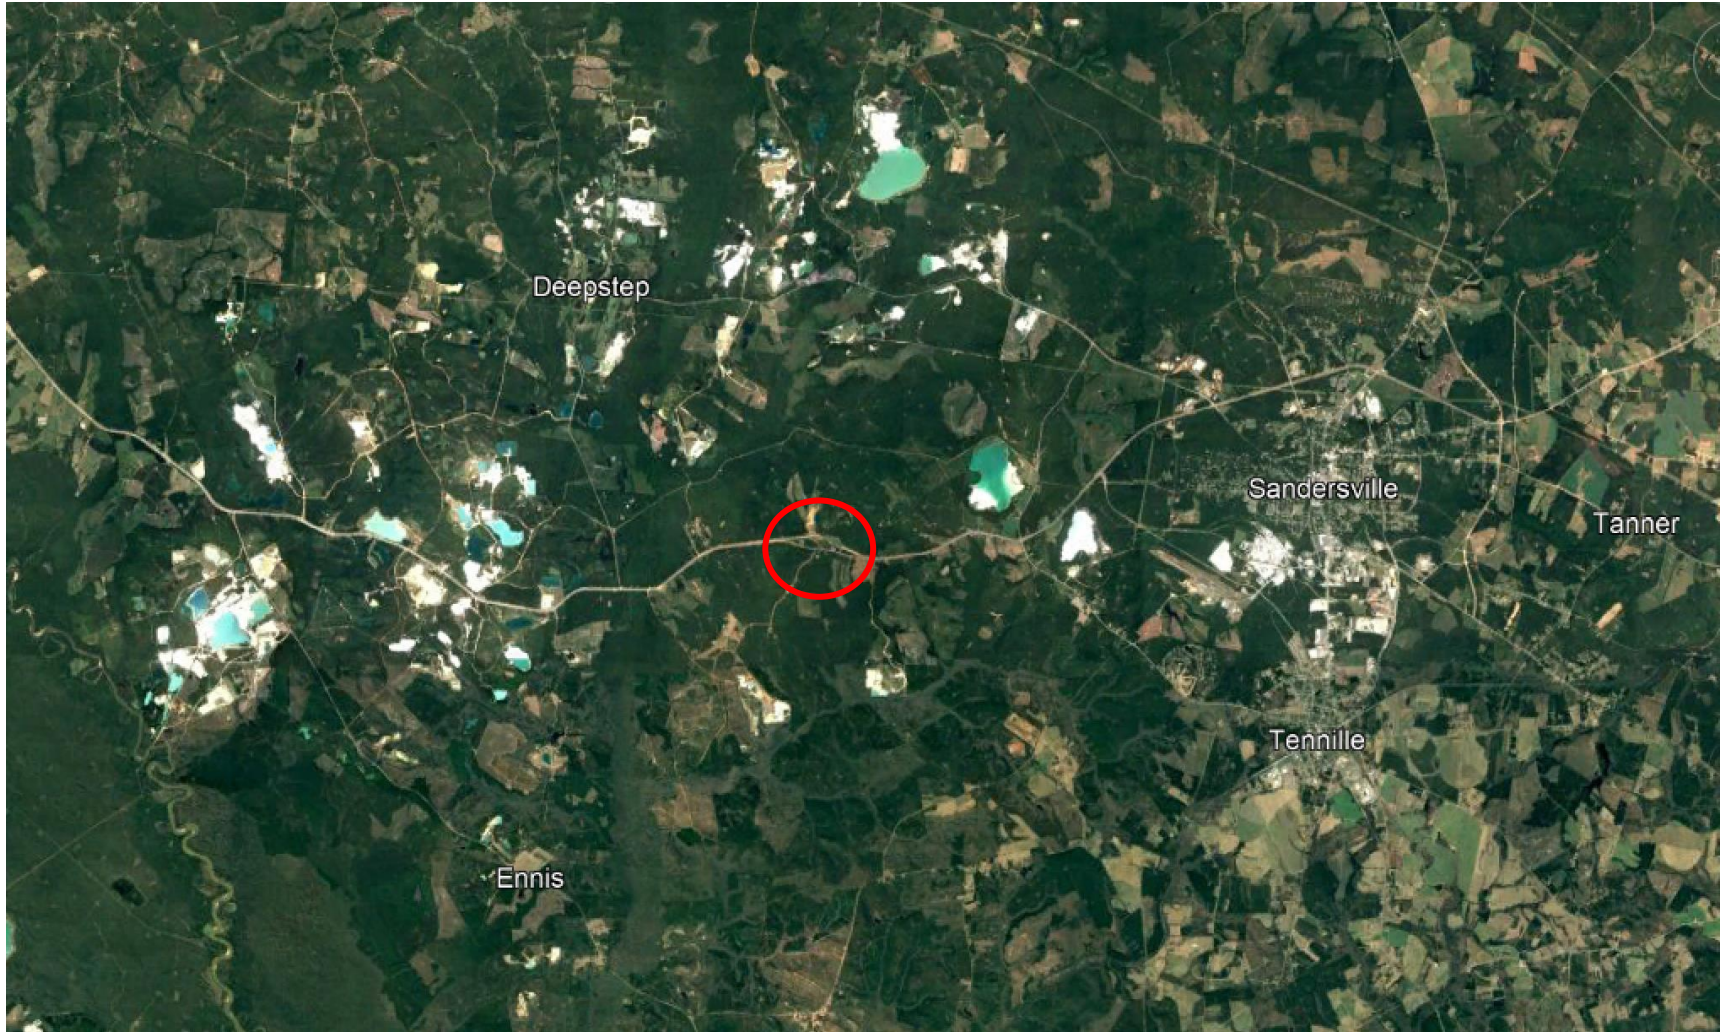
Location

The GDOT Geotechnical Bureau was contacted on March 15, 2016. Construction personnel in this District have dealt with multiple slope stability issues and immediately identified the tension cracks that formed in the pavement section as evidence of a potential slope failure. Because of their quick action, our Office was able to document the failure as it occurred.
