HISTORIC ROCK / SOIL WALL STABILIZATION CASE STUDY – TENNESSEE CAPITAL HILL, NASHVILLE, TN

Presented By: John D. Godfrey, Jr., P.E.

PREPARED FOR THE 54th STGEC CONFERENCE 2025
Williamsburg, Virginia
September 16, 2025

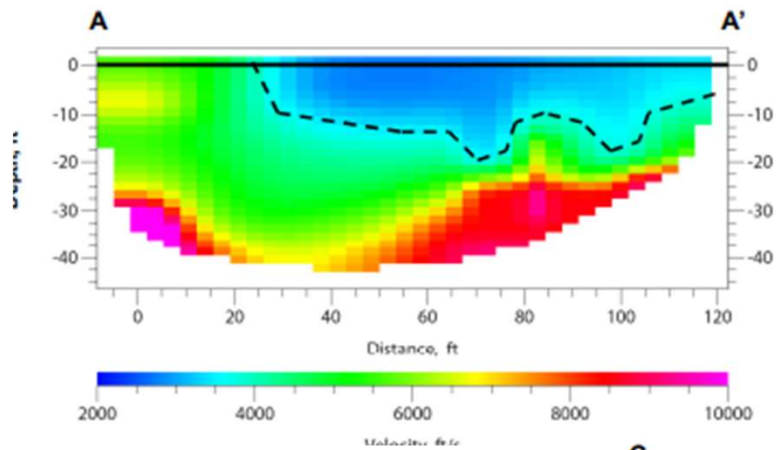
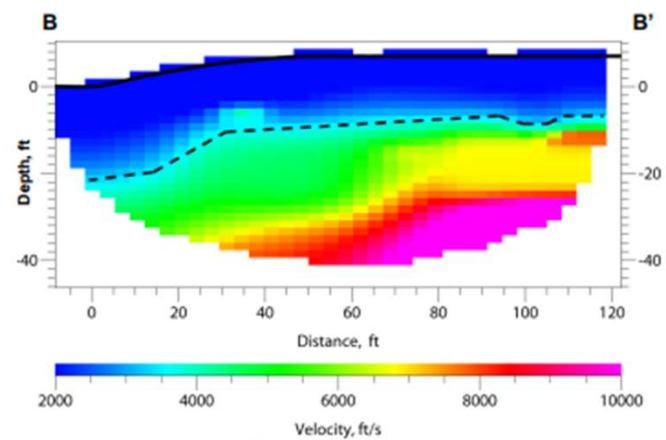
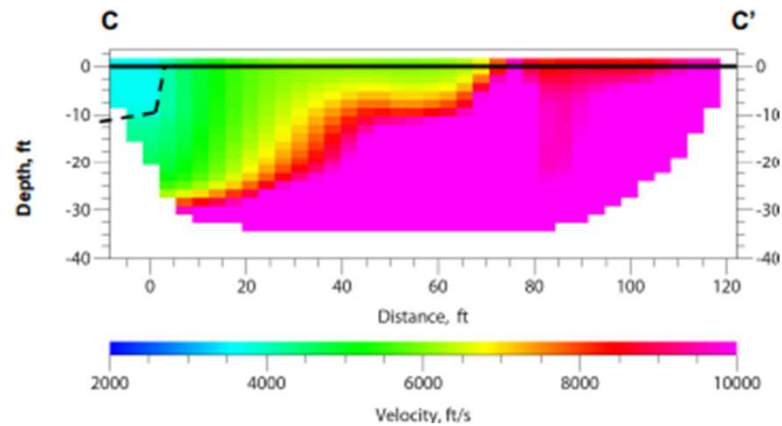
Retaining Wall Repairs:

- Existing limestone block gravity retaining wall along the NE edge of 7th Ave N.
- 85 foot long distressed section of wall (NW end of 7th Ave N)
- Maximum wall height of approximately 6 feet

- The increase in lateral pressure could have resulted from the settlement/movement of fill behind the wall due to self-weight settlement or the raveling of soil into voids associated with boulder laden fill.
- Hydrostatic pressure buildup behind the wall could have attributed to the failure.
- The existing instability can be adequately remedied using a technique known as soil nailing.
- The limestone blocks can be strategically removed as the soil nailing progresses in a top-down manner.
- Based on the composition of the slope materials and the steep existing slope geometry, it is our opinion that these conditions indicate a high potential for long term instability of the slope.

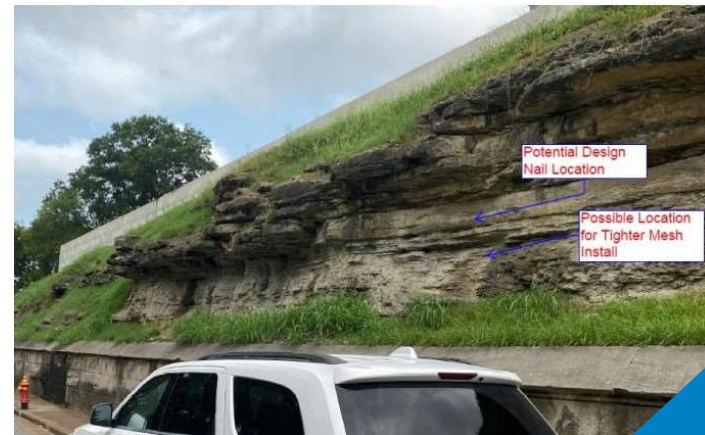
- Stack Stone Wall discovered between approximate Stations 0+00 to 1+80.
- Stacked Stone Wall should be stabilized prior to removing additional rows of milled stone wall.
- ECS approved adjustment of nails to move vertical as needed to clear bottom limestone wall section.
- Remove overhanging rock outcroppings.
- Change 6-inch tolerance of nail spacing to 2 feet tolerance due to boulder spacing.
- Verification and proof test locations can be moved.

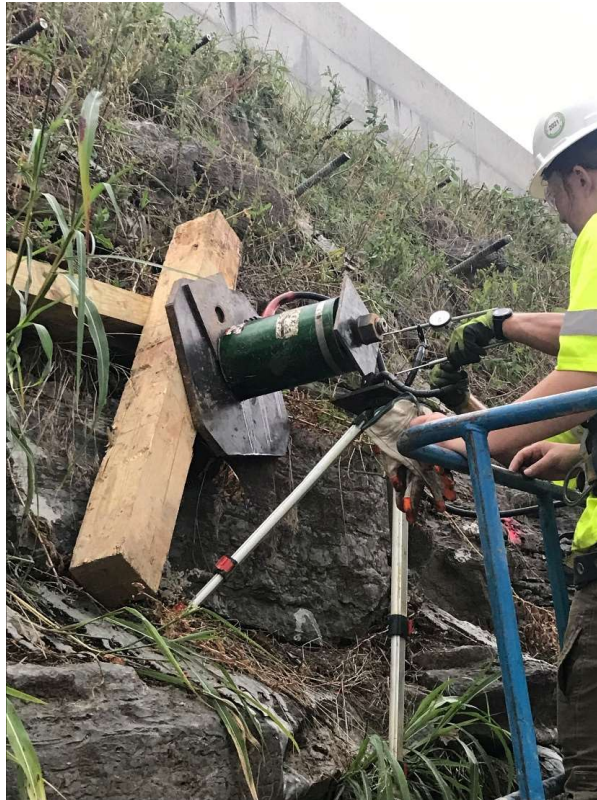
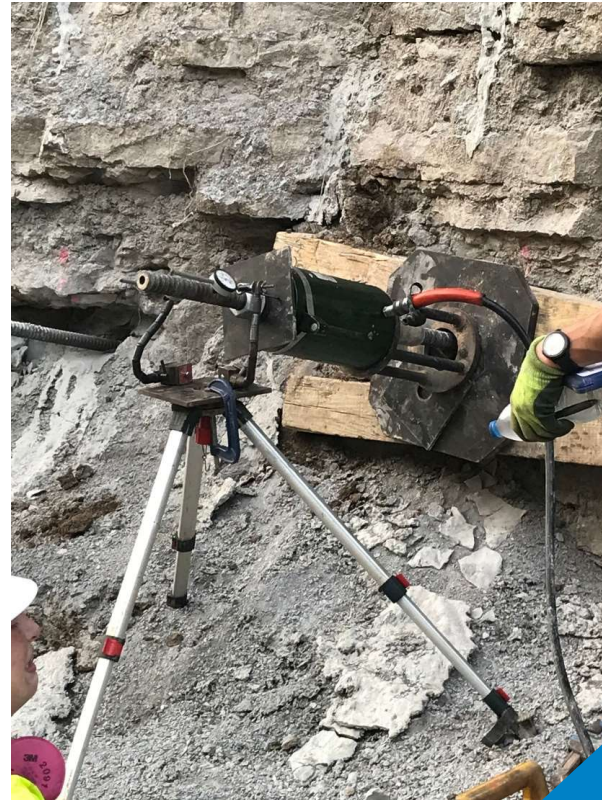
VERIFICATION AND PROOF TESTING

15 Proof Tests
8 Verification Tests
