Puerto Rico Geotechnical Asset Management Efforts

51st Southeastern Geotechnical Engineering Conference

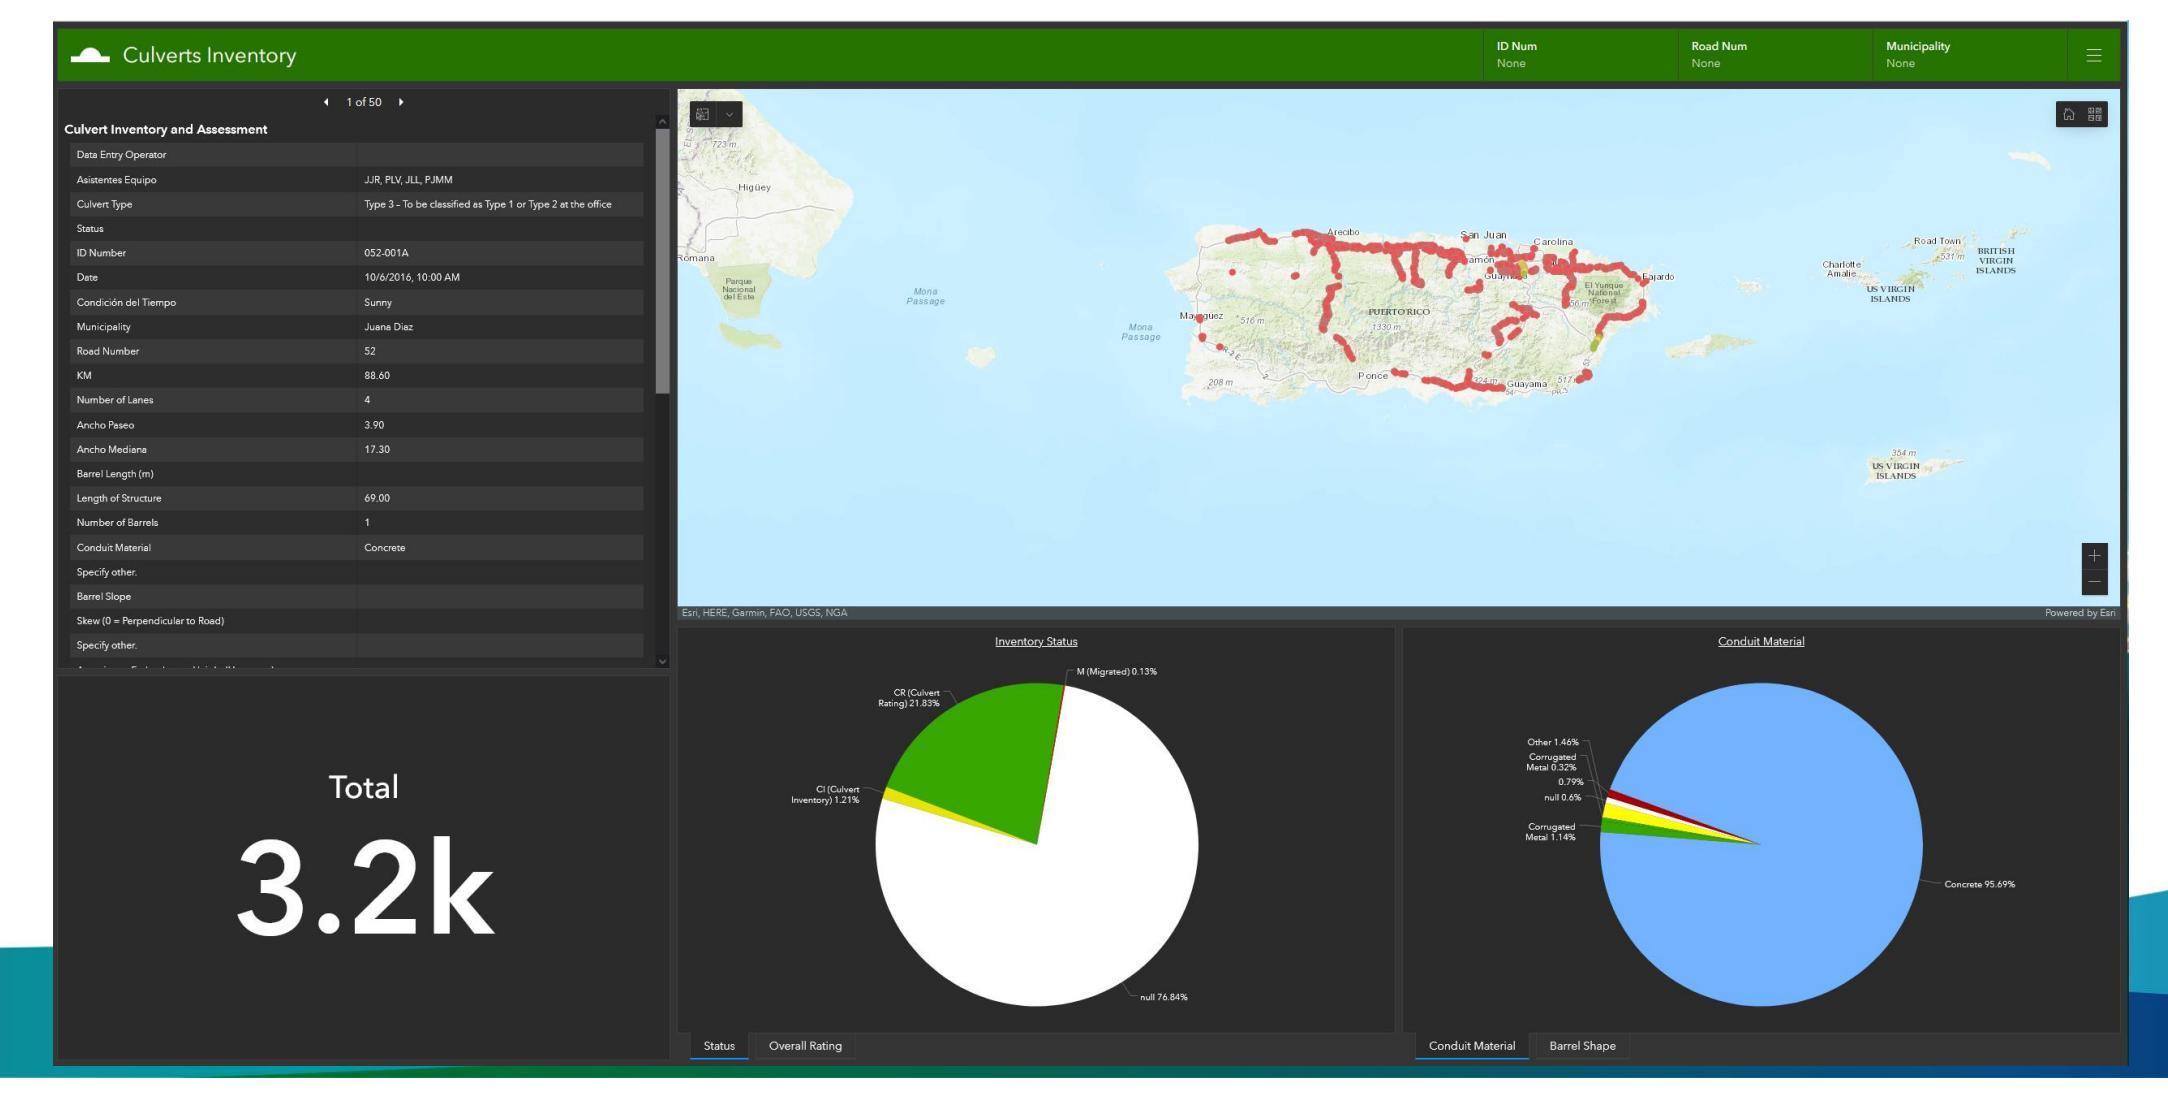
Culvert Inventory and Condition Assessment

- Started with a custom inventory using ArcGIS Collector
- Migrated the inventory to ArcGIS Survey 123, and modified the template to incorporate the recommendations of the "Culvert Assessment and Decision-Making Procedures Manual for Federal Lands"

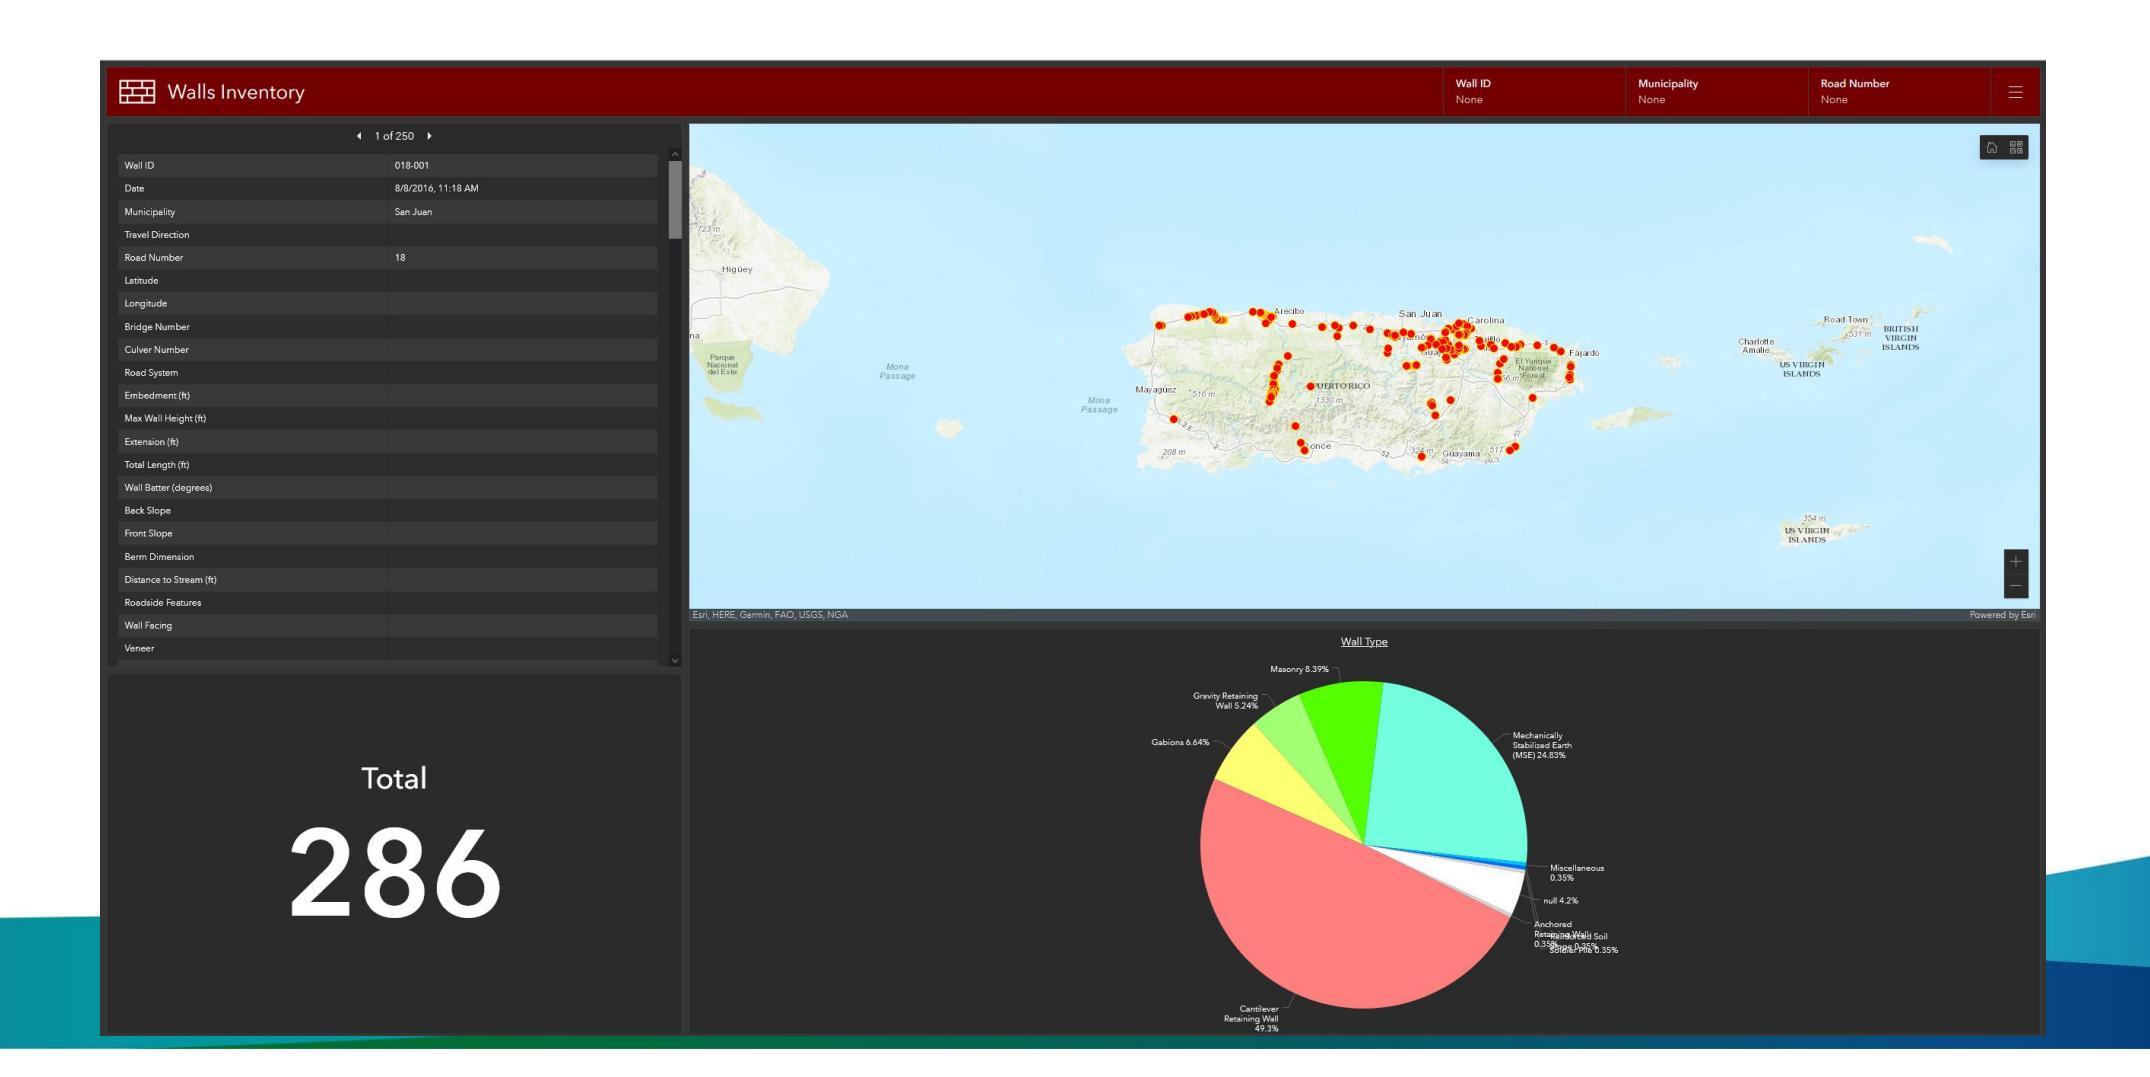
Retaining Walls Inventory and Condition Assessment

- Started with a custom inventory using ArcGIS Collector
- Migrated the inventory to ArcGIS Survey 123, and modified the template to incorporate the recommendations of publication "Retaining Wall Inventory and Assessment System"

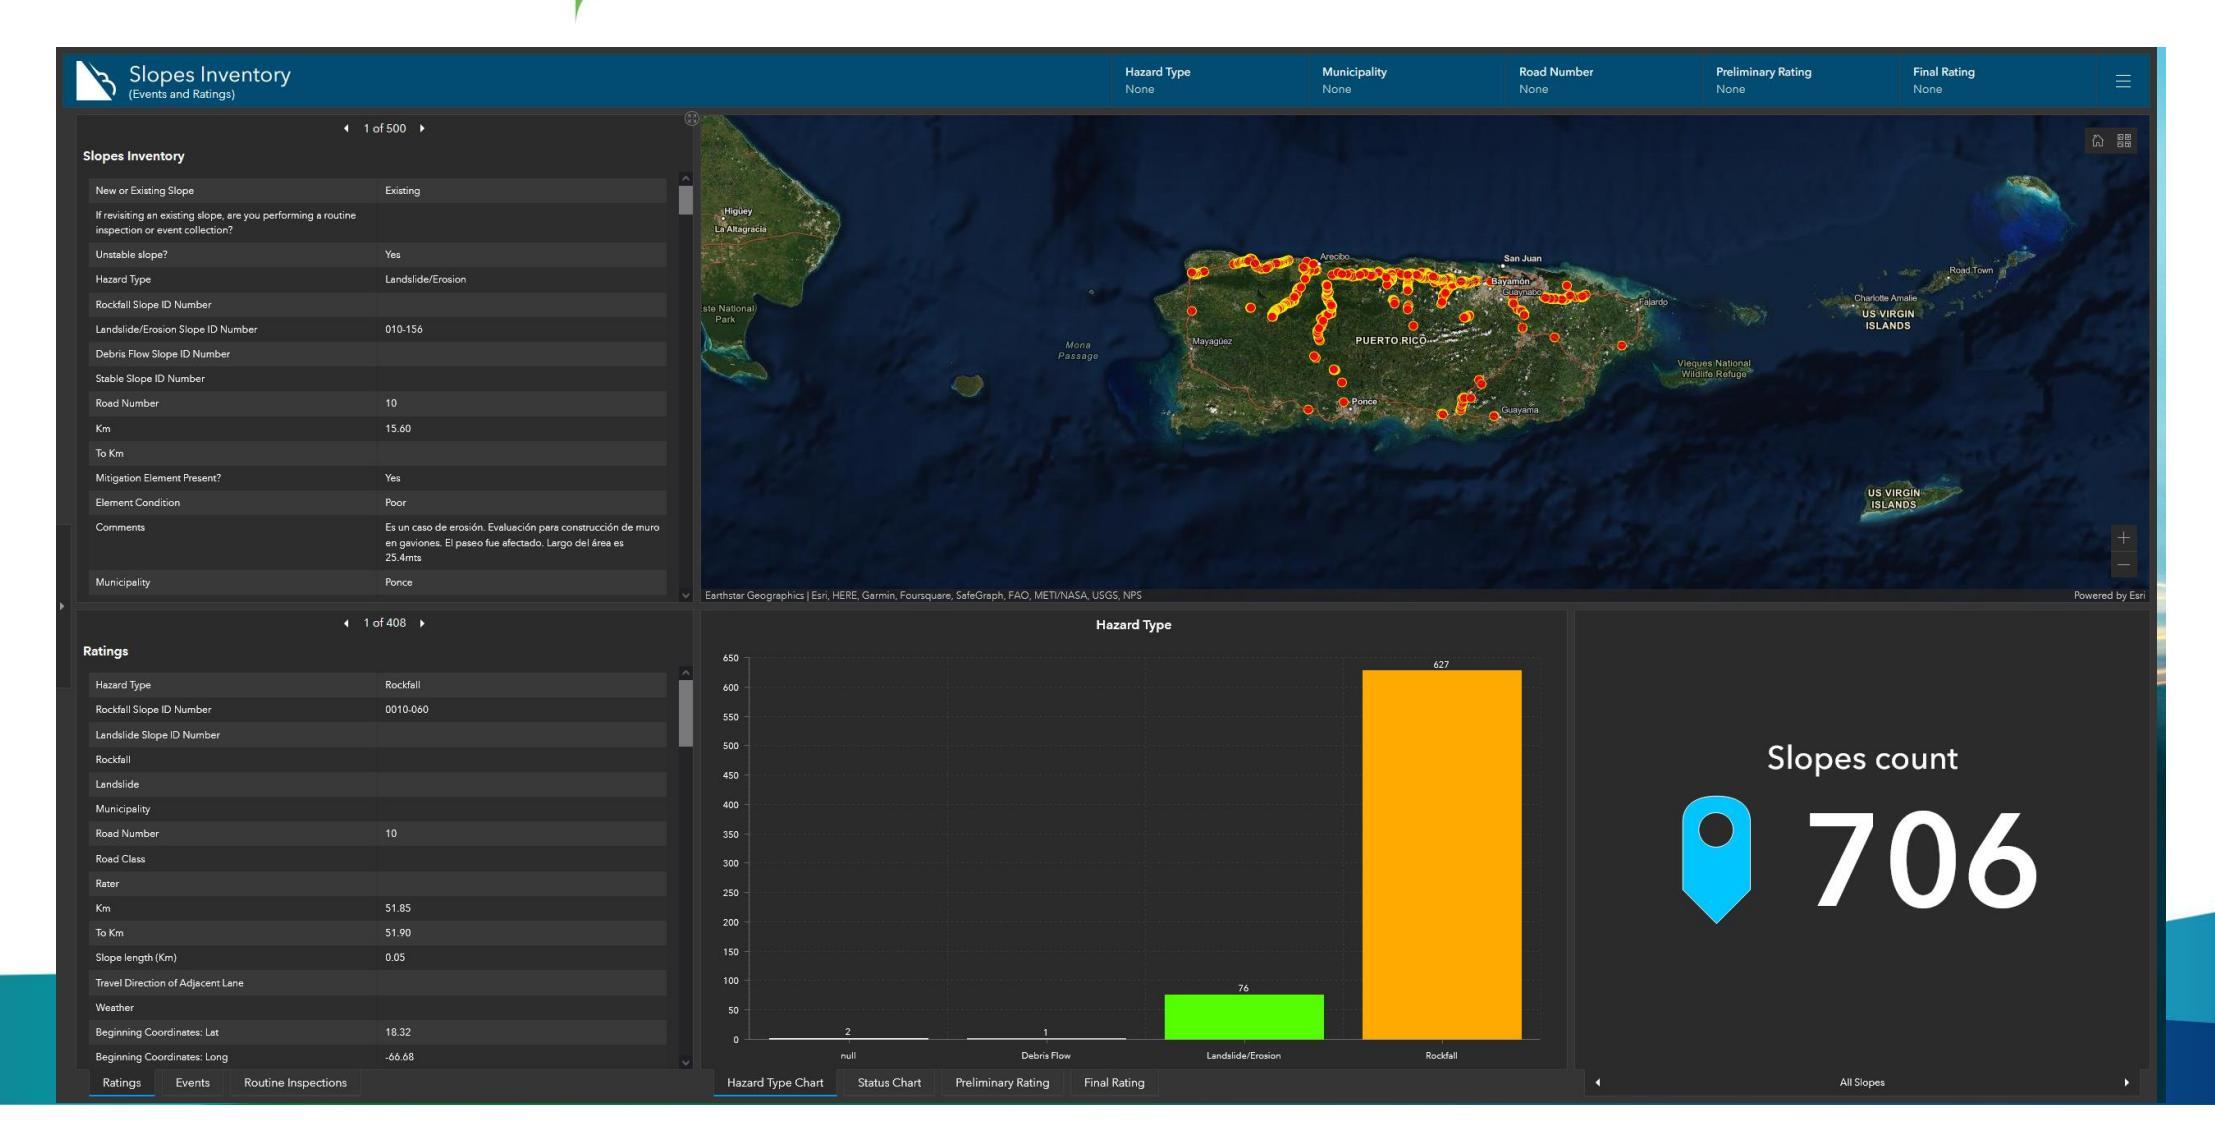
Slopes Inventory

- Started with a custom inventory and rating system using ArcGIS Collector
- Migrated the inventory to ArcGIS Survey 123, and modified the template to incorporate the recommendations of publication "Unstable Slope Management Program for Federal Land Management Agencies"

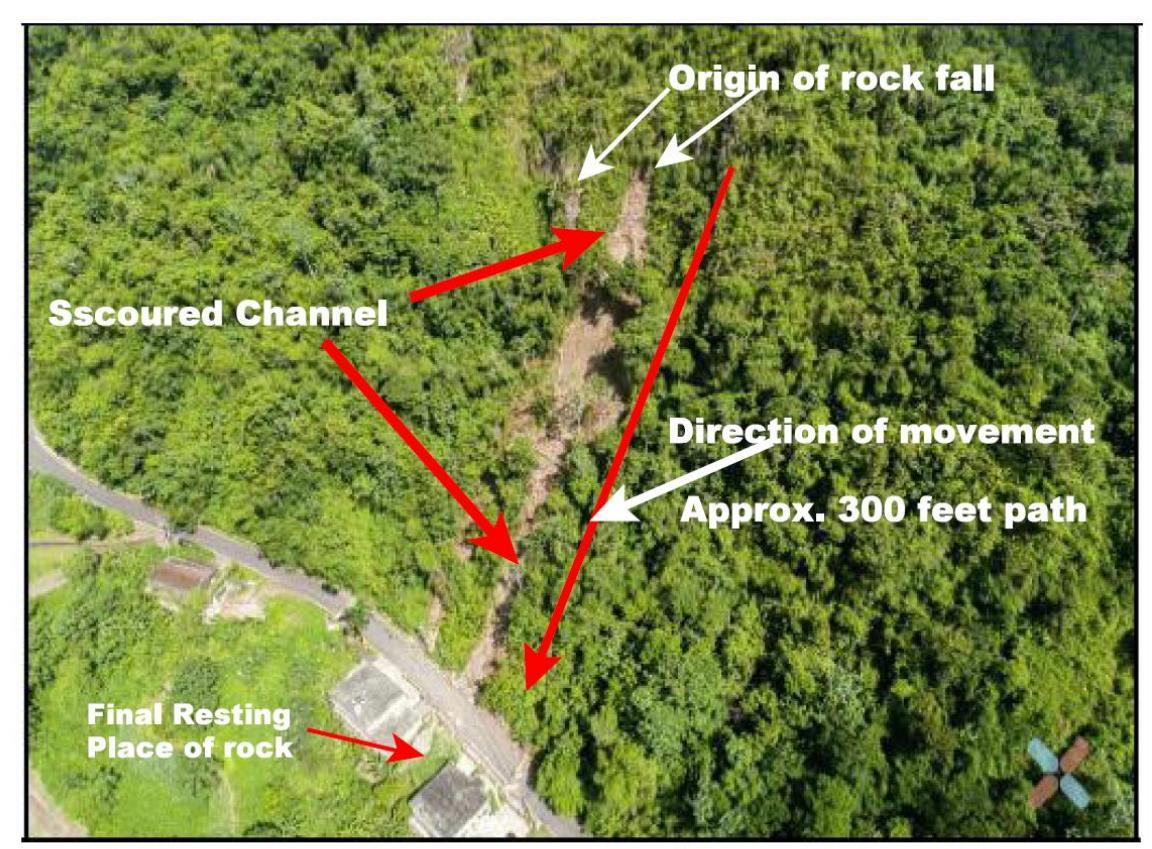
PR-615 Rockfall, First Event June 14, 2021

Figure 3. Photo shows rock fall scour movement direction, approximate path distance, and it's resting place between two houses adjacent to PR-615.

- Case History 1 PR-615 Rockfall, Ciales (Center of the Island)
 - First event June 14, 2021
 - Second Event August 30, 2022
 - No rockfall monitoring system
 - Closed road
 - Relocation of residents
 - Press and public opinion
 - Geological characterization performed using traditional procedures

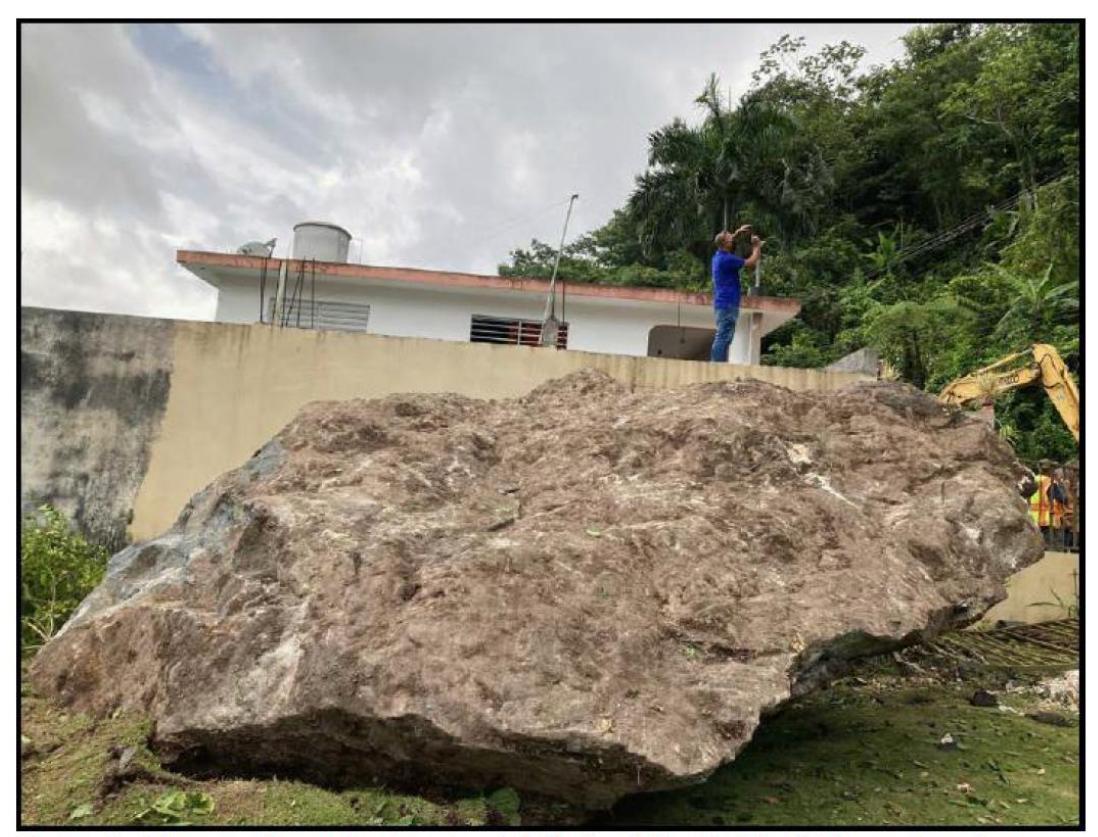
Figure 4. Close up of large boulder (rock fall) that fell and slid 300 linear feet along hillside, bounced on PR-615, and landed between two houses.
